Structural repair of Careva Ćuprija Bridge in Sarajevo

Professional paper

Structural condition and repair of the Careva Ćuprija Bridge in Sarajevo is presented in the paper. This historic structure has been exposed to various atmospheric influences during its use, and also to significant traffic load for which it was not initially designed, which has ultimately resulted in degradation of its structure. To enable continued functioning of this bridge its structure must be repaired taking into account the fact that the bridge was proclaimed a national monument of Bosnia and Herzegovina on 11 March 2009.

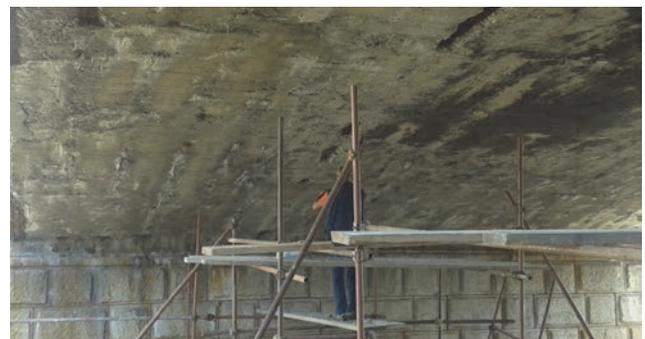
After removing some concrete from the bridge arch, it was established that the bridge intrados is reinforced with rigid reinforcement consisting of 2L sections measuring 60x60x4 mm (20 sets in total), as shown in Figure 6.

Figure 6. Location of rigid reinforcement

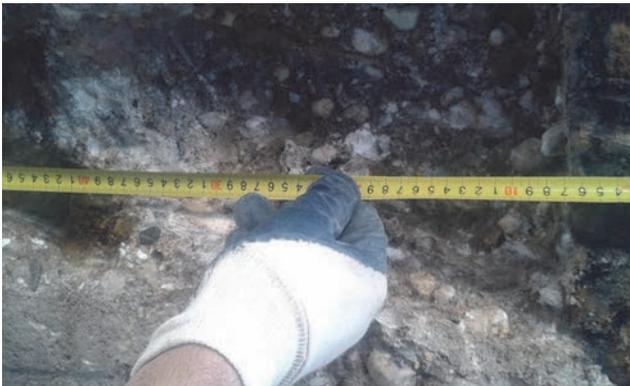
Figure 7 shows the position of the reinforcement that is arranged in the transverse direction at approximately every 45 cm to 50 cm intervals, and extends along the entire length of the bridge.

Figure 7. Rigid reinforcement spacing

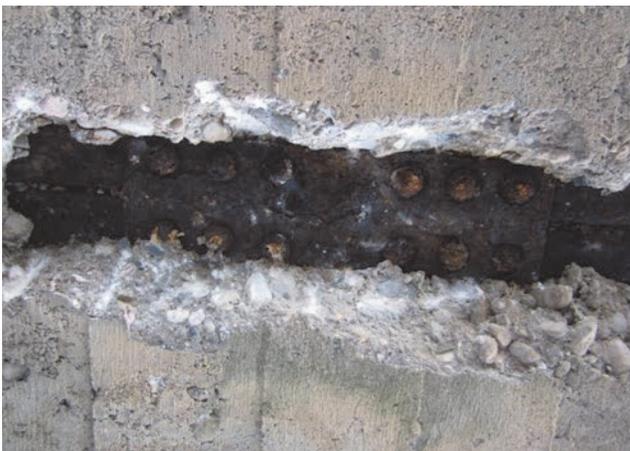
The rigid reinforcement was placed along the entire span of the bridge (Figure 6) with connections at four places. Figure 8 shows rigid reinforcement connection points. The rigid reinforcement connection was realized using a steel plate about 6 mm thick, with a set of six rivets on each side. The steel plate measures 46x13 cm and it is approximately 6mm in thickness. Rivets are spaced at 6 cm intervals. Inner spacing between the rivet sets is 13.5 cm, while the distance from the edge of the steel plate to the first (last) rivet is 4.5 cm. The steel corrosion and scaling was registered on the steel plates used as connections for rigid reinforcement.

Figure 8. Rigid reinforcement connection

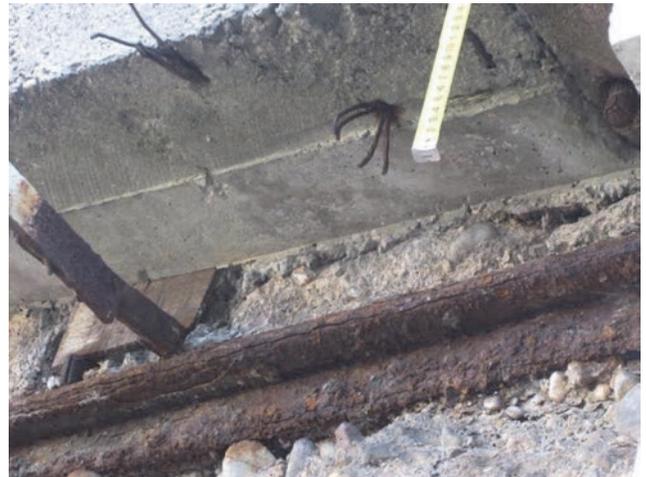
The bridge extrados is made of concrete with rigid reinforcement, which is placed at the ends, on both sides of the bridge (Figure 9). After removal of the top layers of the bridge structure, it will be possible to see whether this reinforcement is placed along the entire width of the bridge, as is the case with the intrados, or it is placed on the sides only. Figure 9 shows significant corrosion of the top rigid reinforcement. This reinforcement is unprotected and is directly exposed to

weather, presenting significant "swelling" due to an increase in the volume of reinforcement, which indicates that the reinforcement has been greatly affected by corrosion. It is well known that parts of the structure on the east side are highly exposed to rain and wind, which has resulted in quicker degradation and impact.

Figure 9. Corrosion of top rigid reinforcement - east façade-upstream side

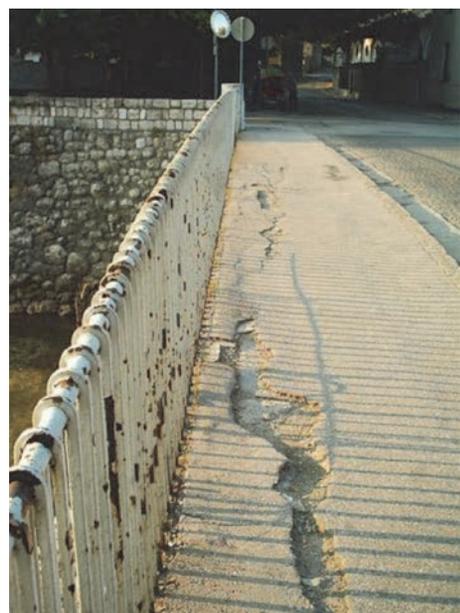
The fence of the bridge is in a very poor condition (Figure 10); the entire structure of the steel fence is affected by corrosion. Also, spalling of concrete was observed on the sides of the bridge structure (east façade - upstream side of the bridge, and west façade - downstream side of the bridge) at the connection with S-shaped steel elements and their corrosion (Figure 11).

Figure 10. Corrosion of steel fence and sidewalk damage

Figure 10 shows sidewalk degradation and lack of asphalt layer. Damage to sidewalk and railing is due to the freezing and thawing

processes. Once water is allowed to penetrate into the capillary system and it freezes, the pores and cavities are enlarged due to hydrostatic pressure, which is caused by an increase in the volume of frozen water. This pressure expands the pores and capillaries quite slowly, over a number of cycles. The damage due to freezing and thawing processes, in the form of sputtering and spalling of concrete, mainly resulting from progressive expansion of cement stone, was also registered. This freezing and thawing effect is greatly enhanced by the use of deicing salts, which are regularly used for road maintenance. This caused maximum spalling on the concrete surface. In the end, breaking and spalling of concrete led to exposure of reinforcement to corrosion due to penetration of chlorides and moisture.

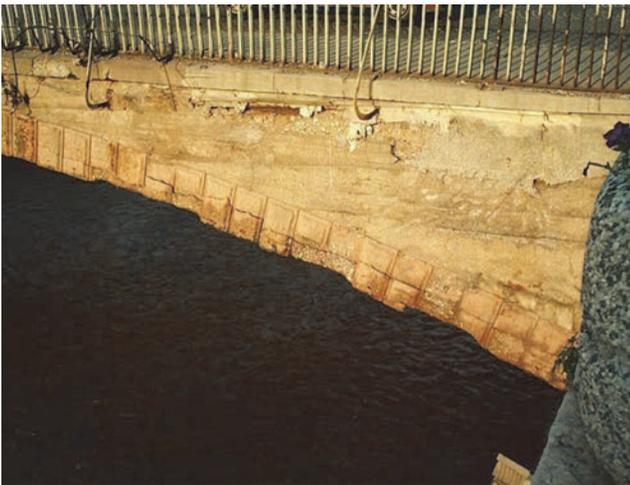
A horizontal crack extending along the entire length of the sandstone lining can clearly be seen at the eastern façade (Figure 11). Due to great exposure to rain and wind action, this stone lining on the east façade suffered considerable damage, the level of which is greater compared to the damage registered at the western façade.

Figure 11. Detachment of decorative elements, horizontal cracks in concrete on the arch, and corrosion at the railing support - east façade - upstream side

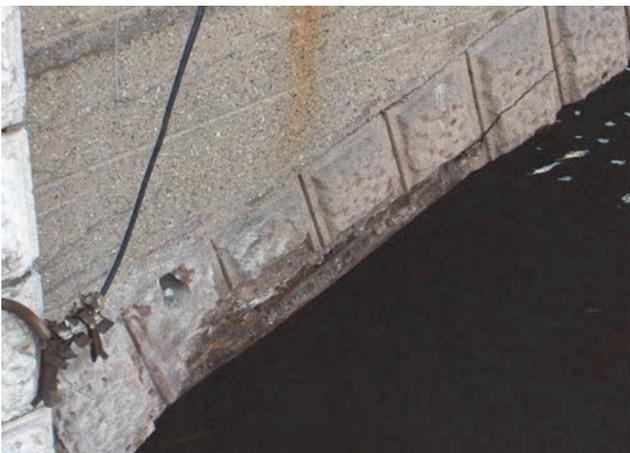
Figure 12. Horizontal cracks on the walls: east façade - upstream side

Figure 12 shows a significant horizontal crack that extends almost along the entire length of the arch on the lateral side. This crack does not affect only the decorative element but extends through the load bearing concrete structure of the arch. This is to be expected given the significant corrosion of the rigid reinforcement on the intrados. Also, vertical cracks are evident on lateral walls of the arch. Cracks generally increase the porosity of concrete and allow water, soluble salts, and chemicals to penetrate into concrete, and thus accelerate its destruction and open the way for further corrosion of the rigid reinforcement. Significant corrosion at the bottom rigid reinforcement along the edge of the arch is shown in Figure 13, as well as the lack of concrete cover. As is known, concrete, thanks to its alkaline nature, protects steel reinforcement from corrosion. A high pH value enables formation of a thin protective layer of stable oxides on the steel surface, preventing further development of rust. When this protective layer of stable iron oxides is damaged by the action of acidic environment, the depassivation phenomenon inevitably occurs, i.e. the steel corrosion is initiated. The increase in reinforcement volume due to corrosion is evident, resulting in creation of internal stress, cracking and spalling of concrete. Longitudinal cracks are evident on the corroded "rigid reinforcement". Parts of rigid reinforcement that are completely "stripped" are exposed to active atmospheric actions, and so the structural capacity of these elements is compromised. This situation creates conditions for expansion of corrosion to the passivated part of rigid reinforcement.

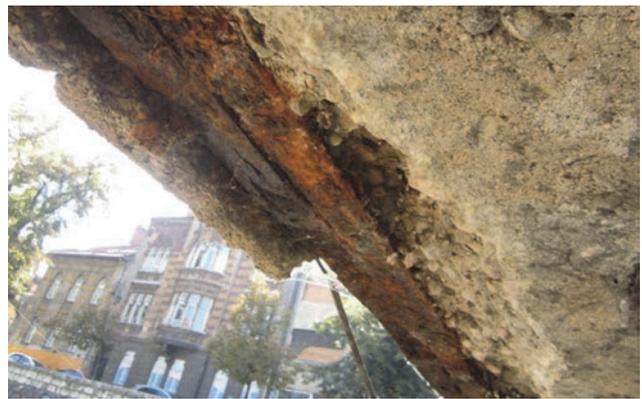
Figure 13. Corrosion of rigid reinforcement at bottom side of the arch - east façade - upstream

The entire surface of the metal is affected by general corrosion, with additional subsurface or layered corrosion. The corrosion is the most pronounced at steel parts that have been in contact with water and acids.

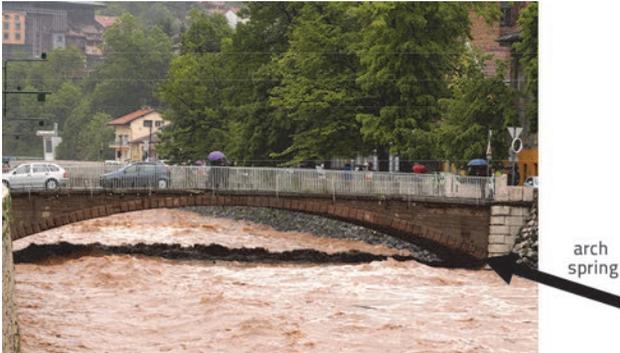
It should be noted that in the May 2014 flooding the level of the Miljacka River was the highest in the last ten years. It was 244 cm and the water reached the level of the arch spring (Figure 14), and so parts of the structure were directly exposed to the action of water. A similar situation, although at a smaller scale was registered in 31 October 2007. In the light of current information about the torrential character of the Miljacka River, the

question regarding safety of this bridge in case of a future flood should rightfully be considered. Besides destruction of the bridge materials due to torrential character of the Miljacka River, the river carries waste materials and debris and thus causes further damage to the bridge structure and the embankment of the Miljacka River. As it is well known, the scouring process differs if it occurs in water not burdened with sediments, compared to the scouring in rivers with significant bed load.

Figure 14. Flooding in May 2014

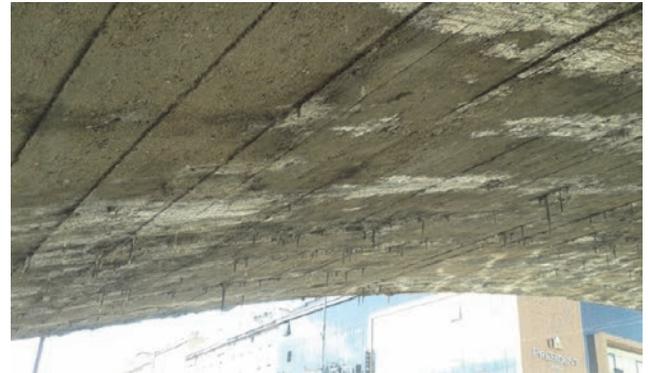
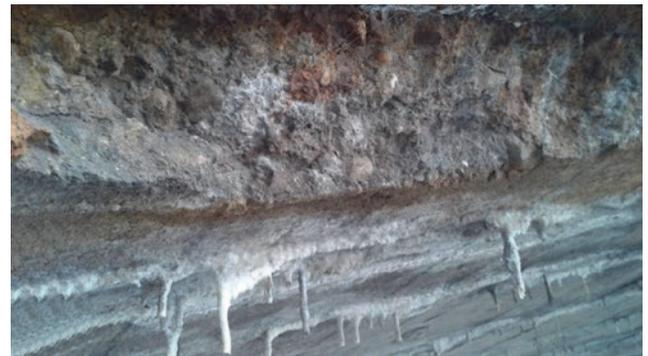
Figures 15 and 16 show that carbonation of concrete occurs when carbon dioxide from the air penetrates into the concrete and reacts with hydroxides, such as calcium hydroxide, forming carbonates. In the reaction with calcium hydroxide, calcium carbonate is formed. This process reduces the pH value of the solution within pores to less than 11.8 and, at that level, the passive iron oxide film on the steel becomes unstable, leading to corrosion. Carbonation is largely dependent on relative humidity. The greatest carbonation level occurs when the relative humidity is maintained in the range between 50 % and 75 %.

Just like chloride ions, the carbonation destroys the passive film on the reinforcement, but has no effect on the corrosion rate. Water from the carriageway penetrated through filling material to the concrete arch and caused flow-assisted corrosion (corrosion of soft water). It is known that on its way the seepage water dissolves calcium hydroxide (product of Portland cement hydration), which is deposited on the surface of the concrete where it reacts with CO₂ (carbon dioxide) contained in the atmosphere, forming a relatively solid, hard, well-adherent, bright coating of calcium carbonate (CaCO₃) appearing in form of downward oriented jets. Eventually, they spread and become thicker ruining the surface, and assuming the form of stalactites or stalagmites. Their formation is evident along the entire bottom surface of the bridge (intrados) in locations of rigid reinforcement. The stalactites are approximately 20 cm in length and about half a centimetre in diameter.

Figure 15. Carbonation of intrados and formation of stalactites

Figure 16. Carbonation of intrados and formation of stalactites

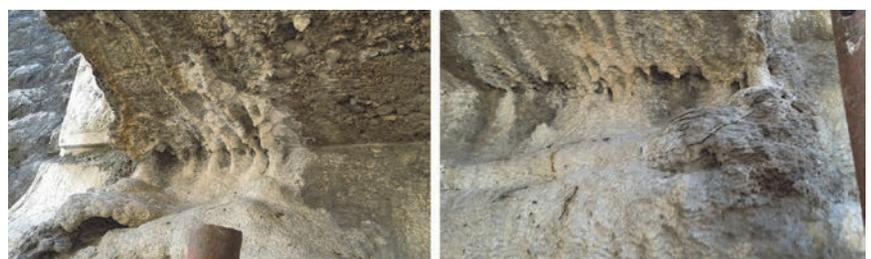
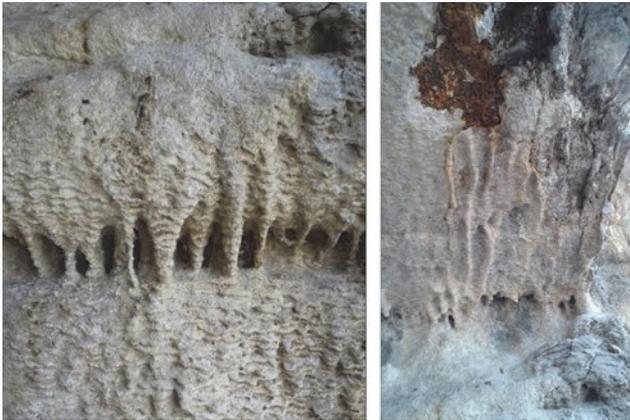
In addition to the flow-assisted corrosion, the concrete on this bridge is also exposed to general acid corrosion. General acid corrosion is formed by the action of from the environment CO₂ on the cement stone, which results in a chemical reaction. Carbon dioxide and water form carbonic acid which reacts with Ca(OH)₂ forming CaCO₃; however other compounds of the cement stone decompose and water is released in the process. Therefore, the bridge is affected by soft water corrosion (flow-assisted corrosion) in combination with general acid corrosion. Figures 17 and 18 show formation of deposits on the abutment. This deposit is up to 20 cm in thickness and it peels off and separates from stone blocks that are placed around the abutments of the bridge structure. Figure 19 also clearly shows significant corrosion of rigid reinforcement near the left abutment on the downstream side. This corrosion penetrates through significant deposits that have formed as a result of corrosion release. The carbonation results in a decrease in concrete alkalinity.

Figure 17. Deposits at left abutment - east side

Figure 18. Deposits at left abutment - east side

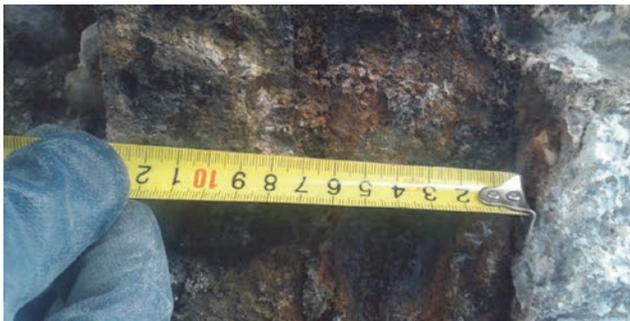
Figure 19 shows rigid reinforcement at the intrados. The rigid reinforcement consists of 2L sections measuring 60x60x4 mm, which are separated by a layer of concrete 1 cm in thickness. The overall width of the rigid reinforcement and concrete amounts to 13 cm. A significant corrosion was observed after removal of concrete cover (5 cm) (Figure 20). The steel peeling can clearly be distinguished. The degree of steel corrosion varies depending on the position of the rigid reinforcement and the existence or absence of concrete cover. Overall, it can be stated that the rigid reinforcement is highly corroded.

Figure 19. Rigid reinforcement

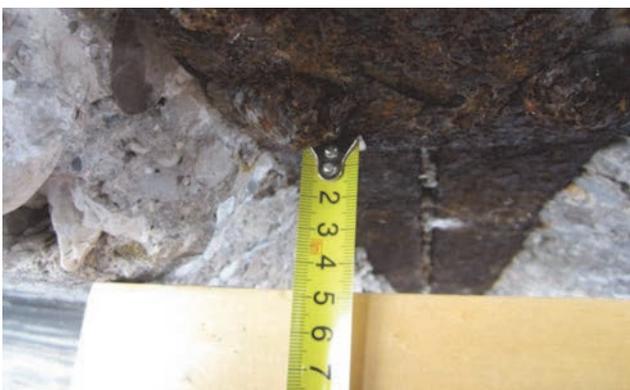
Figure 20. Thickness of concrete cover

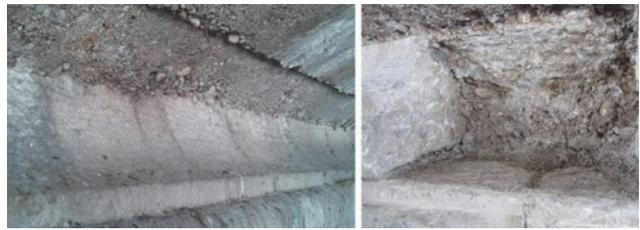
After removal of stone blocks (Figure 21) at the location of left abutment, it was observed that the stone blocks serve exclusively as lining.

Figure 21. Abutment stone blocks at the left bank of the river and situation after their removal

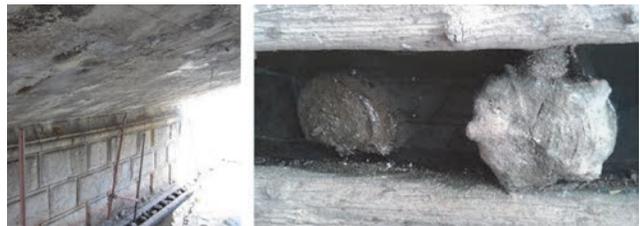
A part of the Miljacka river bank is protected by wooden beams and piles placed between two beams (Figure 22). Wooden piles are of variable diameter ranging from approximately 10 cm (smaller) to 30 cm (bigger ones). They are spaced at approximately 50 to 80 cm from each other. As investigations were conducted in dry period (August 2015), it was noted that wooden piles are not fully covered with water, but are free of water some 5-8 cm.

Figure 22. Wooden piles and beams along the Miljacka river bank

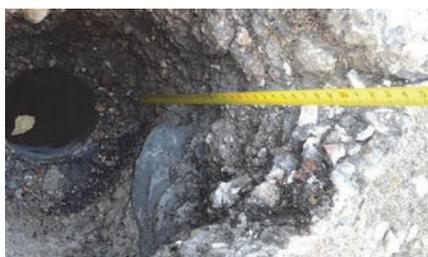
A waterproofing tar layer ranging from 5 to 8 mm in thickness was found on top of the extrados (Figure 24).

Figure 24. Waterproofing tar layer

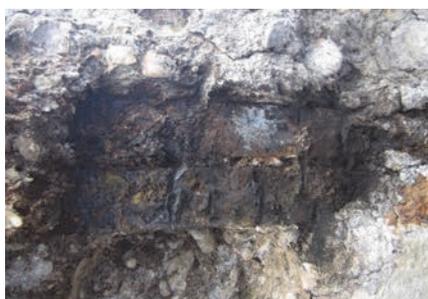
Steel hardness was tested on the site using the POLDI method. The testing of steel hardness of the rigid reinforcement located on the intrados of the bridge is shown in Figure 25. Based on testing conducted on rigid reinforcement 2L 60 x 60 x 4mm, the steel can be classified as steel class Č 0545 according to JUS standards (according to EN 10027-1 E295, and DIN St 50-2), with the tensile strength of 470 N/mm², and the yielding strength of 285 N/mm².

Figure 25. Steel hardness testing

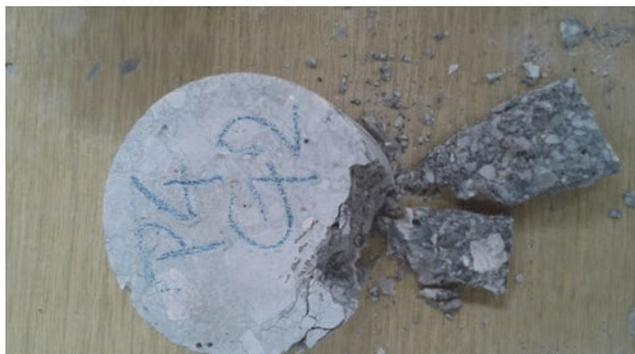
The analysis of P4 samples has revealed that a different type of concrete was used (Figure 28), and that it is a well structured factory-mixed concrete with dolomite aggregate, most probably originating from the post-war decades of the past century, or from this century. These data

cannot be taken into account when calculating the current class of concrete from the bridge arch because it represents a "new" concrete that was obviously used in bridge repair some ten to fifteen years ago. This concrete sample is completely different from the other samples regarding its structure, where in all other samples river aggregate and another type of cement has been used.

Figure 28. Sample from sidewalk (P4)

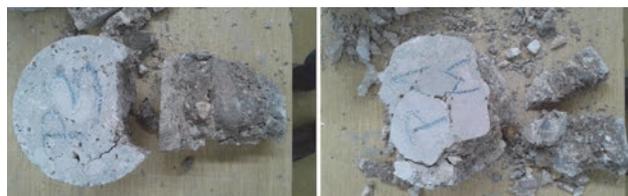
All other samples are of different structural composition involving the use of river aggregate (Figure 29) and cement that has, unlike cements produced since the mid twentieth century, a conspicuous change in cement stone colour (darker and lighter shades of brown).

Figure 29. Samples from other parts of the structure

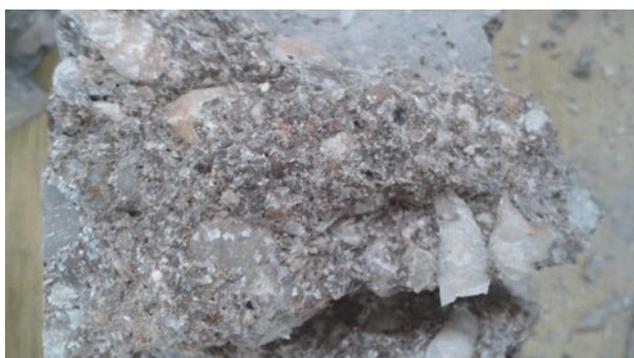
occurs at the location where these samples were extracted. Due to the soft water seepage, capillaries are being filled, which is manifested by concrete coagulation and increase of density in hardened state. The values of density (2142 kg/m³ and 2134 kg/m³) and compressive strength on the cube (37.0 MPa and 39.5 MPa) greatly deviate from all other similar results [8]. Water seepage through concrete is characterised by uneven filtration: the number of filtration channels is the greatest at the beginning of the filtration path, next to concrete surface exposed to pressure. Blockage of filtration occurs due to hydrolytic decomposition of cement stone and swelling of colloidal compounds (mostly calcium hydrosilicate). The process of leaching is significantly slowed down only if the layer depleted and weakened by leaching of lime, which is formed on the surface of concrete, does not fall apart due to mechanical or hydraulic effects (Figure 30). Significant corrosion of concrete can be observed on all samples (Figure 31).

Figure 31. Seepage through concrete

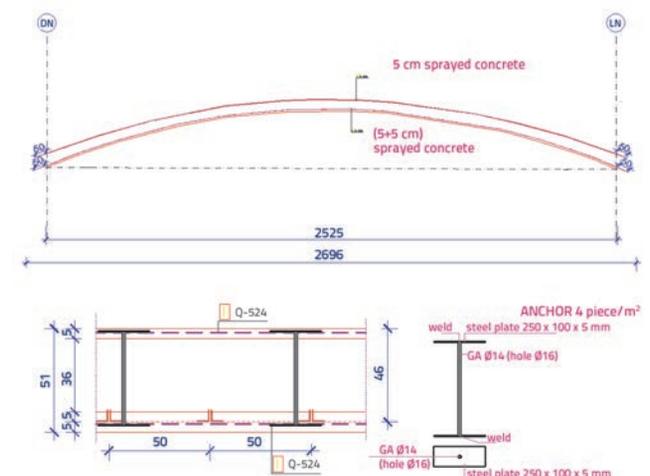
Figure 35. Reinforcement of the arch and anchor detail

It was established according to calculations that the intrados of the bridge structure will be strengthened with reinforcement meshes (MA 500/560) Q524 and with sprayed concrete class

MB 20 10 cm in thickness. The extrados will be reinforced with meshes (MA 500/560) Q524 and with sprayed concrete class MB 20 approximately 5 cm in thickness. Shotcrete is traditionally used to increase the arch thickness in order to increase the carrying capacity, and to stabilize and protect structures exposed to atmospheric conditions. A large number of Victorian masonry bridges and arch structures in England were strengthened in this way [14].

Reinforcement of the intrados and extrados is shown in Figure 35 together with the anchorage detail that will be used for connection of the top and bottom reinforcement.
