# Behaviour of 3D RC frames placed at different angles on shaking table

Behaviour of RC frames placed at different angles (biaxially) on the shaking table is analysed in the paper. The testing was conducted on four two-storey one-bay 3D RC frames scaled down to 1:6 of the original size, the aim being to analyse defects commonly observed on residential buildings. All specimens had infill walls and similar window openings. The specimens were subjected to sinusoidal dynamic testing. Test results show that different failure modes occurred at all specimens in the X and Y directions.

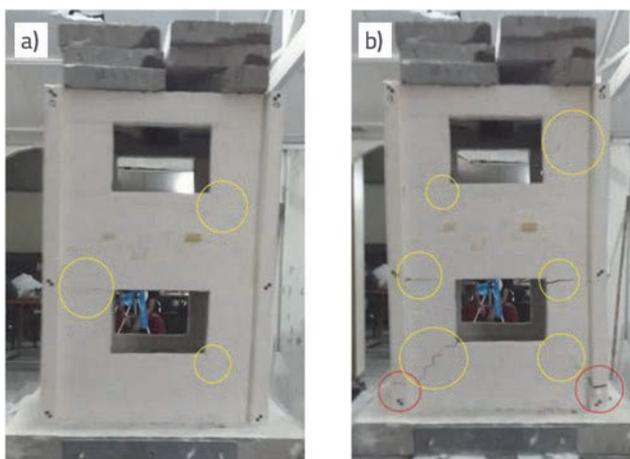
The first specimen was the reference frame (Specimen 1) placed 0 degrees on shaking 7 table and tested to see the reference behavior for comparison purposes. According to Figure 15, this 8 test was begun at 2 sec and finished at 14.2 sec. The first cracks occurred as shear cracks at the corners of the window opening at the 1<sup>st</sup> and 2<sup>nd</sup> storeys at 7.51 s and 7.53 s (Figure 19.a and Table 5). Later on, at Specimen 1, shear cracks occurred at the end point of the left column at 7.66 s and at the end point of the right column at 7.72 s (Figure 19-b and Table 5).

joint (right) of 1<sup>st</sup> storey at 9.56 s. Diagonal shear cracks occurred on two sides of brick wall of the window opening of the 2<sup>nd</sup> storey at 9 seconds. Shear cracks occurred at the window opening of the 1<sup>st</sup> and 2<sup>nd</sup> storeys. Specimen 1 was completely destroyed by collapse of the 1<sup>st</sup> storey at the end of the test (Figure 20).

Figure 19. a) Brick walls of Specimen 1; b) Columns of Specimen 1 where first cracking was observed

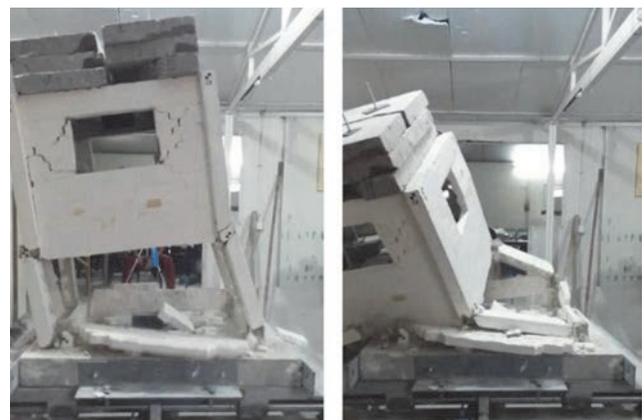
Figure 20. Failure mode for Specimen 1 ( $0^\circ$ )

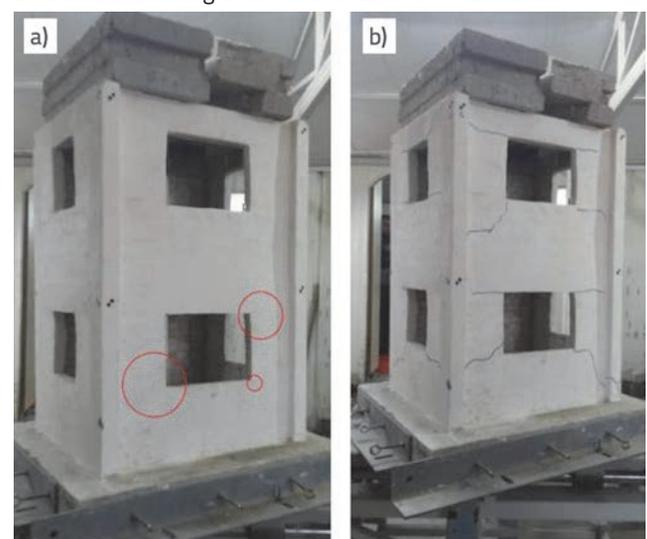
The second specimen was placed 30 degrees on the shaking table. Specimen 2 was 2 tested with 1<sup>st</sup> and 2<sup>nd</sup> ground motions. According to Figure 16, this test was begun at 0 sec and 3 finished at 28.70 sec. The first cracks occurred as shear cracks at the bottom left and top right corners of the window opening of the 1<sup>st</sup> and 2<sup>nd</sup> storeys at 6.43 s and 6.45 s (Figure 21-a and Table 6). The first cracks occurred at the forward ground motion. Later on, the other cracks occurred as shear cracks at the top left and bottom right corners of the window opening of the 1<sup>st</sup> and 2<sup>nd</sup> storeys at 6.54 s and 6.55 s (Figure 21-b and Table 6). These cracks occurred at the backward ground motion. Shear cracks occurred at the end point of the right column at 7.41 s (Figure 21-b and Table 6). Specimen 2 did not completely collapse at the end of the test.

Figure 21. a) first cracks at Specimen 2 occurred at the 1<sup>st</sup> ground motion; b) damage at the end of the 1<sup>st</sup> ground motion

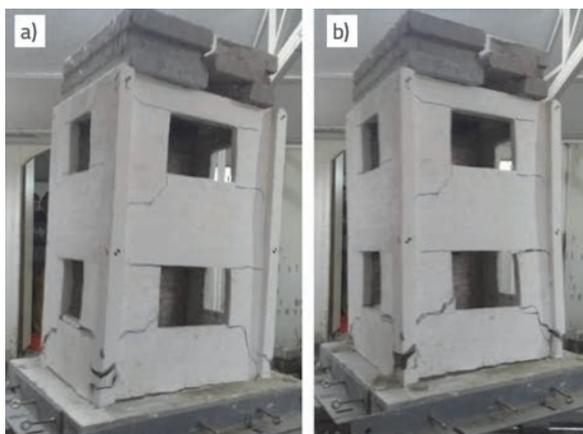
At the 2<sup>nd</sup> ground motion stage, hinge occurred on the long façade at columns-base joints and wall-base joints, and shear cracks occurred under and at the corner of the window opening on the other short façade of Specimen 2 at 16.95 seconds. In addition, separation of the brick wall from the RC frame above the window opening is shown in Figure 22. Cases of damage by the forward and backward movement of the shaking table are shown in Figure 22-a and Figure 22.b, respectively.

Figure 22. Specimen 2 suffered damage in the forward and backward movement of shaking table

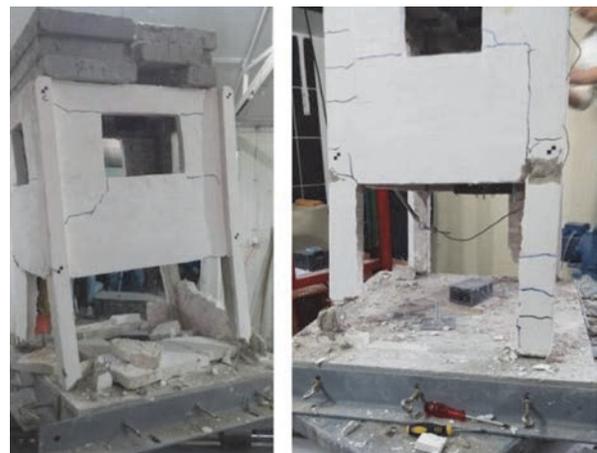
The main damage to Specimen 2 occurred at the column-base joints in form of plastic hinge. Besides, torsional effect occurred at all frames on Specimen 2. Because brick infill walls of the 1<sup>st</sup>

storey were completely destroyed, the soft storey irregularity was observed at Specimen 2 (Figure 23).

Figure 23. Failure mode for Specimen 2 at the end of the 2<sup>nd</sup> stage of ground motion

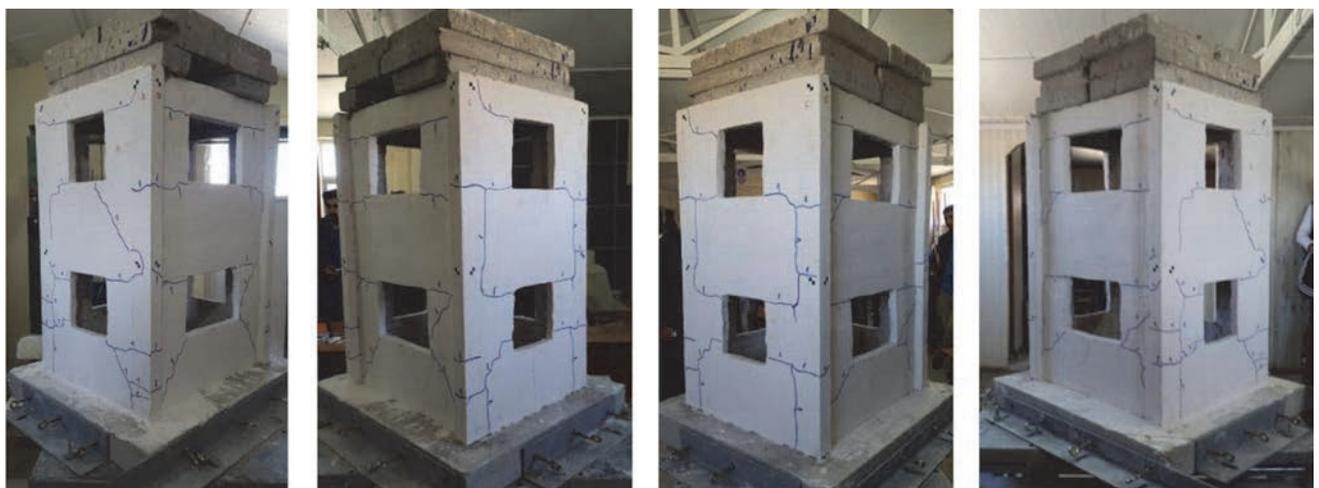
The first cracks occurred as shear cracks at the bottom left and top right corners of the window opening of the 1st storey at 6.54 s (Figure 24 and Table 7). The shear cracks occurred at the end point of the left column at 6.54 s (forward ground motion) and right column at 7.128 s (backward ground motion). These cracks occurred only at the corners of the window openings at the 1st ground motion at the end of the stage (Figure 24 and Table 7). The shear cracks and bending cracks occurred at the columns of the frame (Figure 24 and Table 7). Specimen 3 did not collapse at the end of the 1st stage of ground motion.

Figure 24. Failure mode for Specimen 3 (45°) at 1st ground motion stage

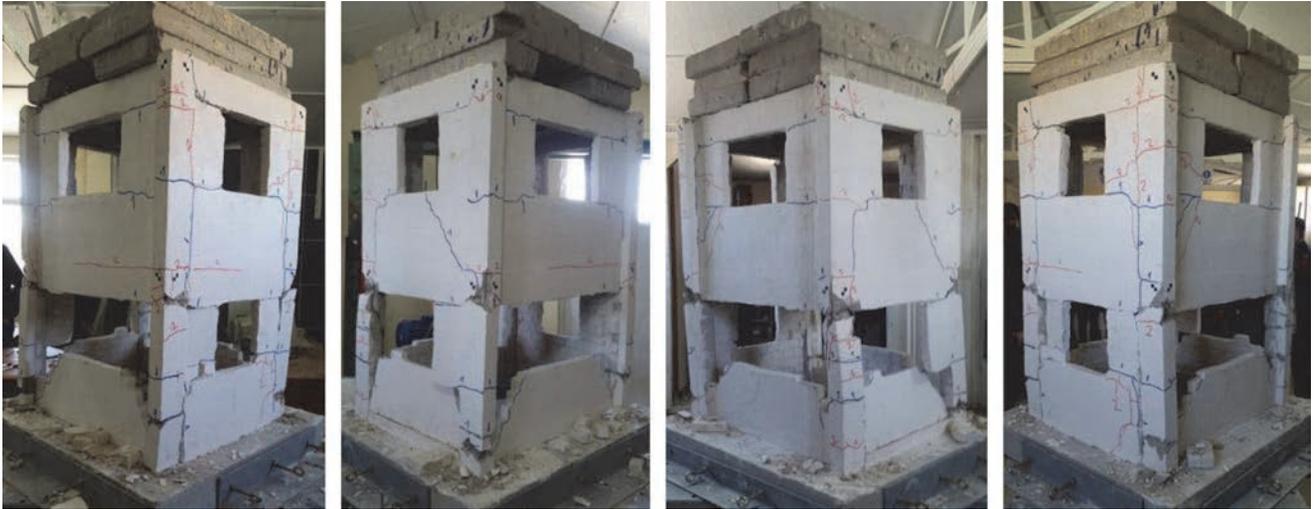
Figure 25. Failure mode for Specimen 3 at 2<sup>nd</sup> ground motion stage

The 1<sup>st</sup> storey of Specimen 3 did not completely collapse at the end of the 2<sup>nd</sup> stage of ground motion (Figure 25). But the 1<sup>st</sup> storey suffered major damage. The top brick wall part of the window opening of the 1<sup>st</sup> storey collapsed. Besides, at the 2<sup>nd</sup> stage of ground motion, the plastic hinge started to occur on the column-base joints and at the column-beam-column joints. These joints suffered major damage. The short column irregularity was observed and the shear cracks and bending cracks reached the columns. Besides, torsional effect occurred at all frames.

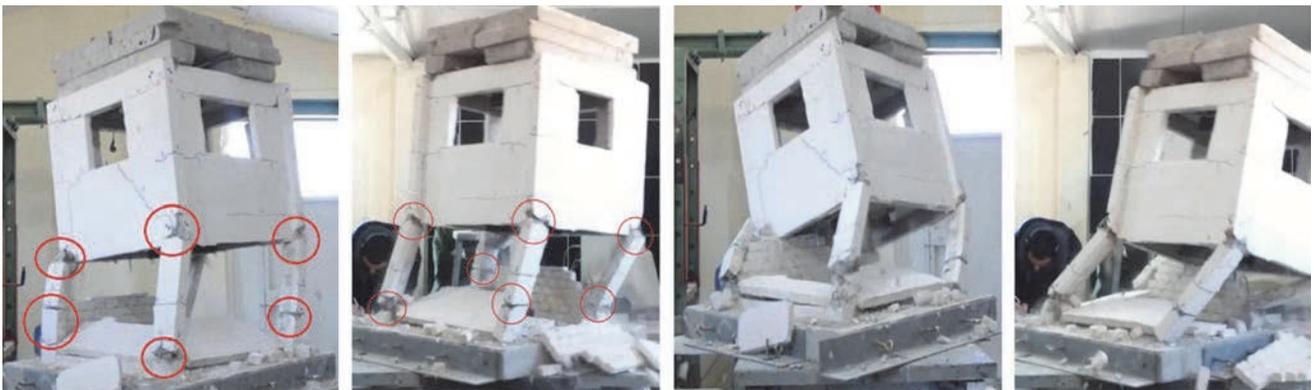
Figure 26. Failure mode for Specimen 3 at the end of repeated 1<sup>st</sup> stage of ground motion

At the repeated 1<sup>st</sup> stage of ground motion, the plastic hinge reached column-beam-column joints and column-base joints at  $8.5\text{ s}$ , and Specimen 3 collapsed completely at the level of the 1<sup>st</sup> storey at the end of the test (Figure 26). Because torsional effect occurred at all frames, this specimen collapsed completely at the end of the test.

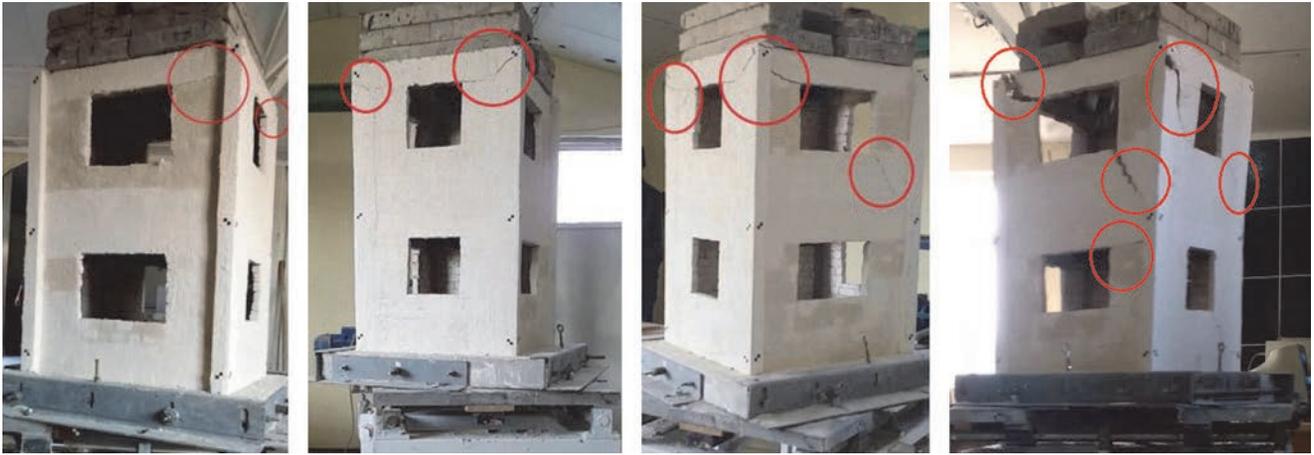
The fourth specimen was placed at 60 degrees on the shaking table. Specimen 4 was tested by applying the 1st ground motion. First cracks were observed at each façade window corner of the 2<sup>nd</sup> storey as shear cracks. They occurred at the column-beam joint of the 2<sup>nd</sup> storey at 1.96 s as hinge formations (Figure 27 and Table 8). Shear cracks occurred at the end point of the column of the 1<sup>st</sup> storeys at 2.03 s and column-beam joint of the 2<sup>nd</sup> storey at 2.25 s (Figure 27 and Table 8). As can be seen in Figure 27, the second storey damage was greater compared to that of the first storey. The plastic hinge formations occurred at the column-beam-column joints of the 2<sup>nd</sup> storey at the end of the 2<sup>nd</sup> ground motion. Diagonal shear cracks occurred at the window corner of all brick walls. All brick walls collapsed at the end of the test (Figure 28). The hinge formation occurred on column-beam-column joints and column-base joints of Specimen 4 at 11 seconds.

Figure 27. First cracks for Specimen 4 (60°) at various directions

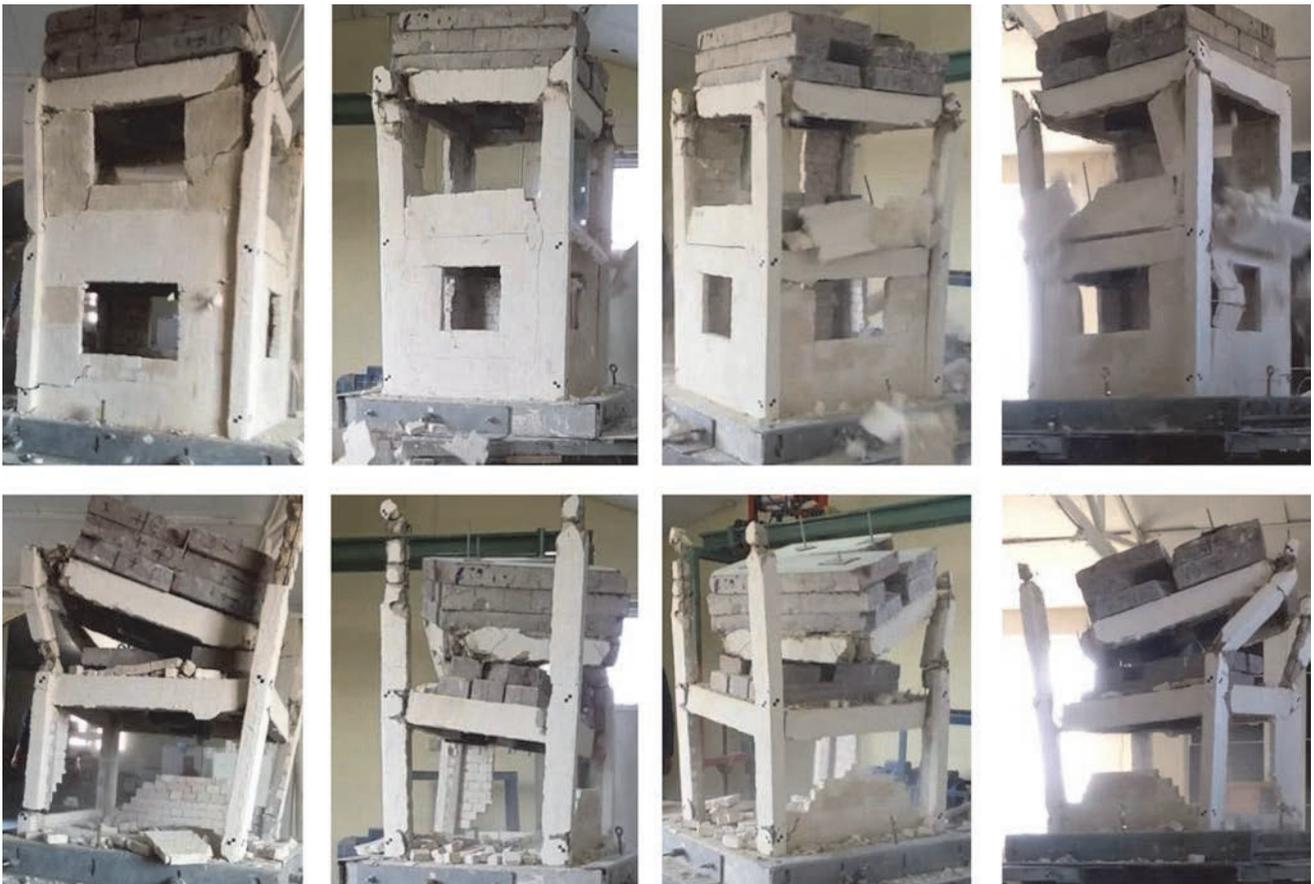
Figure 28. Failure mode for Specimen 4

- Plastic hinge was observed at the column-beam-column joints and column-base joints of Specimen 4. The slab of the 2<sup>nd</sup> storey collapsed due to failure of the slab-beam connections. Also, all brick walls collapsed at the end of the test. Besides, both 1<sup>st</sup> and 2<sup>nd</sup> storeys of the Specimen 4 were completely destroyed.
