Railway infrastructure in earthquake affected areas

Research Paper

Stjepan Lakušić, Ivo Haladin, Katarina Vranešić

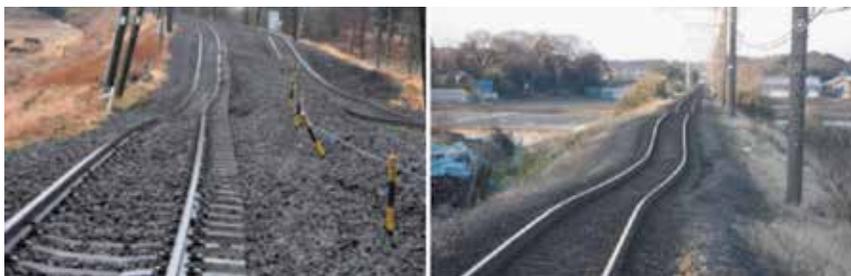
properties of soil on which the track lies [3]. When considering seismic action, embankments present a much greater danger compared to cuttings and, in such case, the embankment slope stability is the most significant parameter [4]. Natural frequency of railway embankments varies from 1 to 10 Hz. If compared with the earthquake frequency that can vary between 0.1 and 10 Hz, depending on an earthquake, it can be seen that the propagation of seismic waves through or around rail embankments can cause embankment resonance, which will in turn result in embankment displacement [4]. In addition, soil liquefaction very frequently occurs on road or railway embankments as a result of seismic action. Liquefaction in foundation layers can cause damage to all structures situated above that level, and rail tracks are highly sensitive to such damage [5]. In the case of rail embankments, horizontal displacement of soil must not exceed 5 cm as track surface deformations occur in case of greater displacements [6]. Figure 1 shows examples of track displacement after settlement of railway embankment caused by the 2011 Tohoku Earthquake in Japan.

Figure 1. Example of embankment damage after earthquake event and reconstruction of the same embankment [7]

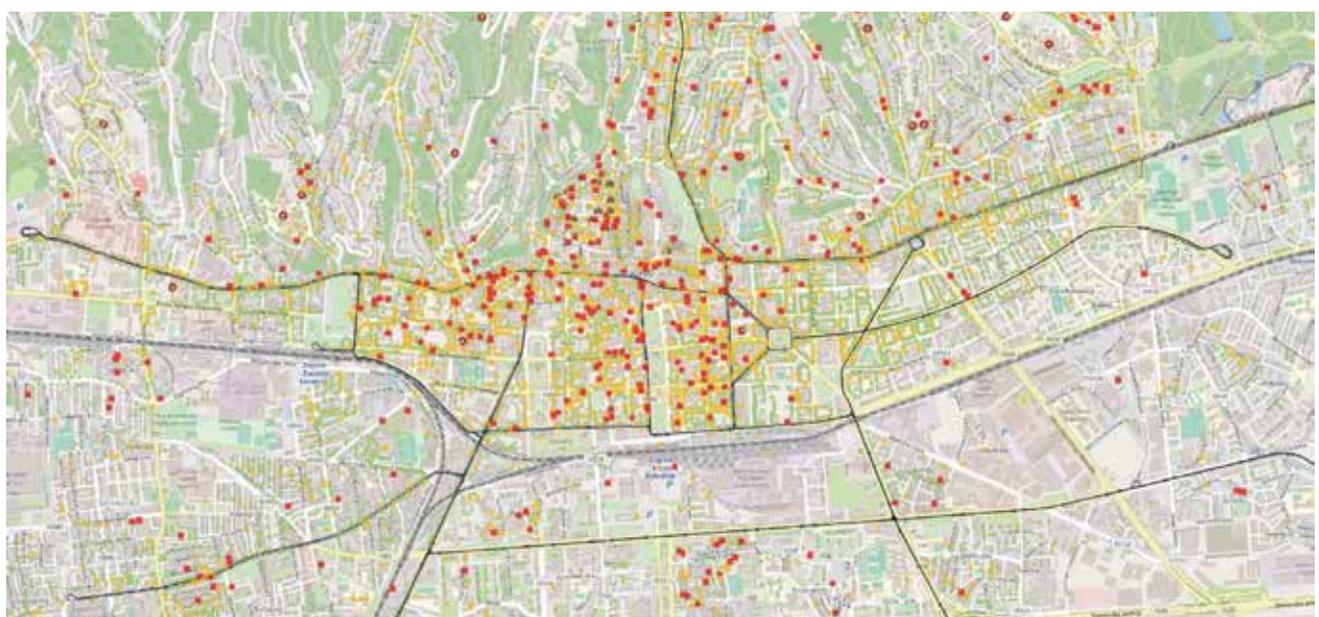
The above figure shows that the tram network passing through the central part of the city traverses the area with a considerable number of permanently unusable (red) and temporarily unusable (yellow) buildings. Immediately after the earthquake, activities aimed at estimating seismic damage to tram infrastructure were initiated, including the analysis of influence the tram traffic resumption will have on earthquake-damaged buildings. Primary activities for earthquake-damaged critical infrastructure requiring a more detailed verification included identification of overhead line anchoring points situated at building facades in the central part of Zagreb, and identification of tram tracks whose condition will directly affect propagation of vibration onto the neighbouring earthquake-damaged buildings. In addition, preliminary inspections were made immediately after the earthquake to identify damage to buildings caused by earthquake either directly (damage to buildings and plants) and indirectly, due to fall of material form damaged buildings onto the rail infrastructure (contact lines and tram track).

Figure 15. Tram network and earthquake damage to buildings based on initial inspection

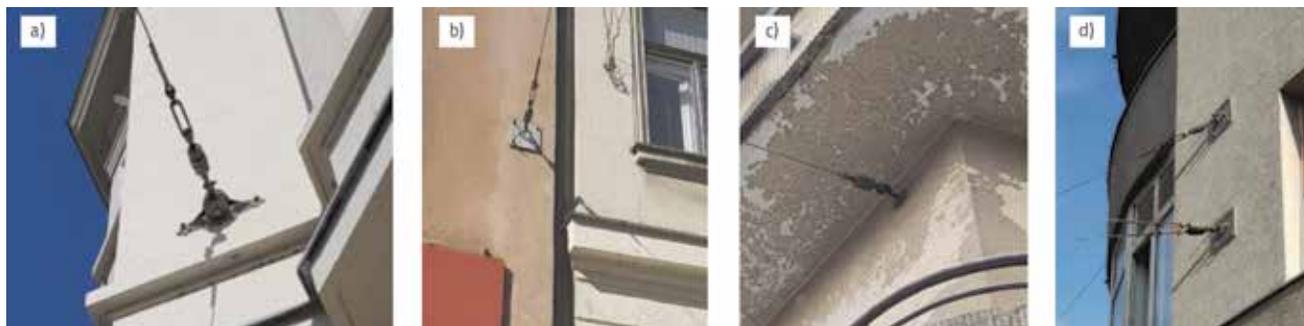
Slika 16. Overhead line anchor points: a) Decorative rosette, b) Plate with four anchoring screws, c) Hook on anchoring screw, d) Connection of several ties on a single fastening point

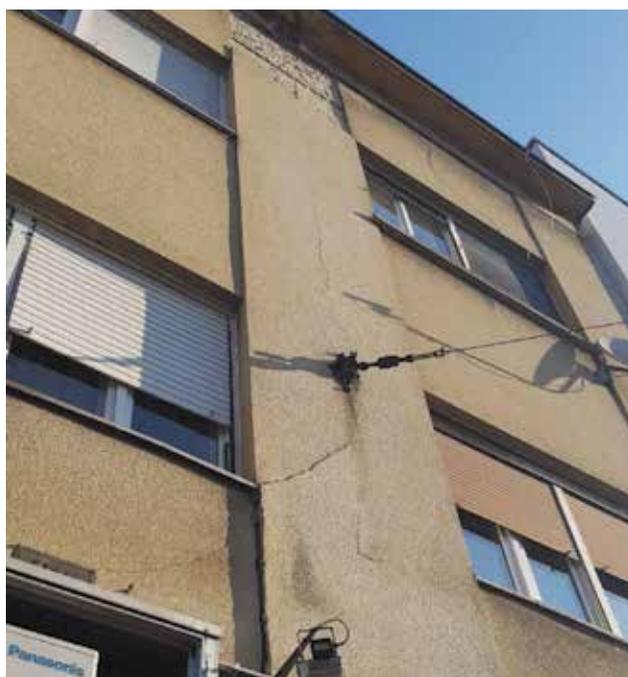
- Loss of mechanical resistance and stability of walls due to seismic action. Cracked places on facades, places with significant wall damage where detachment or pull-out of pins and rosettes is probable.

Figure 17. Example of a potentially unsafe anchor point

After inspection of all contact line connections anchored to building facades, appropriate recommendations were issued for the repair of inadequate anchor points in order to restore their stability and ensure an undisturbed and safe operation of tram traffic.

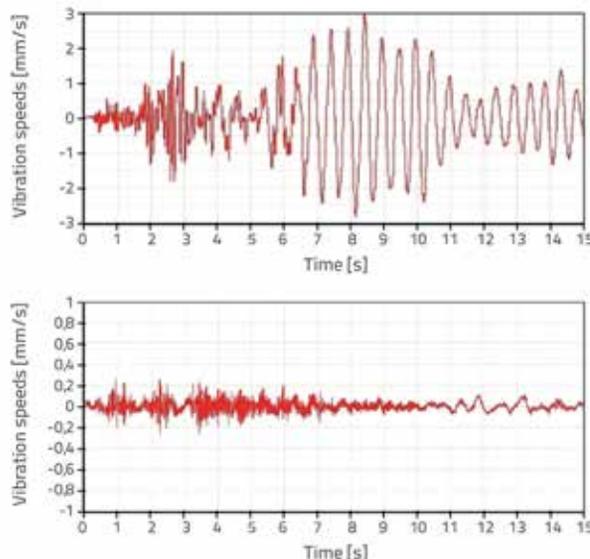
3.0 earthquake reveal that the building is much more affected by earthquake aftershocks than by tram vibrations, which is especially due to the frequency content of seismic excitations. In effect, during the subsequent aftershocks, the excitation of this building is the highest in the low-frequency range (0.5 to 20 Hz). These accelerations succeeded in provoking response of this building which, after initial excitation, exhibits a characteristic response at natural frequencies of 2-4 Hz. During earthquake action, vibration velocities attained the values of up to 3 mm/s. On the other hand, the tram passage excitation causes accelerations at much higher frequencies, ranging from 20 to 50 Hz, while vibration velocities are much lower (up to 0.2 mm/s), as shown in Figure 27. Thus it can be stated, based on preliminary analysis, that the analysed building is much less affected by tram passage than by earthquake generated aftershocks. More detailed conclusions requires a detailed analysis of all tram vehicle types, and of various seismic activities registered in this period, including also monitoring of long term effects of repeated excitations generated by tram vehicles.

Figure 27. Comparison of vibration velocities generated during the Richter 3.0 earthquake (top) and during passage of a tram vehicle type TMK2200 (bottom) at locality MM3, in the direction Y (perpendicular to track axis)
