Why did residential block in Croatian national revival street in Sisak damaged in earthquake had to be demolished

Professional paper

Residential block located in Croatian national revival street in Sisak is the largest building demolished after being damaged by Petrinja earthquakes in 2020. After the earthquake building was declared unsuitable for housing because of damage. All residents had to move out and since then the building is not in use. Classification of damage to building was determined according to The European Macroseismic Scale (EMS-98) and Technical Regulations for Structures (NN 7/22, article 24). In this paper is explained why is it necessary to determine the level of actual earthquake resistance for buildings of this type, period of construction and initial seismic flaws. Earthquake resistance level of existing building can be determined only by seismic design calculations. Except for standard methods of calculations, such as linear-elastic calculation using response spectrum, it is necessary to calculate structures using nonlinear methods, such as pushover analysis. Reconstruction level and concept are defined by buildings damage level and determined earthquake

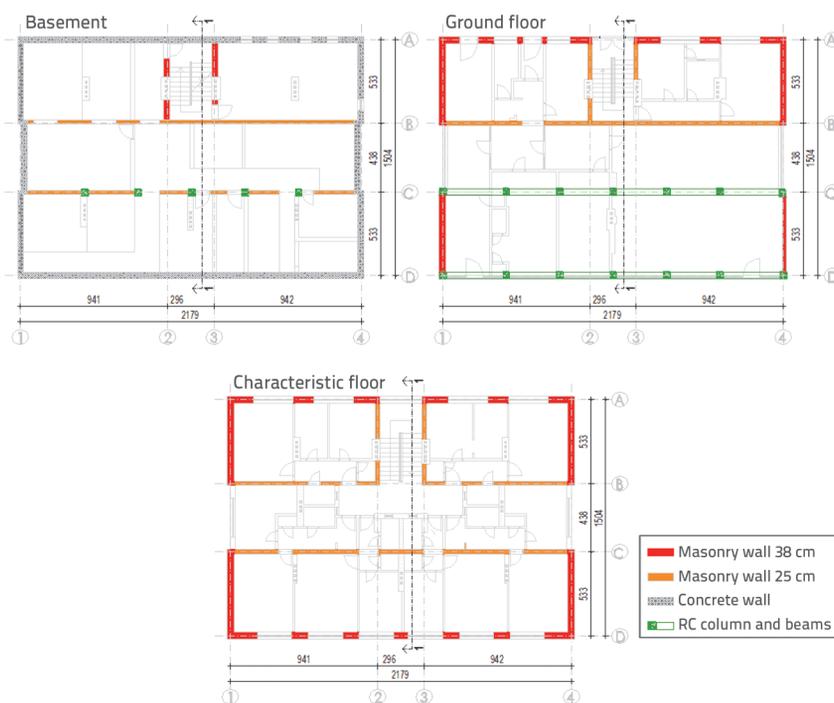
Figure 3. Vertical load bearing structure elements

38 cm thick, interna walls are 25 cm thick, while non-bearing walls are 6.5 cm thick. Outer walls of basement level are made of concrete. Some load-bearing walls are discontinued in ground level and they are supported by reinforced concrete girders and columns instead. Load bearing vertical elements are shown on Figure 3.

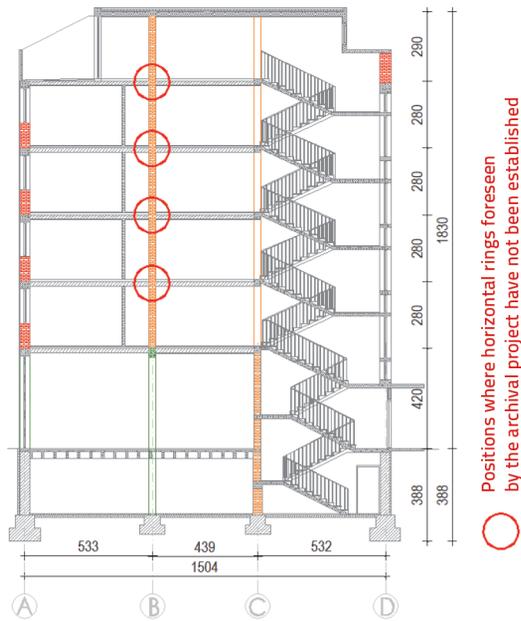
Figure 4. Cross section of existing building

It is visible on the first glance that thickness of load bearing elements is inadequate for building which is 7 floors high. Ceiling structures are made of premade "monta" system which transfers loads in transversal direction of building. According to original project, system consist of reinforced concrete girders with masonry elements inbetween, covered by reinforced concrete slab above. Cross section of the building is shown on Figure 4, while in-situ testing is visible on Figure 5.

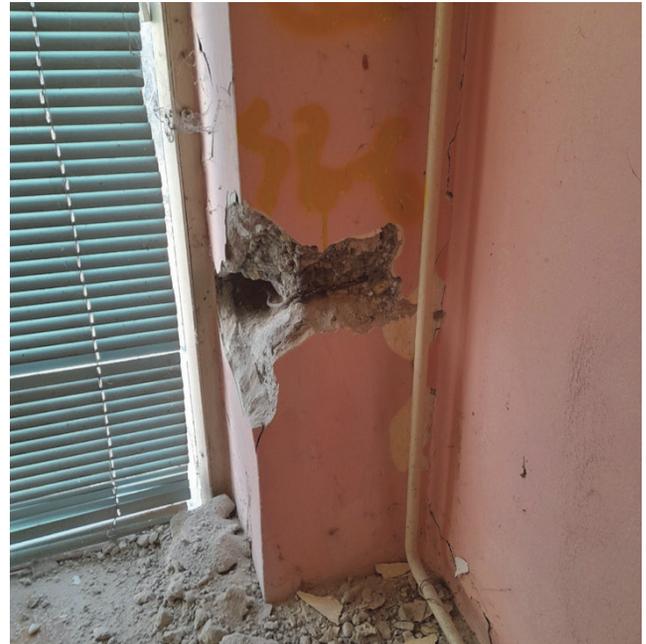
Available archive documentation of existing building consists of original static calculations, formwork plans and reinforcement drawings. Part of documentation is shown on Figure 6. Since available archive documentation was extensive, it was planned to conduct only minor number of in-situ tests. Goal of conducting those tests was to confirm that existing state of building matches with available archive documents. However, those control in-situ tests have shown significant differences compared to archive documentation. Bond beams above

Figure 5. In-situ testing of ground floor column

internal walls were not determined and instead of reinforced concrete slab, unreinforced cement screed was visible above "monta" floor. According to original project, strip footings should be constructed in two central longitudinal axis, but pad footings were spotted after in-situ testings. Since such important structure elements were not built according to archive documentation, desing team was suspicious towards build quality. Original archive drawings are shown on Figure 6. Footing drawing is shown on Figure 6.a, while characteristic

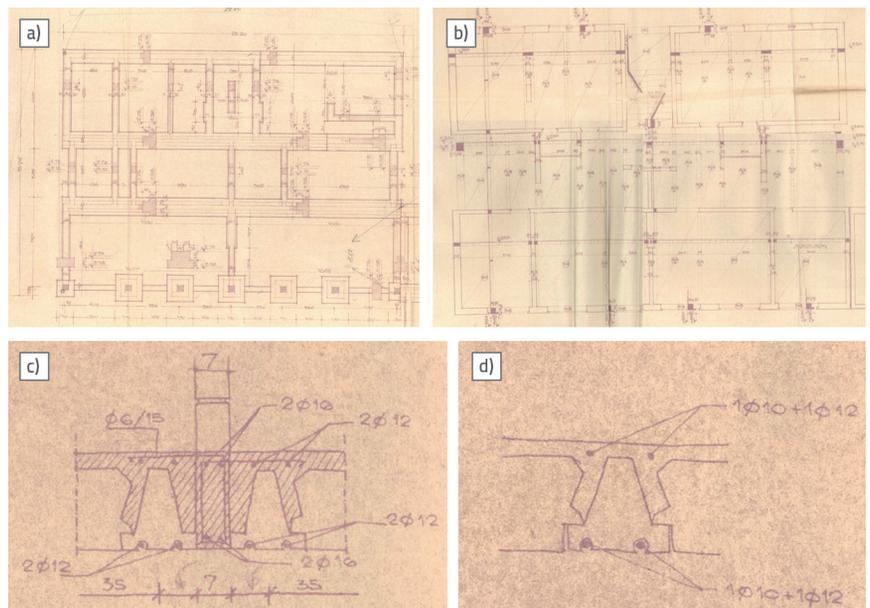
Figure 6. Archive drawings: a) Footing drawing; b) Characteristic floor formwork drawing; c) Reinforcement detail of beam beneath non-bearing wall; d) Reinforcement detail of pre-made floor beams

floor formwork drawing is shown on Figure 6.b. Reinforcement detail of beam beneath non-bearing walls is shown on Figure 6.c and reinforcement detail of precast floor beams is visible on Figure 6.d.

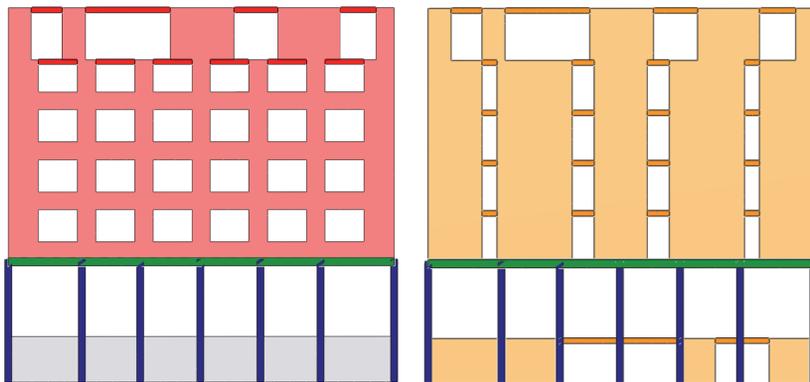
Figure 7. View on walls which are discontinued on ground floor level

- Lack of bond beams and tie columns
- More floors than allowed for unreinforced masonry buildings
- Inadequate area of load bearing walls compared to floor area (less than 3 % in longitudinal direction)
- Too thin walls compared to building height
- Too slender ground floor walls
- Reinforced concrete slab is not cast above "monta" ceiling
- Continuity of load bearing walls does not exists through all levels, because some walls are supported by beams and columns on ground floor level
- Relatively heigh soft storey ground floor level (4.20 m)

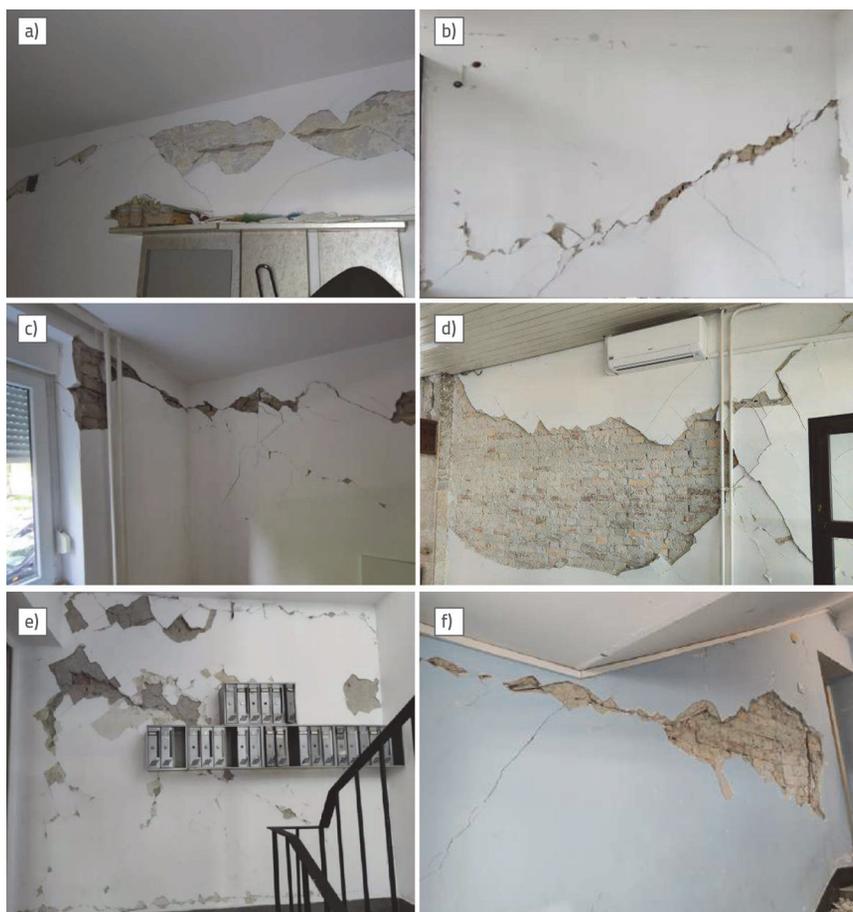
Figure 8. Cracks in load bearing walls: a) Longitudinal wall damage POS 1; b) Transversal wall damage POS 2; c) Damage in corner of the wall POS 3; d) Transversal wall damage POS 4; e) Longitudinal wall damage POS 5; f) Transversal wall damage POS 6

of sustained damage and all residents were promptly evacuated. Damage of structural elements was classified as substantial, while damage of non-structural elements was classified as very heavy.

Part of substantially damaged bearing walls is shown on Figure 8, while on Figure 9 ground floor plan with marked positions of those damaged walls is shown. Typical masonry wall failures, such as diagonal tensional failure and sliding shear failure are visible on those photographs.

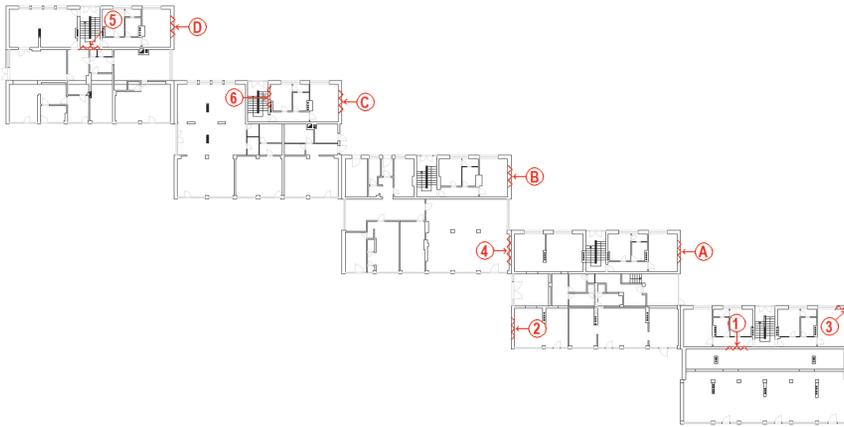
Figure 9. Ground floor plan – positions (POS) of damage shown (POS A to POS D)

Substantial damage was spotted on transversal load bearing outer walls. Such large dislocations of bearing walls are sign of excessive structure deformation. Deformations measured on places where walls have cracked are over 10 cm (between upper and lower part of wall section), which is visible on Figure 10. On Figure 9 location of those damages is shown.

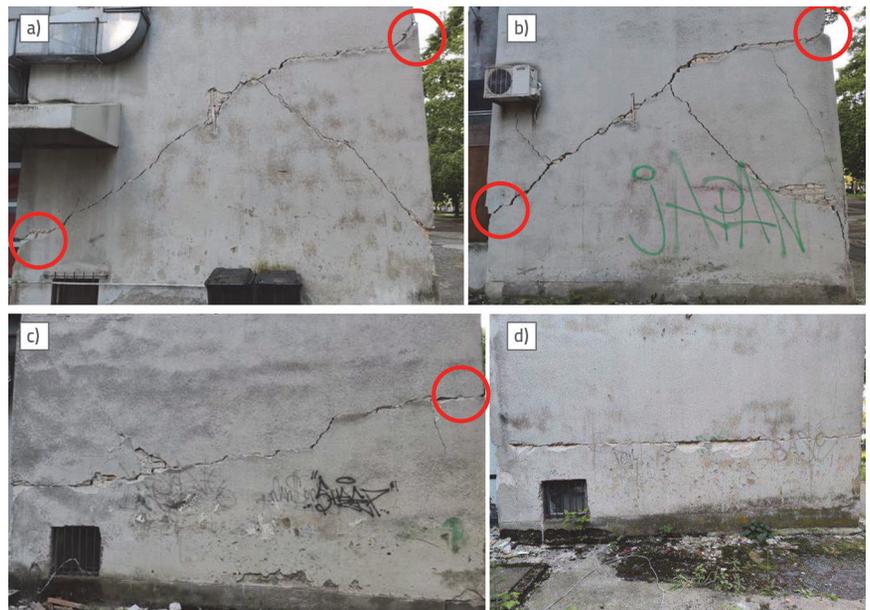
It can be concluded that those substantially damaged walls have no bearing capacity left over. Because of substantial deformations spotted and potential separation of floors and walls in their joints, survey was made immediately after the earthquake. Vertical load bearing structural elements and their deformations were measured, and results are shown in Professional opinion on state of load bearing structure [9]. Horizontal displacements of up to 24 cm are shown in survey, which is visible on Figure 11. According to mentioned Professional opinion, small part of measured displacements are imperfections during the construction phase, which are not recorded separately, but fact that there are measured displacements of up to 24 cm undoubtedly proves that building lost verticality and

Figure 10. Cracks and dislocations of outer walls: a) Transversal wall damage POS A; b) Transversal wall damage POS B; c) Transversal wall damage POS C; d) Transversal wall damage POS D

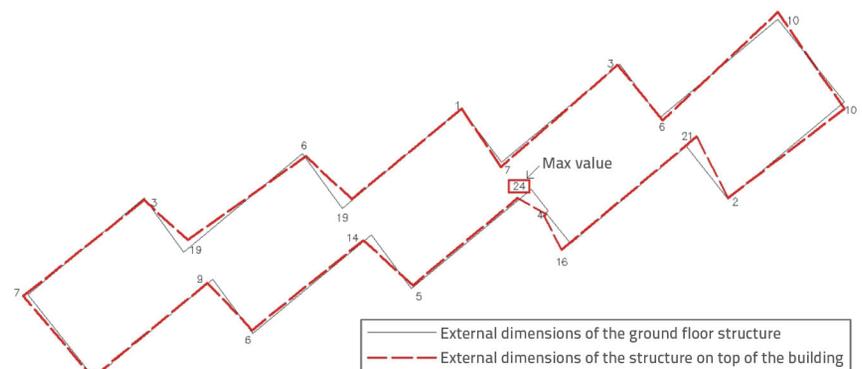
that rotations and separations of walls occurred. Sole survey used to measure vertical displacements is not enough to prove that structure suffered excessive deformations as a result of earthquake. Deformations measured could be results of imperfections during the construction phase. It is necessary to observe survey in correlation with damage building suffered and occurrence of separation of floors and walls (loss of stability out of plane). According to EMS European Macroseismic Scale 1998 [4] classification of damage to masonry building is split in 5 categories, as shown in table 1 below.

Figure 11. Vertical displacements of building contours

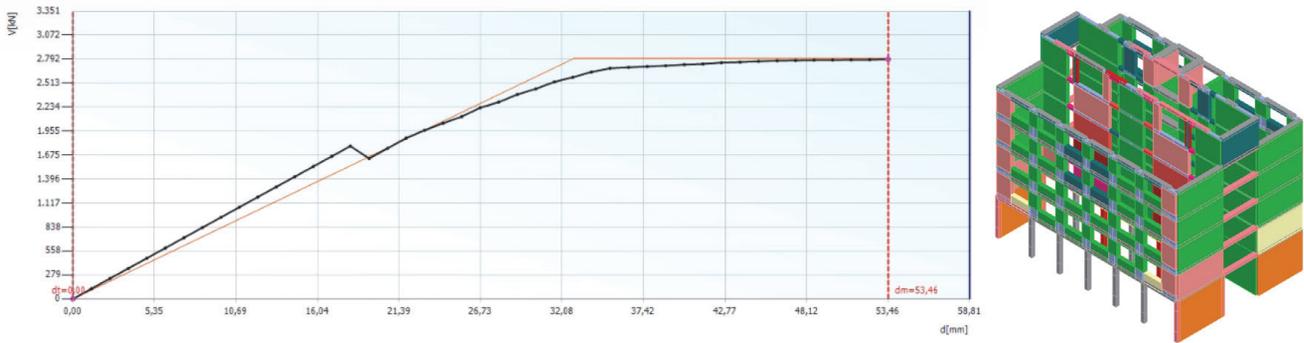
Figure 15. Relevant design curve showing damage in the last step of the analysis (Base shear $V = 2\,792$ kN, Displacement $d_m = 53,46$ mm)

It is necessary to control the limit state of significant damage (SD) and the limit state of limited damage (LD). The ground acceleration for the limit state of significant damage (SD) corresponds to the value of the ground acceleration for the seismic action of the return period of 475 years, and for the location in question is $a_g = 0.152$ g. The ground acceleration for the limit state of limited damage (LD) corresponds to the return period of 95 years, and is $a_g = 0.072$ g. Through nonlinear analysis using the pushover method, the existing resistance of the structure was determined to be 35 %, and the significant damage index (IZO) is 0.35. The significant damage index of the structure is the ratio of the calculated seismic resistance and the resistance for the limit state of significant damage, i.e., seismic action with a return period of 475 years.

The calculation showed lower load-bearing capacity of the building in the transverse direction, which is consistent with the observed damage to the structure, with more significant damage and deformations visible in the walls in the transverse direction. The nonlinear analysis provided a higher resistance compared to the linear-elastic calculation. The significant damage index based on the linear calculation is 0.15.

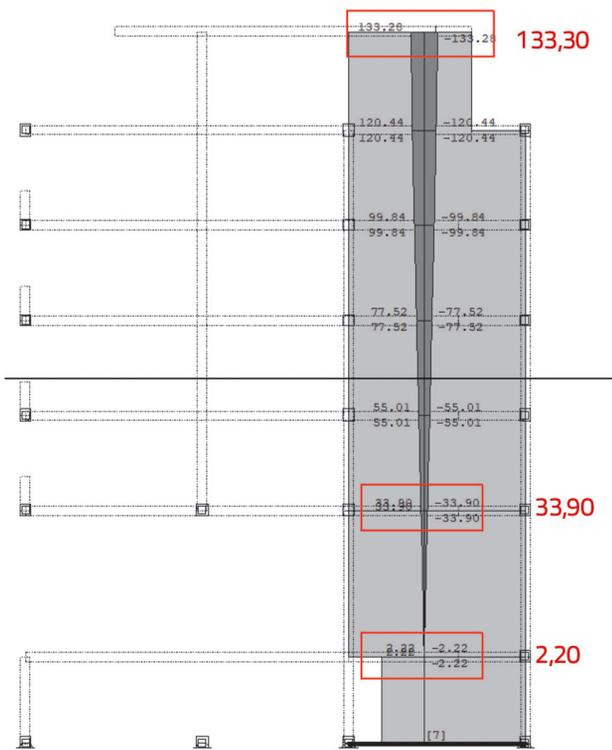
The obtained total elastic displacement of the top of the building is 13.3 cm, while the allowed total displacement is 9.2 cm. The largest inter-storey displacement was obtained for the ground floor, and is 3.1 cm, and the largest allowed inter-storey displacement is 2.2 cm. Figure 16 shows the relevant elastic displacements of the structure for seismic action on the selected frame.

Figure 16. Inter-storey drift

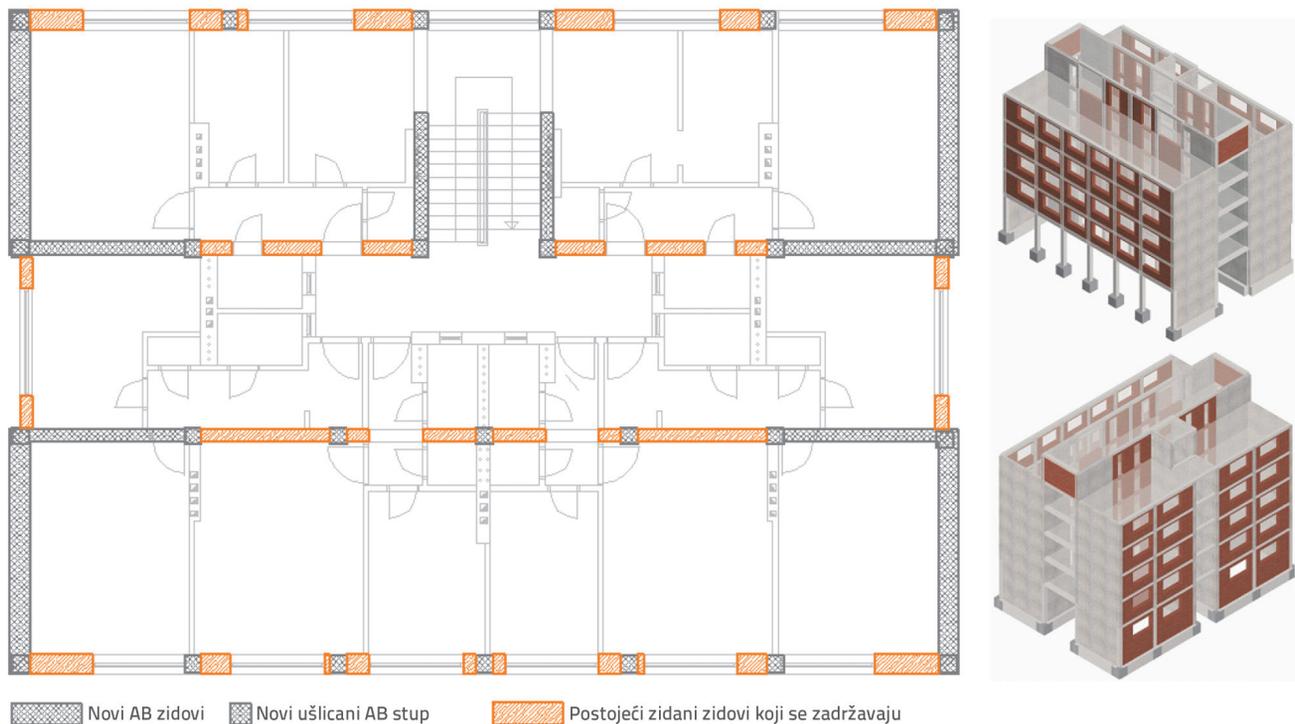
Figure 17. Proposal for a technical solution to strengthen the existing structure to Level 3

For this building, a solution for strengthening the structure was considered, involving the removal of part of the masonry walls and replacing them with reinforced concrete walls. In certain positions, columns and vertical tie beams would be inserted. The aforementioned solution is shown in Figure 17. With such interventions, which belong to Level 3 interventions according to TPGK, a linear elastic calculation was performed (using spectral analysis) and it was possible to achieve an IZO greater than 0.75. However, the removal of masonry walls and their gradual replacement with reinforced concrete is an extremely complex intervention. As determined by in-situ tests, there are no horizontal tie beams above the interior walls, nor are there compression slabs on the prefabricated ceilings. Additionally, survey established that the building has suffered significant permanent deformations. The execution of the works would require complex spatial supports for the remaining structure, and such complex interventions would pose a high risk of losing the stability of the structural elements during construction.

was unable to ensure and guarantee the load-bearing capacity and stability of the structure during the construction phase, or to comply with the requirement from the technical regulation. This was the final technical reason for the designer's decision that the existing structure must necessarily be removed.

construct a rigid reinforced concrete structure in both directions of the building.
