# Time-dependant stability of slopes excavated in marl

Prof. **Predrag Mišćević**, PhD. CE  
University of Split  
Faculty of Civil Engineering, Arch. and Geodesy  
Department of Geotechnical Engineering  
[predrag.miscevic@gradst.hr](mailto:predrag.miscevic@gradst.hr)

**Goran Vlastelica**, B.Sc. CE  
University of Split  
Faculty of Civil Engineering, Arch. and Geodesy  
Department of Geotechnical Engineering  
[goran.vlastelica@gradst.hr](mailto:goran.vlastelica@gradst.hr)

Preliminary note

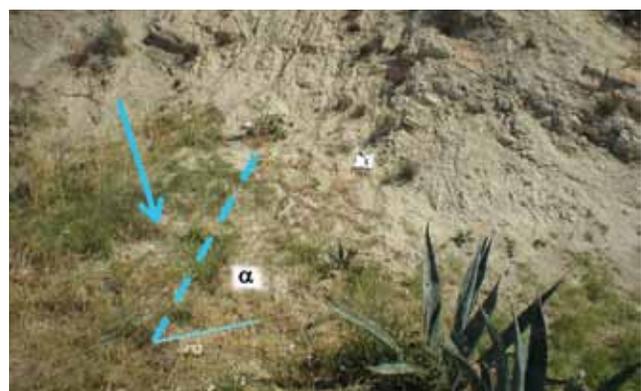
If the back analysis of a stable slope built of marly clay is conducted using shear strength parameters measured for marly clay, then the obtained slopes have the values that correspond to field measurements of inclination of deposited weathered material. It was established by field measurements that the inclination of the weathered marl deposited at the bottom of the slope amounts to  $\alpha = 31^\circ - 38^\circ$ , [10] (example shown in Figure 6). The weathered material at the bottom of the slope indicate a material with marly clay properties.

Figure 6. Measured inclination of weathered marl material deposited at the bottom of the slope (arrow), inclination range:  $\alpha = 31^\circ$  do  $38^\circ$
