Static and dynamic analysis of the old stone bridge in Mostar

Professional paper

Jure Radnić, Alen Harapin, Marija Smilović, Nikola Grgić, Mladen Glibić

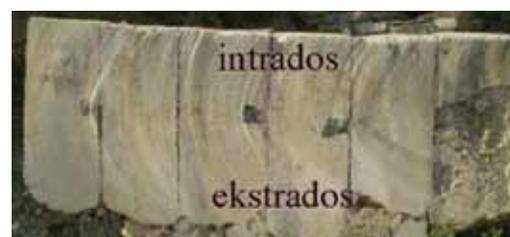
At the original bridge, the arch thickening at the spring was realized using a hard crushed limestone bound with a special mortar (mixture of quicklime, terra rossa, sand, gravel, and water). At that, some blocks situated in between external frontal walls were more than 0.8 m in thickness, and were rounded or slit at the top, with very rough extrados surface (Figure 4). In case of the renovated bridge, a lower strength mortar was used for arch thickening at the spring level, and stone blocks are of similar thickness (0.8 m), with a relatively flat extrados surface. Thus the initial shear bearing capacity, at the connection between the arch extrados and arch thickening at spring, was reduced, i.e. the resistance of the composite structure was reduced.

Figure 4. A remaining part of the original bridge's stone arch at spring, with a thickening above extrados

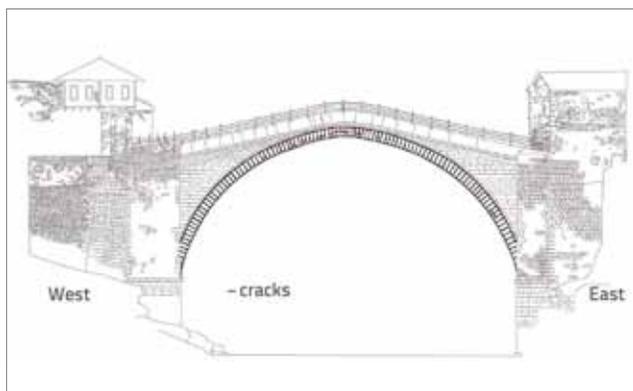
The stone arch and some other parts of the original Old Bridge were repaired in 1963 [7]. It is now not known what kind of arch damage was repaired at that time. Photogrammetric survey of the original bridge, made in 1982 [3], and used as basis for bridge renovation, revealed cracks at the south face of the arch (Figure 5). After a detailed inspection of numerous remains of the original stone arch (Figure 6) was made in November 2011, many points of damage were noted at the intrados and face of the arch.

Figure 5. Cracks at the south face of the Old Bridge prior to collapse [3]

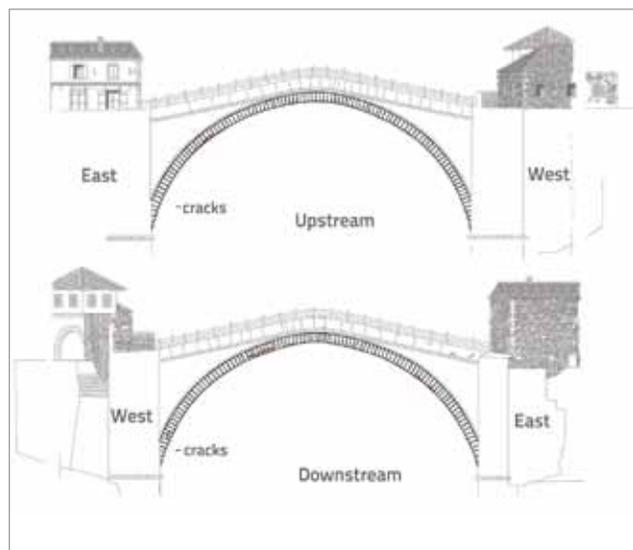
The cracking was first noted on the renovated Old Bridge in 2007 [8]. The cracking registered at arch faces is shown in Figure 7. The greatest crack width amounted to 8 mm. In addition, a smaller number of cracks were registered at the arch intrados next to the left-side (east) bank of the river. Cracks revealed at the arch intrados in 2010 are shown in Figure 8 [9]. Besides cracks in stone blocks, the transverse horizontal detachment of blocks, perpendicular to the bridge plane, was also registered. It was noticed during bridge inspection conducted in November 2011 that crack zones previously registered on arch face [8] have extended along the length of the arch. The disposition of cracks is shown in Figure 9. The greatest crack width amounted to about 10 mm. Cracks were also registered at the arch intrados, as presented in paper [9], and as shown in Figure 8. No cracking or damage was registered at other parts of the superstructure.

Figure 7. Cracks at arch faces of the renovated bridge, registered in 2007 [8]

It can be seen that cracks at arch faces are almost parallel to the arch axis, and that they are close to the arch intrados. The cracking depth in the transverse direction of the arch is not known. It is assumed that cracks locally reach deep into the interior of external stone blocks, and that some have probably spread along the entire width of such blocks. It can also be noted that the cracking zone on the south face of the arch is greater than the one at the north face.

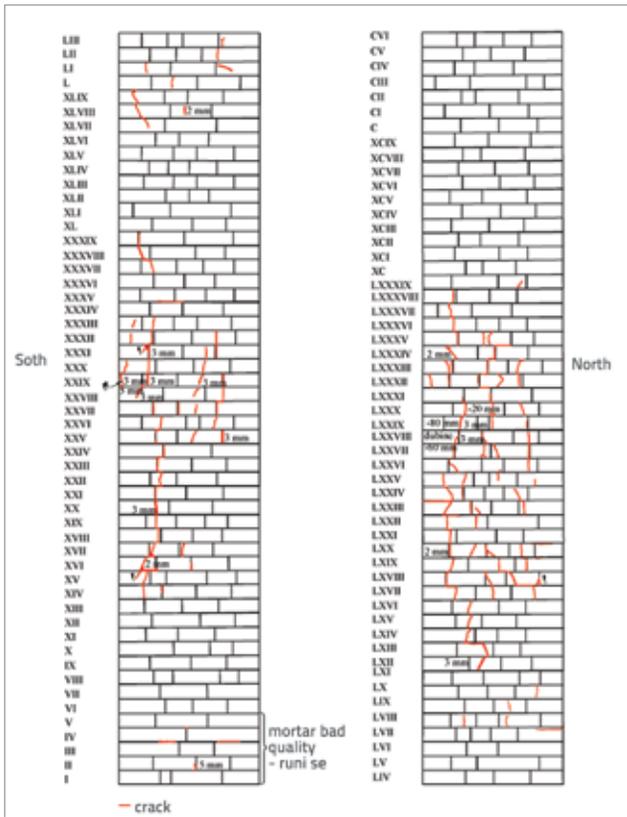
Figure 8. Cracking at the intrados of the renovated arch, registered in 2010 [9]

The cracks at arch intrados are also oriented in the direction of the arch axis, and are disposed in several vertical planes along the bridge width. It can be seen that the greatest intrados damage is concentrated at the south face of the arch. Here also, it is not known what is the depth attained by the cracks. It is however assumed that they locally extend over the entire arch thickness. The above mentioned cracks in stone arch are due to the fact that tensile strengths (limit tensile deformations) of stone blocks in the direction perpendicular to the plane of these cracks have been exceeded. Tensile stresses (deformations) perpendicular to arch axis in two planes perpendicular to one another, i.e. these cracks, result from compressive stresses (deformations) in the direction of the arch axis.

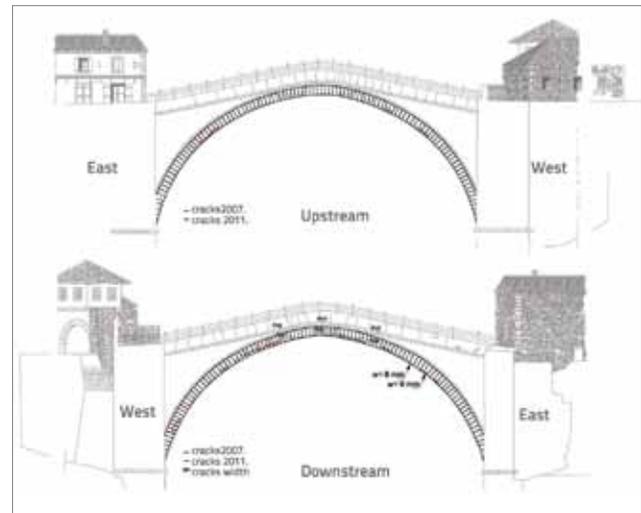
It is believed that the mentioned damage to the original arch and the renovated arch has dominantly been caused, in addition to

vertical loads, by temperature changes. The possibility that the extent of damage has been influenced by weak earthquakes that occurred after renovation has been ruled out, as additionally confirmed in the paper [8]. Small tensile strength of tenelija stone, out of which both the original arch and the renovated arch were built, is the main cause of cracking.

Figure 9. Cracks registered in 2011 at the faces of the renovated arch

Therefore, the cracking in both the original arch and the renovated arch was most probably caused the same load actions, probably of similar intensity. Greater damage to the renovated arch, when compared to the original one, is probably due to one or several of the following influences:

- Increased stiffness of the stone arch – unfavourable influence of temperature.
- Increased horizontal deformability of the stone arch and spandrel structure due to hollow areas realized behind of the arch spring.
- Reduced efficiency of connection between the arch spring and arch thickening above the extrados.
- Quality of new stone blocks is probably lower, when compared to original blocks (greater inhomogeneity of the structure and smaller tensile strength).
- Temperature conditions during arch closing at the crown were probably less favourable.
- Deviations in arch geometry.

The extent of arch damage at the renovated bridge is such that its original mechanical resistance and safety have been reduced. It is probable that the situation will continue to deteriorate over time. Already at this time, there is a real danger that the pieces of damaged stone blocks might fall out. The repair of arch damage is urgently needed, which should include preparation of the study that is to propose appropriate solutions for the avoidance or reduction of further arch damage, and define the need for its durable successive repairs, in the ways similar to the original arch.

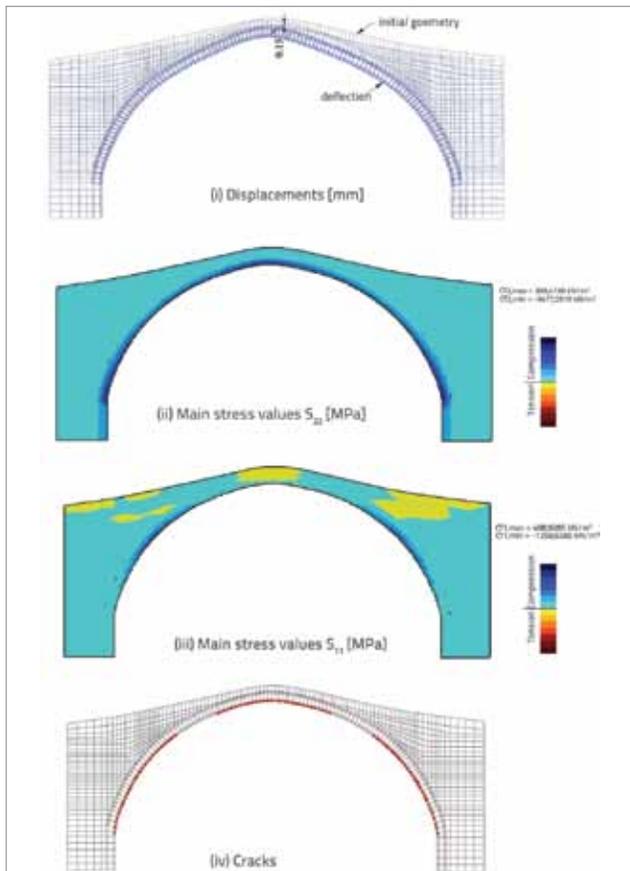
The stress in arch due to temperature changes was activated after the final arch closing at the crown level (21 August 2003). In fact the arch was closed in crown in the summer period, at the ambient temperature of about 25 °C. Annual temperature variations in the town of Mostar are quite big, and mostly range from -5 °C to 50 °C [8]. Different annual and diurnal temperature variations are also possible along the arch length and thickness. For simplicity of analysis, we assumed that the temperature is constant along the arch length, and variable along the arch thickness. Some temperature changes, believed to be possible and ranking among the most unfavourable ones, are presented in Figure 12. Relevant temperature variations are those that cause pressure next to the arch intrados, as compared to the pressure situation at the arch closing time. The temperature coefficient of $\alpha_{tb} = 6,5 \times 10^{-6}$ was assumed for stone blocks, and this coefficient in joints was assumed to be $\alpha_{tm} = 6,0 \times 10^{-6}$. Some results obtained for simultaneous action of vertical load and temperature changes according to Figure 12a are shown in Figure 13. The highest main compressive stress in stone blocks amounts to -3.48 MPa. The design position of cracks in stone blocks at the arch face is shown in Figure 14, which corresponds well to the actual present time cracks shown in Figure 9.

Design cracks in vertical plane of the arch along the intrados (overstepping of limit tensile deformation of stone perpendicular to the arch) were also obtained. This is consistent with the actual situation according to Figure 8. It should be noted that analysis results depend on various stone and mortar parameters, and especially on the tensile strength, elastic modulus, Poisson ratio, and temperature coefficient. Numerous analyses were made by varying these parameters. Due to limited space, not all of these results can be presented in the paper. The following conclusions can be made after analysis of influence exerted by the above mentioned parameters for materials:

Figure 13. Some results for vertical load and temperature changes according to Figure 12a – NM1

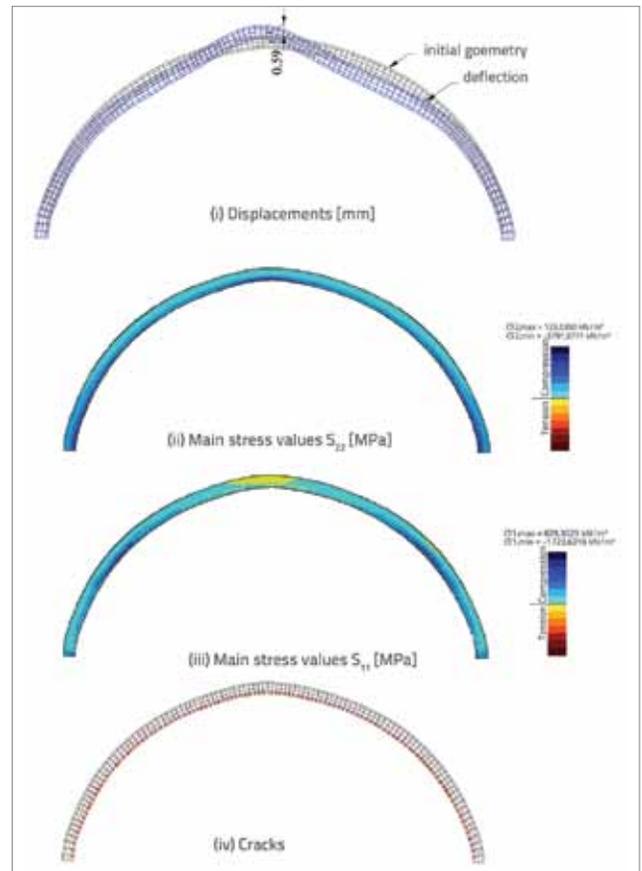
Figure 14.. Some results for vertical load and temperature changes according to Figure 12c – NM1 Model

Model Some results for simultaneous action of vertical load and temperature changes according to Figure 12c are presented in Figure 14. It can be seen that, for this possible load, the crack zones extend along the entire length of the arch next to the intrados, which unfortunately can happen at some future time on the real arch. Compressive stress values in stone arches attain – 3.79 MPa.
