# Remediation of traditional stone columns by lead inlays

Original scientific paper

Typical cracks often occur on traditional stone columns at the position of joints. In addition, such columns bear witness of various repair methods that have been used over time to stop continuous spreading of cracks. Systematic numerical and laboratory analyses conducted on almost real size samples have revealed that the basic cause of cracking is the concentration of stress at contact surfaces. Some laboratory testing and numerical analysis results, relating to the traditional form of repair with lead inlay placed between column parts, are presented in the paper.

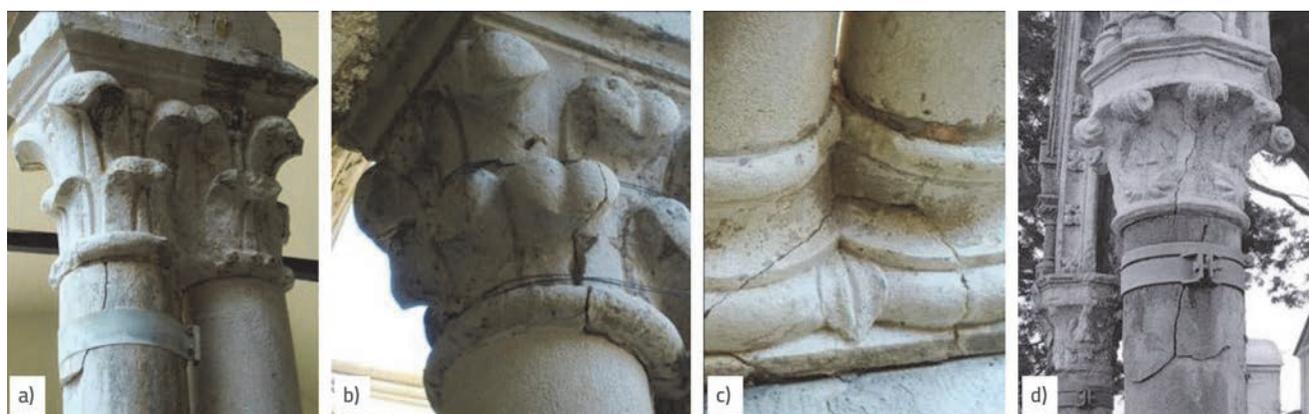
Figure 1. Fractures on traditional stone columns with traces of previous retrofit strategies [5]

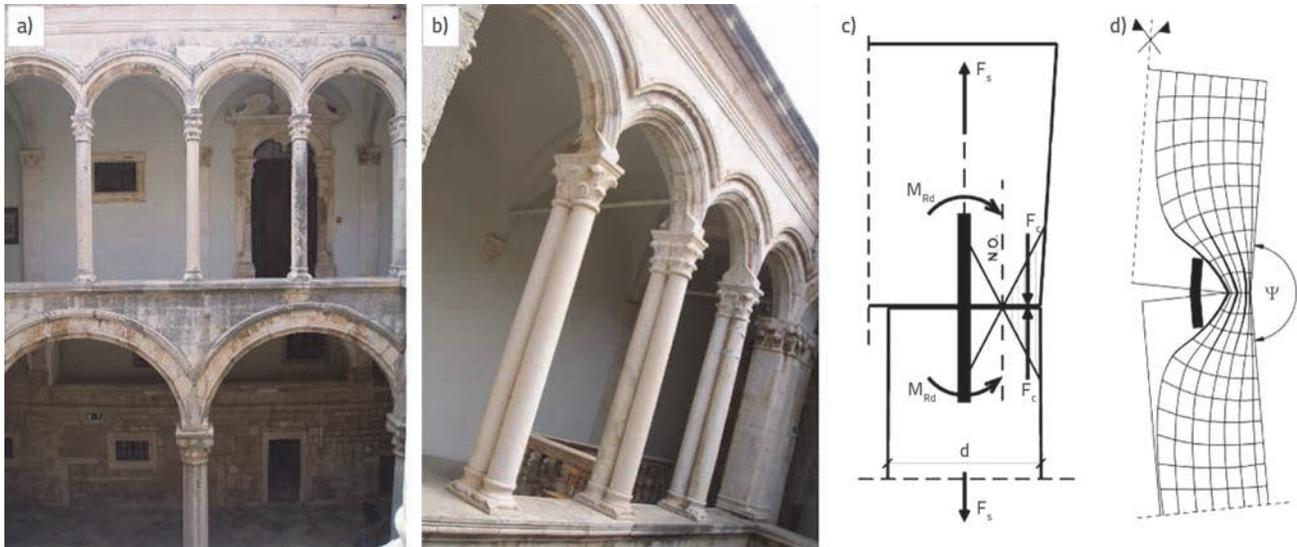
Figure 2. a) Traditional stone columns; b) coupled columns on the first floor of the Rector's Palace in Dubrovnik; c) Connection behaviour model with internal forces and stresses [7]; d) Distribution of stress trajectories [6]

Various traditional stone columns have frequently been used by builders, especially with regard to column slenderness. This paper focuses on traditional columns (Figure 2.a) composed of the body, base and capital, which were usually joined together by an iron dowel (placed into openings of a somewhat greater diameter that were subsequently filled with lead), while contact surfaces were carefully smoothed down and joined together (Figure 1). It is obvious that this type of connection was mostly used as a means to transmit centric load, i.e. it was not capable of transmission significant eccentric loads, which is in line with the concept of structural systems that was normally used in historic buildings. In addition, it is important to note that columns, although in most cases the most slender elements, were very rarely highly stressed while horizontal load (such as the load generated by earthquakes) was in most cases resisted by walls. However, when subjected to earthquake action, columns have to follow displacements of the structure, which

The test procedure developed for this purpose (Figure 4) involves application of load through a steel beam, because numerical checks and comparison between results of three-dimensional numerical model of the existing structure (Figure 16.a) and test model results (Figure 16.b) have revealed that this procedure is the most appropriate. The basic intent was to closely simulate behaviour of existing structures, i.e. to ensure highly realistic distribution of stresses affecting the column. In addition, the load application region had to be moved away from contact surfaces, and proper attention had to be paid to testing safety, controlled application of force, simple assembly, laboratory constraints, etc. The steel beam (Figure 4) is specially adapted for application of load using the universal compression/tension machine Zwick/Roell with two hydraulic pistons, one of which ( $\pm 600$  kN in capacity) was placed on the beam above the column (centrally) and the other (approximately 250 kN in capacity) was placed in the middle of the steel beam length (eccentrically). During the testing procedure, the force level was applied by displacement control with increments of 0.01 mm/s, which is significant for monitoring post-critical behaviour of the connection, i.e. for defining residual bearing capacity at cracking. The relative rotation of column elements, i.e. the pressure of the capital exerted on one side of the column cross section, was obtained by bending of the steel beam and by fixed connection between the beam and the capital (realized using four bolts in epoxy resin) (Figure 2.c and Figure 16.b). Sample dimensions were selected based on coupled columns constructed at the storey of the Rector's Palace in Dubrovnik (Figure 2.b). The capital (measuring

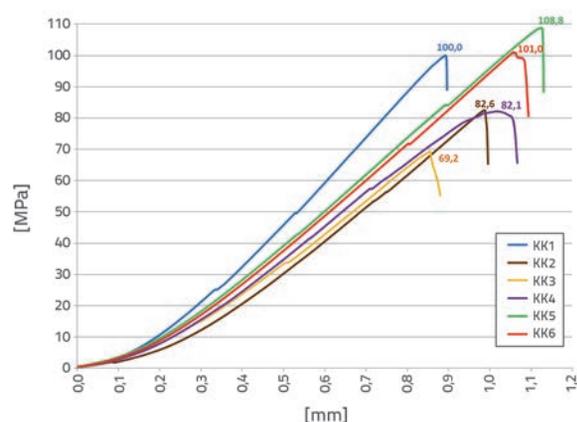
Figure 3. Compressive strength diagram

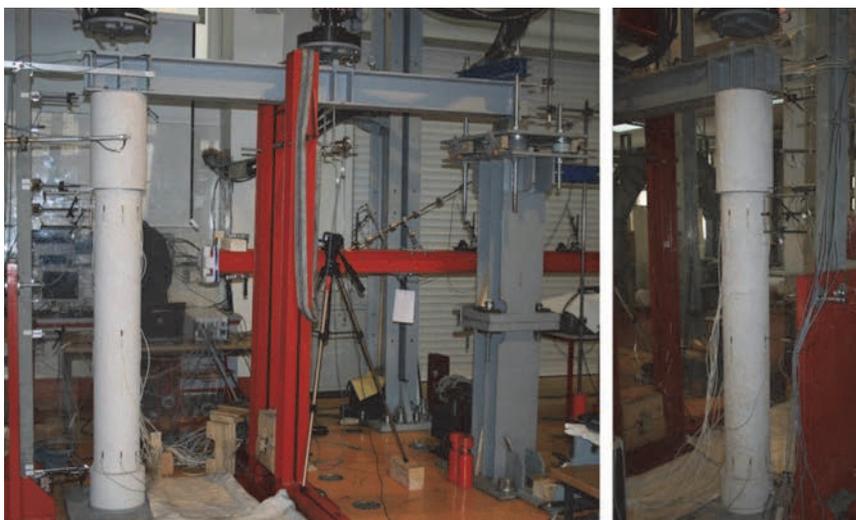
Figure 4. Laboratory test setup illustrated by sample K5

300 mm in diameter, and 500 mm in height) was placed onto the column ( $d = 250$  mm,  $h = 1500$  mm) and the two were connected with a steel dowel ( $d = 16$  mm,  $h = 150$  mm) placed in openings ( $d = 19$  mm,  $h = 100$  mm) in the centre of cross-section. The column was similarly connected to the base ( $d = 300$  mm,  $h = 200$  mm), which rested on the steel pedestal [5]. The height of the column body (1.5 m) corresponds to about one half of the height of existing columns, which proved sufficient for not disturbing stress distribution in the connection area, as proven by numerical calculations.

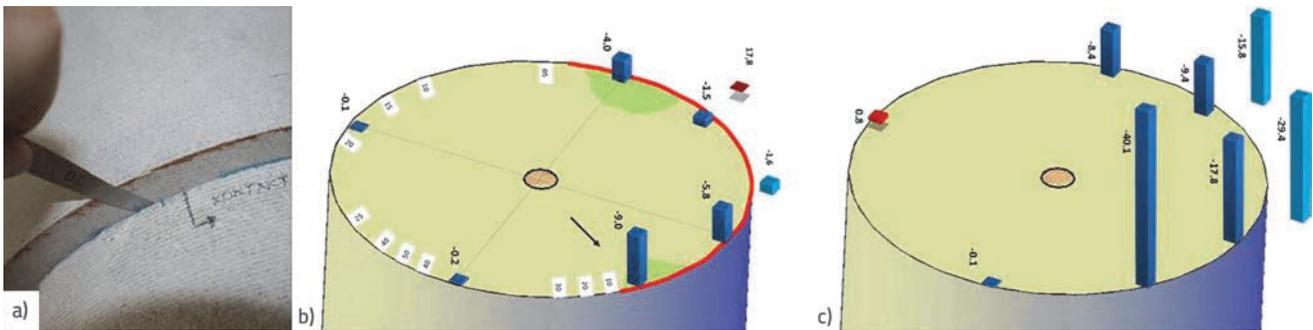
Figure 5. a) Determination of gaps by measurement sheets; b) Stress values at VS for test phase K3 [MPa]; c) Stress values at VS for central and eccentric load [5]

A three-dimensional schematic presentation of stress distribution, obtained by measurement of relative deformations in strain gauges, was selected for presentation of results, because it also shows stress relationships (compression stress is shown in blue colour, and tensile stress is shown in red). A rough estimate of the influence of irregularities can be obtained by comparing peak stress concentration values (about 9.0 MPa – Figure 5.b) with average stress in the case when the stress distribution along the cross-section is uniform (about 2.0 MPa). At that, it is important to take into account the fact that measurement points are situated 10 cm away from contact surfaces, so the values also contain stress distribution from the concentration zone at contact surfaces to measurement locations (at the column surface). A more accurate estimate of real stresses at contact surfaces can be obtained using numerical models (Figure 16.c), which also include measured gaps between contact surfaces. Usually, stress concentration values (at contact surfaces) are 2 to 3 times higher in numerical models compared to values at

measurement points (10 cm away from contact surface), which would mean that in the example given in Figure 5.b the greatest stress at the contact surface exceeds 20.0 MPa (ten times more than the expected value).

Numerical models enable good estimate of the areas of contact between column elements (surfaces) such as those given in Figure 5.b. (marked in green), but also of the stress distribution along the entire sample (Figure 16.c). Irregularities on contact, i.e. even the slightest gaps, means that the entire cross-section of the column will not be activated during the load transfer, but rather that small stress concentration areas will be formed. Concentrations of contact stresses actually caused the occurrence of first crack after application of force in a centrally placed hydraulic cylinder between 136 and 297 kN for all tested samples without lead insert. It is obvious that initial gaps during setting up of contact between elements cannot be solved in any other way, so stress concentrations eventually lead to crack opening. Due to reserves in bearing capacity, the column maintain its bearing capacity after redistribution of stresses (within the cross-section), but such fractured state can become dangerous due to action (superposition) of other loads (Section 2) and because fractured parts of the column may fall off.

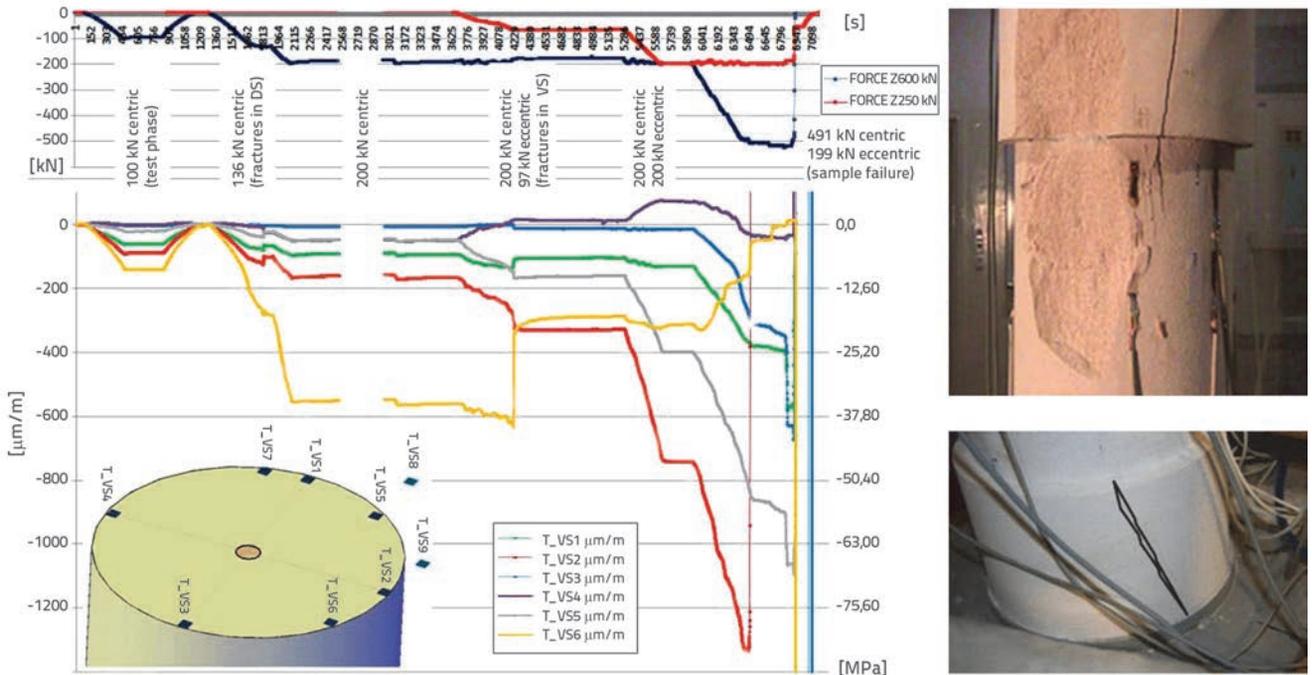
Figure 6. Testing diagram for sample K3 – relative deformation (stress) over time with presentation of load input for measurement locations at column top (VS), with photographs showing crack opening at VS and DS

The above mentioned effect is related to approximately centric load (centrally placed hydraulic cylinder), but usually much less favourable column behaviour arises from eccentric load (eccentrically placed hydraulic cylinder). The influence of eccentric load directly depends on irregularities between contact surfaces, as, during eccentric load, the capital normally exerts additional pressure in one of initially determined contact zones (areas), and causes pronounced stress concentrations. Depending on the initially realized concentrations, the eccentric load can lower the stress in the concentration zone, additionally increase stress concentration, or cause propagation of the existing fractures. It is significant to note that even a slight change in angle, i.e. from 0.003° to 0.2° causes pressure increase on one side of the cross-section (Figure 5.c) and development of high concentration, which very rapidly results in the opening of new fractures and, eventually, in complete failure of the column (typical behaviour of all samples). The eccentric load causes faster increase in stress, as can clearly be seen on the testing diagram (Figure 6) which also describes the overall course of testing for sample K3. The diagram presented in Figure 6 shows the values of centric load

(force Z600 – marked in blue) and eccentric load (force Z250 – marked in red), and also provides marks showing typical testing phases. Furthermore, the values of relative deformation are also presented (a set of values to the left) as well as the corresponding stress values (a set of values to the right) for measurement positions at the top of the column (VS) which are distributed according to the enclosed schematic. Changes at measurement locations can clearly be monitored on the testing diagram (Figure 6) as related to the level of load, e.g. opening of cracks, typical re-distribution of stress along cross-section (after crack opening) and, eventually, sample failure (Figure 7).

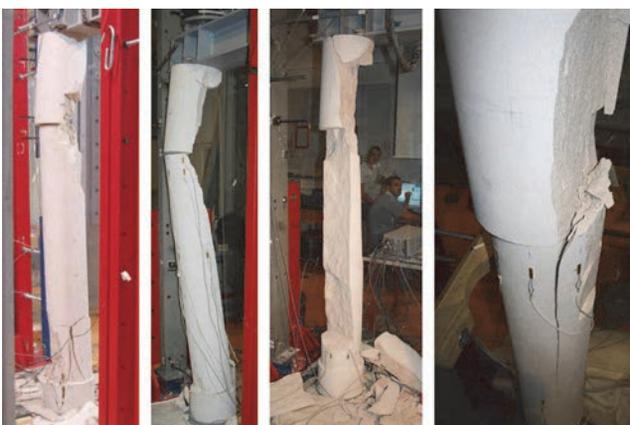
Figure 7. Samples K1, K2, K3 and K6 after failure

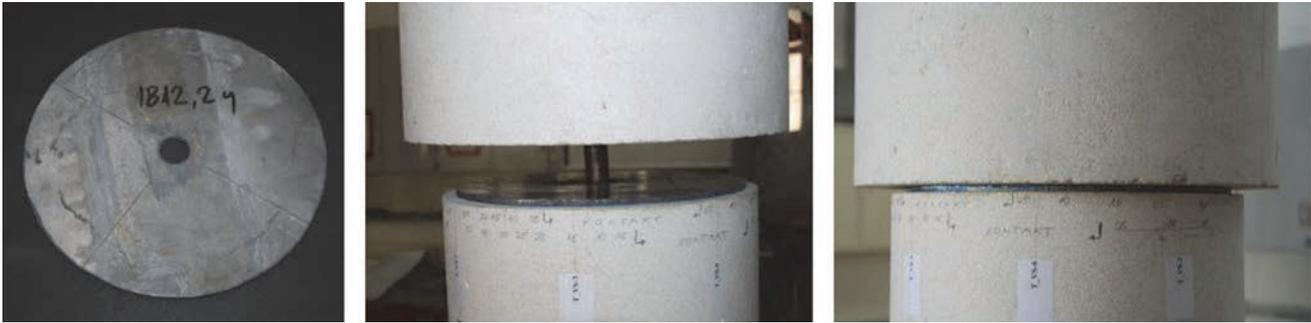
Figure 8. Lead inlay and its placing into column top for sample K5

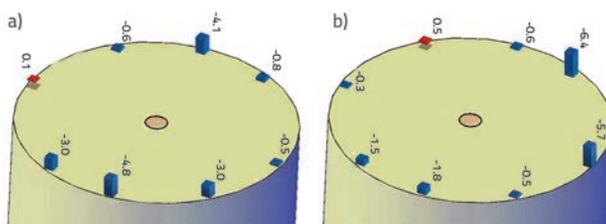
Figure 9. Testing phase for sample K5 with lead insert: a) stress at VS [MPa], b) stress at DS [MPa]

The process of testing sample with lead insert will be described using sample K5 as an example. The testing itself was conducted based on the previously described test configuration. The lead insert 23 cm in diameter and 4 mm in thickness was placed between contact surfaces of column elements (Figure 8), i.e. as connection between the column body and the capital and base. It should be emphasized that the radius of the lead inlay is by 1 cm smaller than the column radius. The idea behind this is to ensure exertion of column pressure closer to the column axis (away from the edge itself) and to take into account the unknown behaviour of lead at such specific load, and at other loads such as temperature, cyclic load, etc. Smaller radius allows lead to extend and to adapt better to irregularities at contact surfaces, and the insert can be made invisible if requested (e.g. by historic preservationists). The usual measurement of gaps between elements using measurement sheets was not conducted because of the lead insert, but it was observed by visual inspection that the pressure at contact is uneven. The usual irregular distribution of stress was confirmed by results from the testing phase (Figure 9) in which two pronounced areas of pressure can be noted for VS at opposite sides of the cross-section, while pressure is dominant at one side of cross-section for DS. Stress values are lower compared to all other samples, which can be attributed to the role of the lead insert.

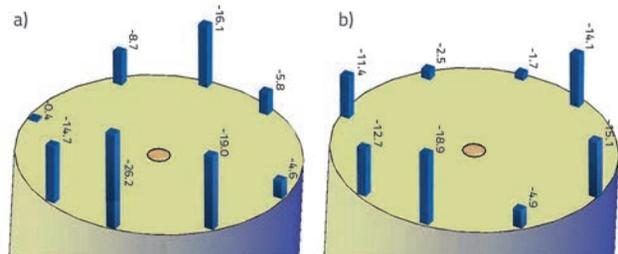
Figure 10. Testing phase at centric force of 500kN for sample K5 with lead insert: a) stress at VS [MPa], b) stress at DS [MPa]

results (Figure 10) reveal a highly uniform distribution of stress compared to other samples [13], i.e. the zone of pronounced stress concentration cannot be distinguished. On top of that, numerical analysis results reveal that the stress distribution presented is possible only when there are four similar areas of support, which was not the case for other samples.

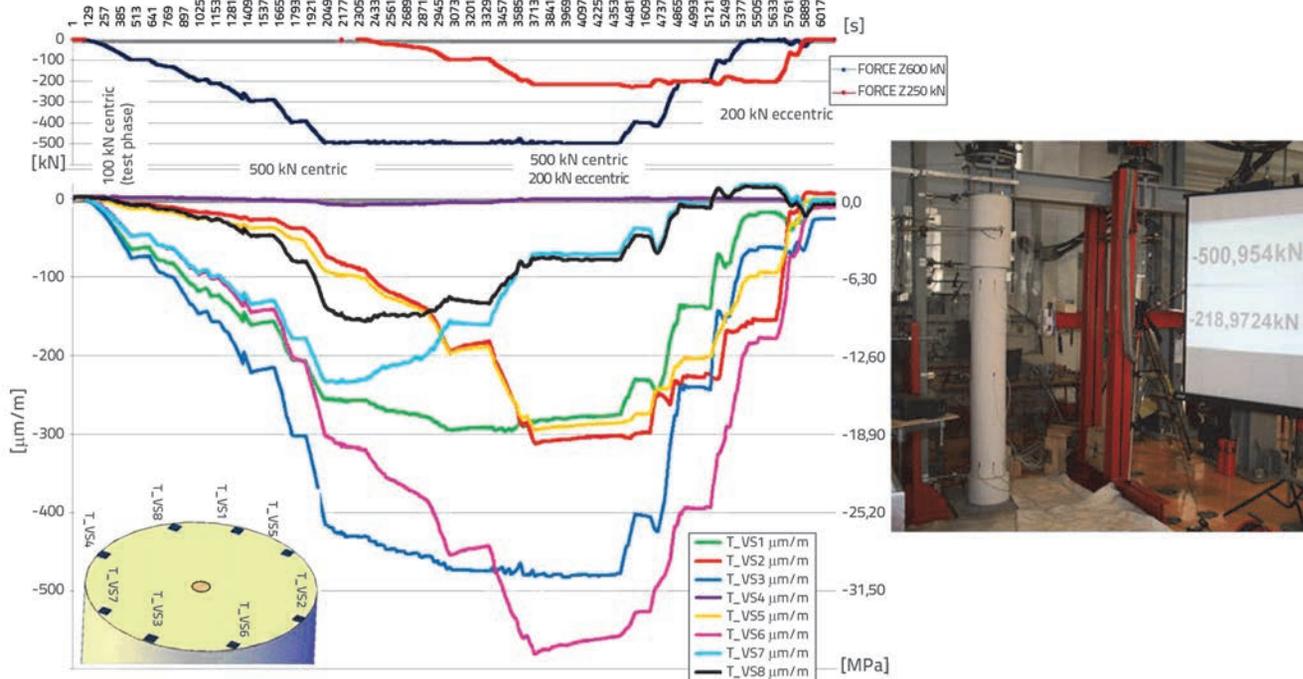
Figure 11. Testing diagram for sample K5 – relative deformations (stresses) over time, with load input for measurement point at column top (VS) and photograph of the final phase of testing

"More regular" behaviour can also be observed at the testing diagram (Figure 11) where the stress increase at measurement locations is more uniform and less pronounced. The highest increase can be observed at the measurement point T\_VS3, but this increase does not greatly differ from increase registered at other measurement locations. Such results can be attributed to the influence of the insert, i.e. it can be concluded that properties of the lead inlay have enabled the sample to adjust itself to irregularities of contact surfaces, but without cracking. The testing continued with application of eccentric load (using hydraulic cylinder at the mid-length of the steel beam), which caused the capital to press onto the edge of the column. The rotation of capital with respect to the axis could also be visually observed, and the results obtained at almost all measurement locations revealed a highly uniform re-distribution of stress toward the edge of cross section at VS (Figure 12.a). This was also confirmed by changes in relative deformations (stresses) at the testing diagram (Figure 11), where a relatively rapid increase of stress can be observed for measurement locations adjacent to the expected contact (T\_VS2, T\_VS5 and T\_VS6), but also a pronounced regularity (compared to other samples) and a more uniform distribution of stress (to a wider area). A certain stagnation can be observed at the measurement location T\_VS3, which was marked as critical with regard to centric load. This stagnation is due to the fact that the measurement

deformations along the entire surface and a pronounced dent that corresponds to the place where capital exerted pressure at the edge of the column. It is important to note that, due to eccentric load, the capital actually rotated with respect to the column body by only 0.17°, which corresponds to the values obtained for other samples [13], and is also in line with other research results [6]. In the scope of additional analysis at the last phase of testing, the column was subjected to eccentric load only (201.9 kN) at an angle of 0.362°, but the sample did not suffer any damage (Figure 11).

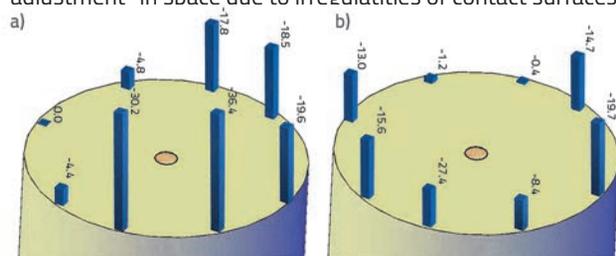
Figure 12. Testing phase at centric force of 500kN and eccentric force of 200kN for sample K5 with lead inlay: a) stress at VS [MPa], b) stress at DS [MPa]

location is not situated in the vicinity of the expected contact. Results for column bottom (DS) reveal influence of eccentric load (Figure 12.b), but also the slight contribution of the sample "adjustment" in space due to irregularities of contact surfaces.

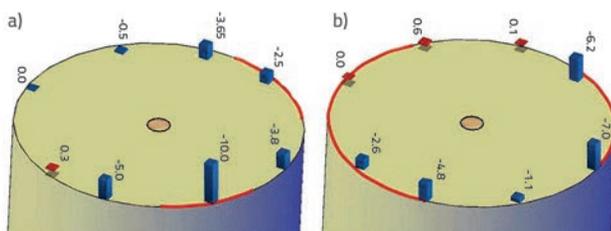
Figure 13. Test phase of testing for sample K5 without lead inlay: a) stress in VS [MPa], b) stress in DS [MPa]

Two distinct areas of capital contact with the column body were distinguished already for the test phase based on the results obtained for the column top (VS), which is also typical for other samples without lead inlay. One point of contact is at the edge of the column (rapid stress increase), and the other is within the cross-section, which was also confirmed by numerical analyses. Two contact zones were also identified for the column bottom (DS) but, unlike VS, without pronounced stress concentrations (Figure 13.b). These zones of contact approximately correspond to gaps measured between contact surfaces (using measurement sheets), with a usual minor adjustment of sample after application of load.

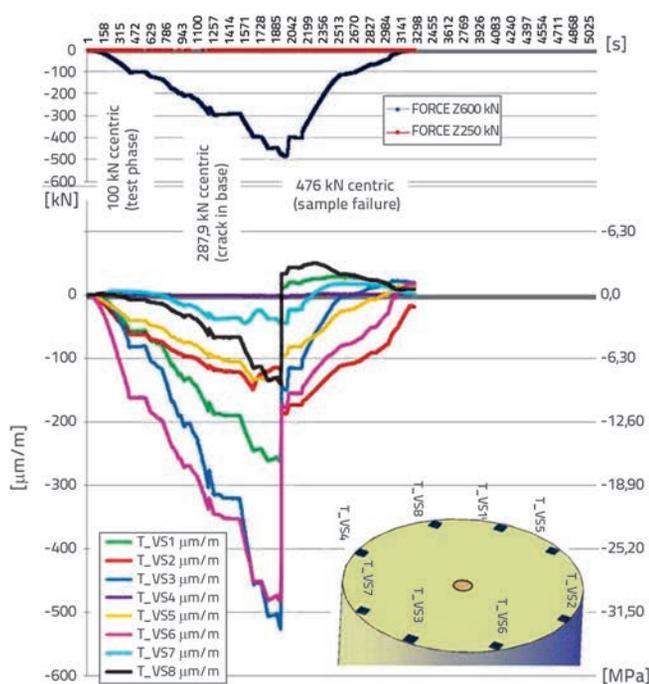
Figure 14. Test diagram for sample K5 (without lead insert) – relative deformations over time with application of load at measurement for column top (VS) and with crack opening photos for VS and base

The first visible crack opening (Figure 14) was visually observed at the base at a centric force of 287.9 kN, what can be also noticed on results at almost all measurement locations (especially at DS). A detailed analysis of numerical modelling results and experimental test results points to the conclusion that the top

The testing was continued and sample splitting occurred at a centric force of 476.2 kN (Figure 14). At that point the testing was interrupted. The fracture opened almost along the middle of cross-section, and it was visible from both sides of the column (Figure 15). Lengthwise, it spread along more than one half of the column height. The fracture opening corresponds to measurement results for VS (Figure 14), i.e. they are a direct consequence of stress concentration near measurement locations T\_VS3 and T\_VS6 and near the location of contact within the column cross-section, which was observed at MM T\_VS1, and confirmed by numerical calculations. The analysis of stress distribution prior to and after column splitting reveals redistribution within the cross-section, and shows that the sample maintained its balance by mostly leaning onto one side of the cross-section. It is important to note that each half of the split sample has a cross section area that is sufficient to bear centric load of 500 kN, i.e. it is possible that the sample will "find" a new leaning zone, i.e. a new state of balance for load bearing. Stress redistributions within the cross-section (after crack opening), by which the column maintains its bearing capacity until the full loss of stability, can be defined as typical behaviours, as they can be observed at all samples subjected to testing. Additional tests (not relevant for results presented) were made prior to sample dismantling. During these additional

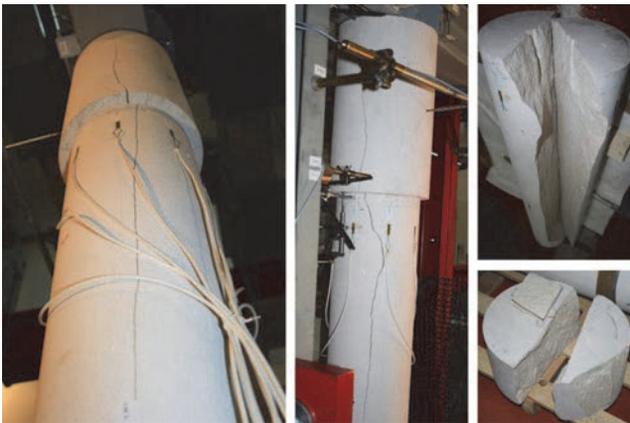
Figure 15. Crack on both sides of sample K5 without lead inlay, and column body and base splitting after sample dismantling

tests, the column body was fully split in the end, but the same was observed for column base in the direction of the crack that opened the first (Figure 15). Finally, after removal of lead inlay, significant stress concentrations (with rapid stress increase) were observed at contact surfaces that caused crack opening and, eventually, failure of the sample.

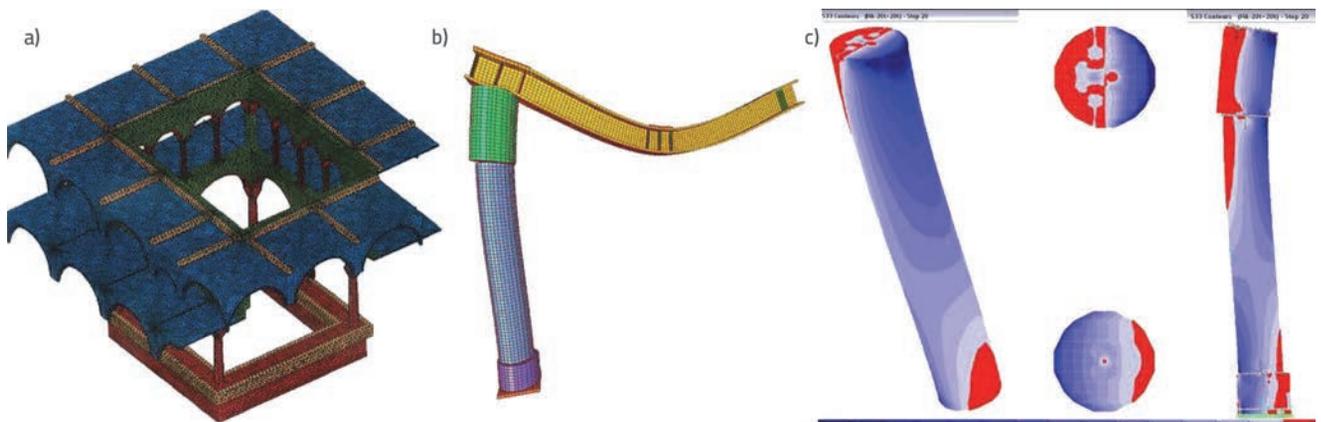
Figure 16. a) Numerical model of the Rector's Palace [10]; b) Numerical model of testing – deformed state at eccentric load [19]; c) Stress distribution along column shaft, contact surfaces, and in vertical cross section through column axis [5]

The test setup includes definition of measurement locations (MM) for measuring displacement and relative deformation according to numerical calculation results (Figure 16.b). On an average, 15 LVDT (Linear Variable Differential Transformers) of variable base were used for measuring displacement (Figure 4). The stress distribution in column was obtained by measuring relative deformations using strain gauges placed along the column body (Figure 4). The secant modulus of elasticity ( $E_0 = 62900$  MPa), obtained by experimental measurement [13] according to HRN EN 14580:2008, was used in the calculation. The measurement locations were divided into three groups (20 strain gauges on an average) along the column height: column top (VS), column mid-height (SS) and column bottom (DS), with the note that MM (measurement locations) were situated 10 cm away from contact surfaces. Such distribution proved sufficient for interpretation of stress distribution, with additional use of numerical models. At that, direct measurements on contact between column elements was avoided, as such measurements could disturb local distribution of stress. It should be noted that the test configuration has been continually improved [14] during the testing, especially after preliminary tests on similar concrete samples. An appropriate test setup adequate for approximation of column behaviour - involving use of appropriate numerical models - was obtained in the end, as will be shown below on appropriate test examples.

Causes of problems with traditional columns are identified by a numerical model of the atrium of the Rector's Palace in Dubrovnik (Figure 16.a) created in program packages FEAP 7.4 [17] and GID 6.1.2a [18], which were additionally extended to exclude overstressed finite elements. This contributed to better description of behaviour in the vicinity of connections [6]. Recent numerical analyses were more oriented toward modelling the connection itself using models of varying complexity, through which investigation results were linked with the existing structures [19].

Ever since the early planning and testing phases, laboratory tests have been supported by models created using the software SAP2000 [15]. The laboratory testing model (Figure 16.b) is described in full detail in paper [5]. This model was ultimately used for the verification of testing, interpretation of results, and calibration of global models. It is important to note that the behaviour of connection, i.e. relative rotation between column elements (modelled by brick elements) and contact with one side of the cross-section, was successfully modelled by adjustment of elements within the SAP program package. The described non-linear behaviour was defined by the link elements between model nodes (contact surfaces) according to the theoretical basis defined by Wen (1976) and by Park, Wen and Ang (1986), and further elaborated by Nagarajah, Reinhorn and Constantinou [20]. Typical distribution of stress at the contact between capital and column edge is presented in Figure 16.c. The results show concentration of compression trajectories at the edge of the cross-section (nuances of blue colour), and distribution of stress from the area of concentration on contact surfaces to the measurement points. The subsequently discovered problem of uneven connection of contact surfaces was taken into account by the models so that the properties of connection elements also included measured deviations (distances between contact surfaces). This was crucial for a more accurate approximation of connection behaviour, and for interpretation of test results. As emphasized

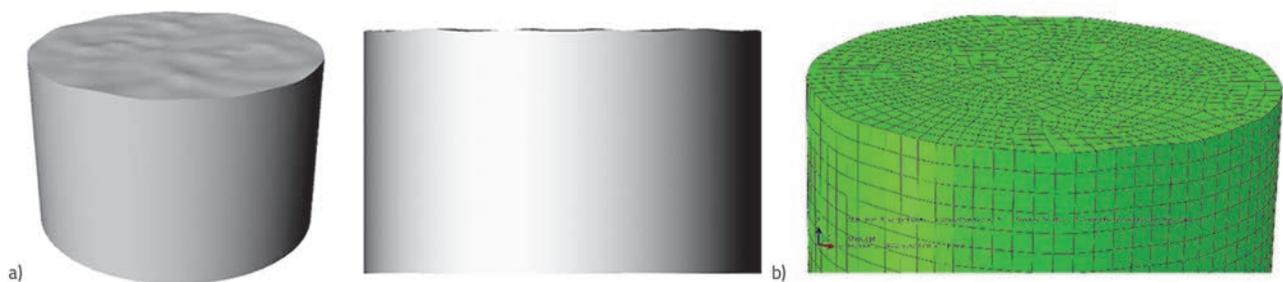
Figure 17. a) Sample geometry and irregularities at contact surfaces, b) numerical model of the sample

Numerical computations and results obtained in the scope of a wider research are presented in this section. The development of cracks on contact surfaces due to centric and eccentric loading of stone blocks will be presented, and favourable effects of lead inlay will be analysed in detail. The analyses were conducted using the program package Abaqus Standard. Due to considerable complexity of the model, only results obtained on the test sample that approximates sufficiently well the described typical behaviour will be presented in the following text. The test sample is formed of two cylinder-shaped stone blocks, measuring 25 cm in diameter and 15 cm in height (Figure 17). The model is smaller compared to laboratory samples due to high complexity of failure mechanism. In fact, the basic objective is to qualitatively present the mode of failure and the influence of lead inlay. Numerical verifications were made on two basic model types. In the first one, the connection between two blocks was realized by direct contact between two uneven surfaces, while in the second model type a lead inlay 10 mm in thickness and 25 cm in diameter was placed between uneven surfaces. Considerable effort was made to realistically describe unevenness of contact surfaces. Therefore, the surfaces were artificially defined by cutting one piece with irregular surface (Figure 17.a). As two cut blocks perfectly correspond to one another, the non-uniform contact was obtained by rotation of

The finite element mesh is formed of approximately equal regularly shaped hexahedrons (Figure 17.b). Elements are approximately 10 mm in length, and the mesh is adjusted to material behaviour in the post-critical tensile area, in which the system is unstable and becomes sensitive to the mesh size. The calculation was conducted in two phases. The initial adjustment of stone blocks is modelled in the first phase in which the top block is freely lowered onto the bottom block.

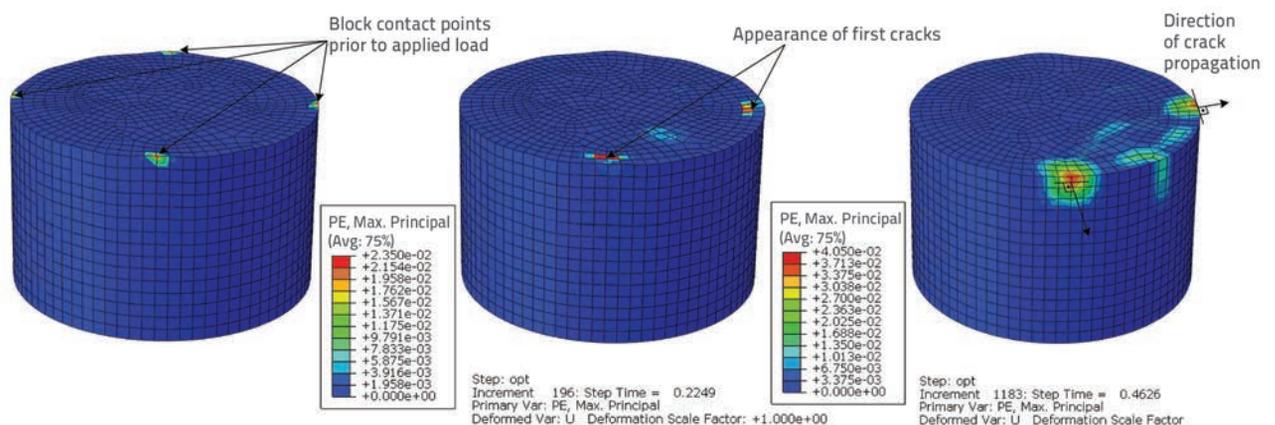
Figure 18. a) Points of initial contact between blocks; b) Plastic strain at the start of eccentric load; c) Plastic strain a moment before failure

Calculation results presented in this section are related to typical loading phases. The cracking pattern is presented through maximum principal plastic strain (PE). Contact points after establishment of contact between the top and bottom stone blocks are shown in Figure 18.a, where an initial contact in four points can be observed. Due to increase in eccentric load (second phase), the stress is concentrated in points situated in the zone in which the force is applied. Figure 18.b shows positions of initial cracks at the bottom stone block, which correspond to the stress concentration points. The crack opening direction is mostly radial and, over time, the cracks gradually propagate and start to connect with one another. A moment prior to system failure is shown in Figure 18.c, where the zone to be detached can be observed. This is followed by failure with pronouncedly unstable post-critical behaviour.

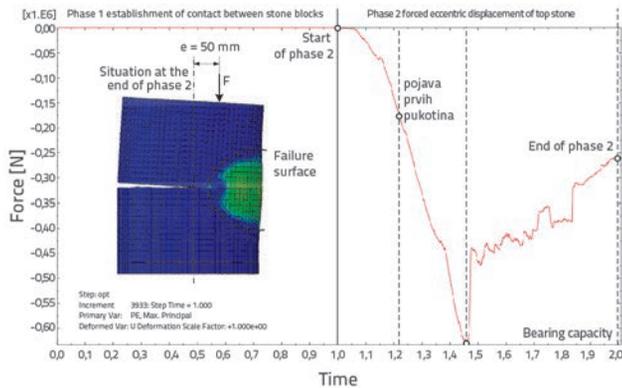
Figure 19. Diagram of force and pseudo-time on sample without lead inlay

The described phases can be seen in Figure 19 on the force-displacement diagram for the force application point. The diagram is divided into two typical areas (two loading phases).

The first area is the zone in which the contact between surfaces has been realised, and the second area is the phase of eccentric load of the top stone block. According to the previously described process, the bearing capacity is achieved in the moment of  $t = 0.47$  of the second phase (marked in the figure); it is the pseudo-time that represents a calculation increment (without any physical meaning). Additionally, the loading scheme is presented, and the failure surface of the stone sample (end of phase 2) is also marked.

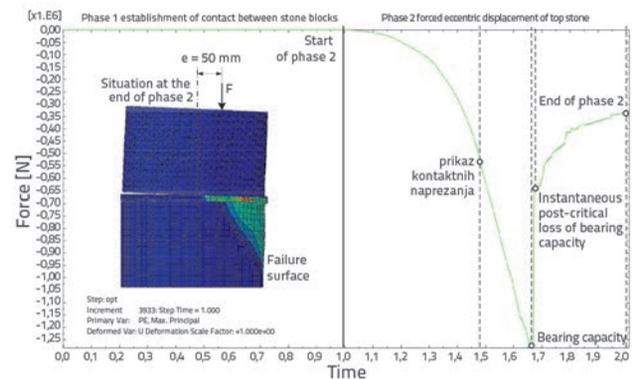
Figure 21. Diagram of force and pseudo-time for sample with lead inlay

cracks, and subsequent gradual formation of a failure surface. The crack opening is accompanied by stress relaxation, and so further development of cracks is slowed down. This enables favourable distribution of stresses in critical cross-section in time until formation of the surface failure (Figure 20.c). This point is marked by sudden stone block failure. The direction of crack development (detachment) is perpendicular to the failure surface. The stress relaxation is enabled by yielding of the lead inlay in maximum stress zones. All these loading phases can be seen in Figure 21. It can easily be observed that the failure surface is unsymmetrical compared to the lead inlay, which is caused by the difference in boundary conditions between the bottom stone sample (fixed) and top stone sample (free rotation about both horizontal axes through the point of force application). The initial distribution of stress is similar but, due to unfavourable position of failure surfaces, it occurs in the bottom sample. The bearing capacity is achieved in the moment  $t = 0.67$  (of the second phase) and it should be noted that it is approximately two times greater compared to the sample without lead. A pronouncedly unstable post-critical area and sudden drop in bearing capacity after failure can be seen in the diagrams.

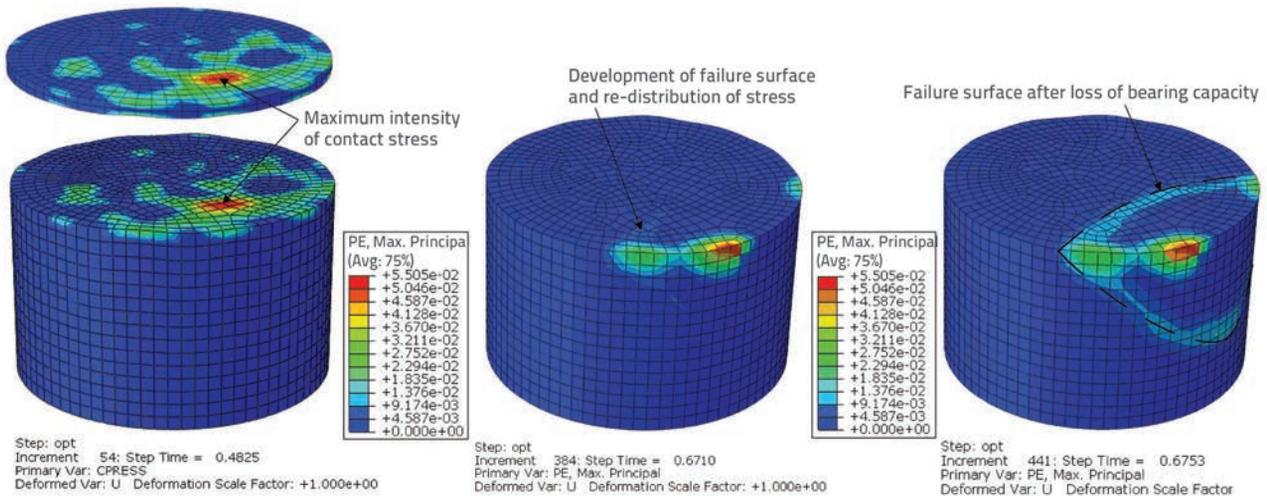
Figure 20. a) Zone of contact stresses between stone surfaces; b) Main plastic tensile strain immediately before failure; c) Main plastic tensile strain a moment after failure

The sample with lead inlay in between the stone blocks is analysed according to the same scenario. Figure 20.a shows the area of contact between the lead and the stone at the force equalling approximately 40 % of bearing capacity. It can be observed that there is no local concentration of load at the edge, but rather a redistribution to a wider area. Although the area of force transfer can still be observed, it is no longer localised. Figure 20.b shows the area of the opening and development of

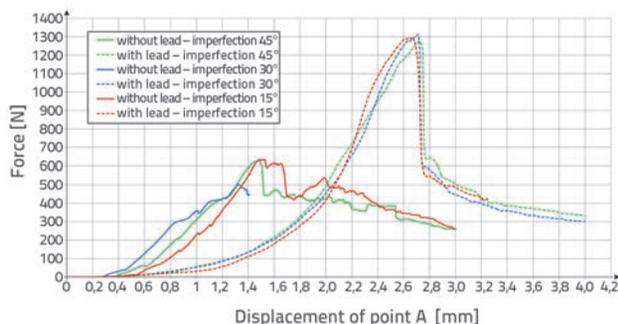
Figure 22. Force – displacement diagram for blocks with and without inlay, with eccentric load

Figure 22 shows comparison of equilibrium curves of the numerical models with and without lead inlays. The calculation was made for different positions of contacts surfaces, which was realized by rotation of the top part of the model about the vertical axis for an appropriate angle (15°, 30° and 45°). Each position results in different contacts between stone blocks, i.e. in a different distribution of stress concentrations. However, a common feature to all models without the lead inlay is the concentration of stress in the local (small) area and rapid opening of cracks. By increasing the load, cracks continue to develop and cause failure without an increase in load, which results in a relatively low bearing capacity. Unlike the described behaviour, the use of lead inlay (as a "buffer zone") enables considerable reduction in contact stresses, i.e. the stress is redistributed to include areas that were initially not in contact. By increasing the load, the lead is in the state of yielding and is hence able to transfer load more uniformly from the top stone to the bottom stone. One of the consequences of stress relaxation in cracks is the redistribution of stress to other areas of the contact surface, which ensures a much greater bearing capacity of blocks.

In the presented example, the bearing capacity of blocks with lead inlay is by approximately two times larger compared to the model without the inlay. An additional advantage is that highly uniform bearing capacities for various contact positions (depending on the angle of rotation of the top stone) are

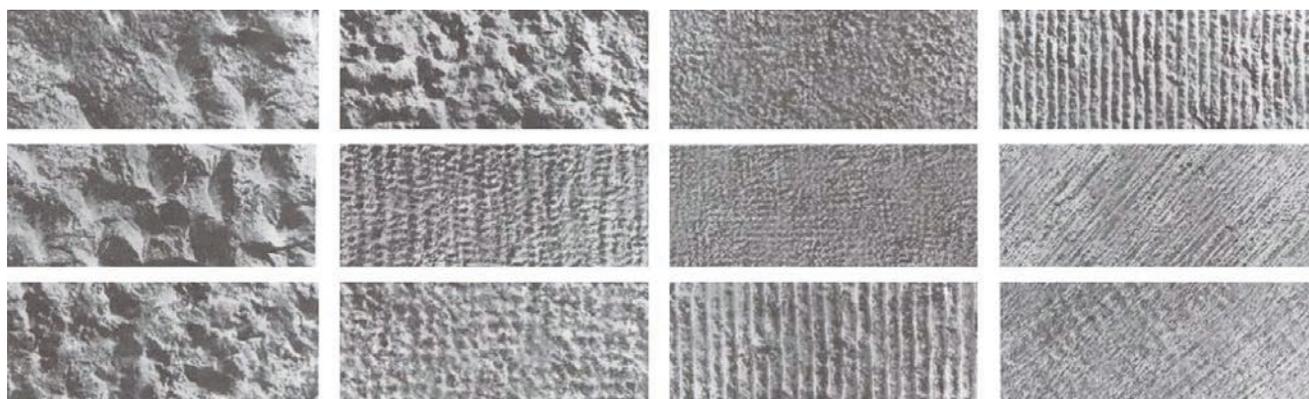
Figure 23. Appearance of stone surface during manual treatment of stone [23]

For samples tested in laboratory, the treatment of contact areas was conducted with an accuracy of approximately 0.5 mm, which was confirmed by laboratory measurements. This accuracy is in accordance with recommendations given in stone-related standards, although it should be noted that the standards do not set limitations with regard to this problem of contacts. If the level of treatment is compared with manual procedures, i.e. with values that could have been obtained by ancient builders, it can be reasonably assumed that the problem is actually even more pronounced. Manual treatment of contact areas results in local deviations (Figure 23), which depend on tools used in the treatment (and these tools have been changing over time), and on the level of expertise and experience of the builder. It is also important to take into consideration geological age, mineralogical composition, various physical properties, and structure or texture of stone but, considering high frequency of cracking of traditional columns built of various types of stone, it could be stated that the problem is of rather general nature. This has also been confirmed by various retrofit strategies throughout human history using
