# The influence of floor structures on the seismic response of unreinforced masonry buildings from the late 19<sup>th</sup> and early 20<sup>th</sup> century in Zagreb

Subject review

The paper examines structural deficiencies of unreinforced masonry buildings of traditional Zagreb construction practices from Austro-Hungarian period, with an emphasis on the role of floor structures in the transfer and distribution of seismic actions. A historical overview of the development of such structures and building typologies is provided. Special attention is given to the insufficient interconnection of load-bearing elements and the uneven distribution of horizontal forces, which directly affect the seismic resistance of buildings. The paper analyses the properties of the materials used, typical floor plan layouts, and characteristic floor structure systems in Zagreb. Through three representative case studies, different structural system configurations are examined using two strengthening methods, based on which conclusions are drawn regarding the effectiveness of individual interventions.

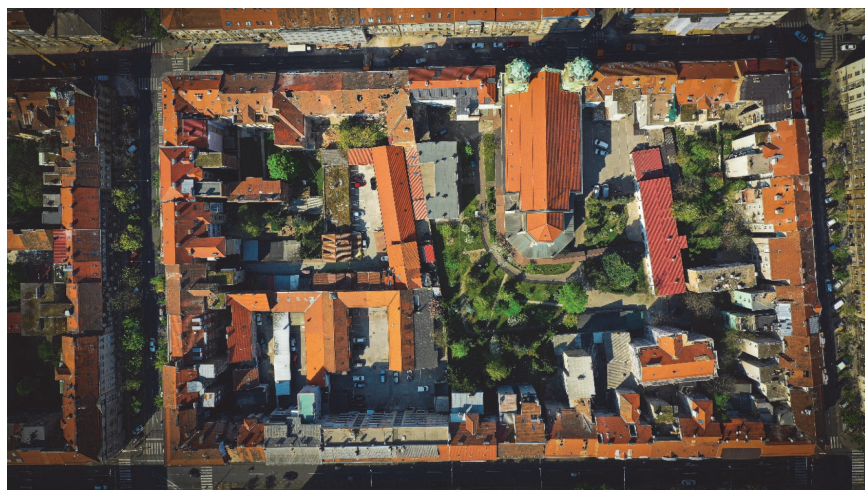
Figure 1. Typical Lower Town urban block in Zagreb

building stock of the protected historic urban ensemble of the City of Zagreb predominantly dates from the late 19<sup>th</sup> and early 20<sup>th</sup> centuries [5]. Buildings from this period were systematically organized into closed urban blocks (Figure 1), defined by street fronts and inner courtyards. Such block construction resulted in continuous rows of buildings with adjoining walls and a clearly defined urban matrix. Load-bearing walls are generally arranged predominantly in the direction parallel to the street, while in the direction perpendicular to the street insufficient percentage/number of walls is observed. In the study by Stepinac et al. [6], based on a representative sample of 103 analysed buildings, it was determined that the wall percentage of 5 % in plan is not satisfied in 12 % of buildings in the x-direction (parallel to the street) and in 16 % in the y-direction (perpendicular to the street). Under a stricter criterion, i.e., a threshold value of 10 % of wall area in plan, approximately 75 % of buildings do not meet the requirement, regardless of direction [6]. The study also provides a detailed analysis of parameters such as wall slenderness, plan asymmetry, aspect ratio, projection length, compactness, and the relative position of the center of mass and center of stiffness.

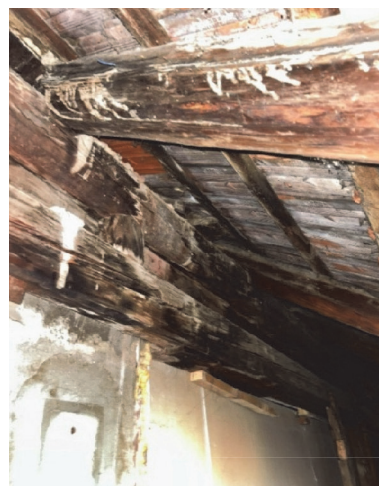
Figure 4. Timber structure damaged by biological agents

Floor structures generally do not exhibit significant degradation due to biological agents, unlike roof structures shown in Figure 4. The degradation of timber due to rot caused by the presence of moisture in floor structures occurs primarily in the beam-end support zones, specifically in the portions of the timber joists embedded within the wall where ventilation is not provided. This is expected considering the principles of building physics and the typical detailing of timber joist bearings in masonry walls. Timber joints within floor systems are "preserved" by layers of rubble and sand, and damage typically occurs in areas where these layers have been removed or where new timber elements with excessive moisture have been introduced. During the rehabilitation and strengthening of floor structures, it is essential in the initial phase to review archival documentation, conduct a preliminary visual inspection, perform geometric measurements, and subsequently carry out a detailed assessment of interventions and connections within the structure [17].

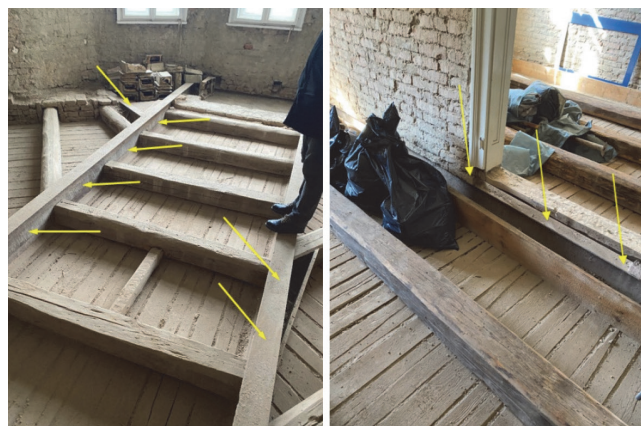
**Figure 5. Steel floor joists in a typical Lower Town corner building in the bay window zone, and steel beams beneath partition walls**

In historic residential buildings, steel is used to a very limited and localized extent, primarily in positions where high loads are concentrated and where other materials with lower strength cannot meet the required mechanical properties. Steel beams are frequently installed beneath stair flights as stringers, beneath partition walls at floor level, in balcony zones, in conjunction with Prussian vaults in ceilings above basements or semi-basements, and in geometrically more complex floor plan

configurations that cannot be spanned using timber joists, as shown in Figure 5.

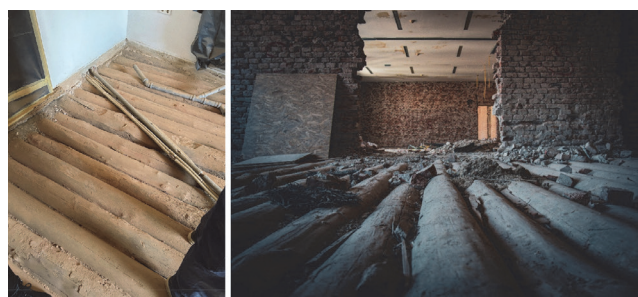
Figure 15. Floor structure made of three-side hewn beams in a residential building and a monumental structure

In this system, the timber beams are hewn on three sides, while the upper side retains the original rounded shape of the log (Figure 15). The beams typically have a cross-section of 20 cm x 18 cm and are placed tightly next to each other. It is also evident that they are interconnected using wooden dowels to achieve better structural connectivity and stiffness. A fill layer of varying thickness, depending on the position, was placed on top of the beams. Within this layer, bedding pads and wooden decking were installed if parquet flooring was used, or brick tiles were laid directly onto the fill layer. In addition to greater stiffness and higher load-bearing capacity, this type of floor structure is characterized by a relatively small structural depth. However, it also requires significantly more timber, which consequently results in substantially higher construction costs.

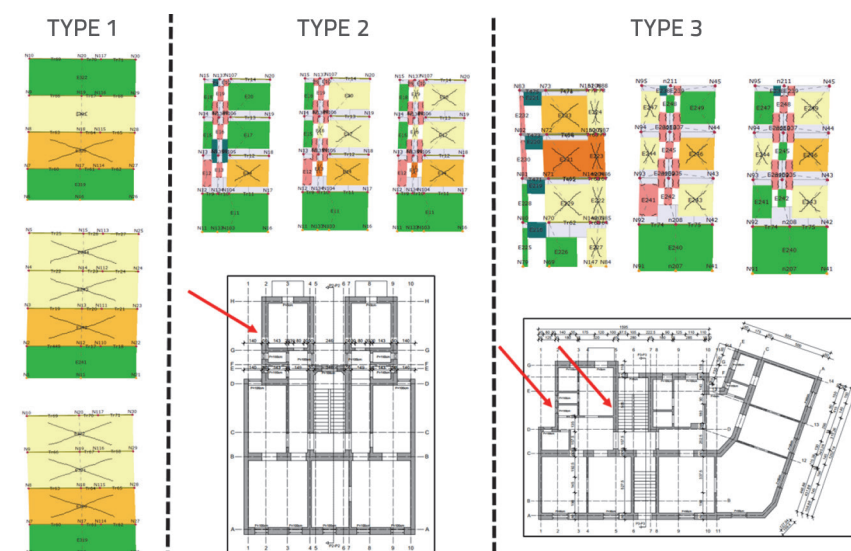
Figure 29. Critical positions for the three structural types in the original and strengthened states

As a result, very short walls enter a state of significant damage at relatively small displacements. For other floor plan configurations, even with strengthening measures, there is no substantial increase in load-bearing capacity. This is because the capacities of vertical elements are already exceeded, and despite improved connectivity and a more favorable distribution of inertial forces, very high stresses still occur in critical zones. It should also be noted that timber joists are predominantly supported by longitudinal walls (x-direction), which results in significant axial compressive forces in the walls, having a favorable effect when checking shear resistance. Figure 28 presents the values of the IZO coefficient for all analysed structural types and strengthening methods.

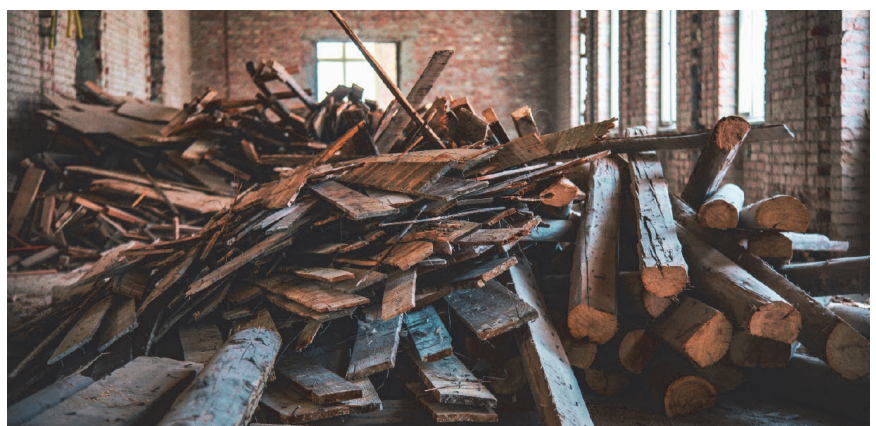
Figure 32. Dismantled timber primary load-bearing elements during structural rehabilitation

earthquake reconstruction of Zagreb, a pronounced trend has been observed of removing and replacing timber structural elements, particularly in roof structures, where traditional systems are systematically replaced with new materials [38]. Such practice reflects a clear inconsistency in the approach to rehabilitation: while masonry components are regularly treated as valuable heritage to be preserved, timber, despite its clearly defined role as a structural material, is often neglected and unnecessarily removed. This overlooks the fact that timber structures, with appropriate rehabilitation and targeted strengthening, can meet modern requirements of load-bearing capacity and serviceability. As a result, timber elements frequently end up as waste (Figure 32), leading not only to the loss of material value but also to the loss of the original structural logic and authenticity of the system.
