Adjustment of small-span masonry arch bridges to present-day demands

Professional paper

An overview of deterioration mechanisms and damage to masonry arch bridges, methods for inspection of existing structures, and conservative and sophisticated assessment methods, is presented in this paper. An original preliminary assessment procedure is developed based on the analysis of small-span masonry arch bridges using three conservative assessment methods, and an additional analysis of strengthening and adjustment of these bridges during their service life to modern traffic demands. The procedure contains three basic steps: data collection, arch assessment, and deck slab assessment.

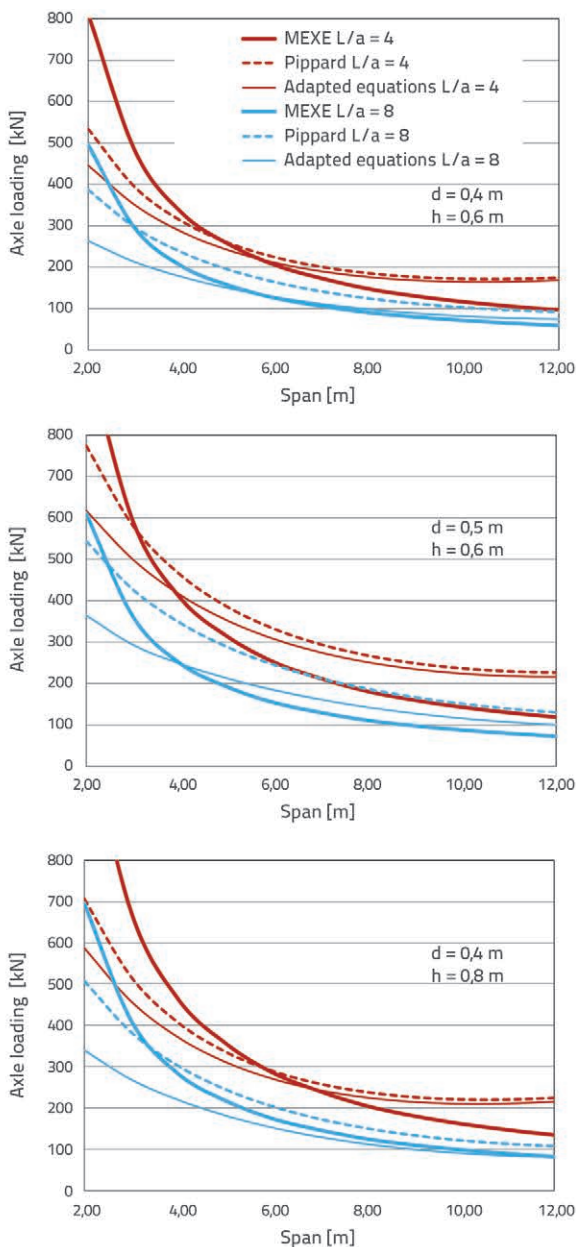
The comparison of results obtained by three methods for determining the axle load for bridge spanning 2 to 12 meters is shown in diagrams given in Figure 1. New equations adapted for smaller spans (thin solid lines), as compared to the original Pippard's equations (dashed lines), produce lower limit values of axle load. The difference is more pronounced with the greater span to rise ratio of the bridge (greater L/a ratio shown in blue lines), and with the greater thickness of the barrel d compared to the depth of the fill above the barrel h . According to additional comparison with the MEXE method (thick solid lines), involving the same material properties, joints and general condition of the bridge, it is evident that new equations for small span bridges are authoritative for the spans of less than 4.0 m (middle diagram, thin solid lines show the inferior limit axle load compared to the thick lines). As the depth of the fill above the barrel h is larger compared to the thickness of the barrel d (middle diagram $h/d = 1,2$, upper diagram $h/d = 1,5$, bottom diagram $h/d = 2,0$), these new formulas will become authoritative even for larger spans. With higher span to rise ratio L/a , new formulas may be

Figure 1. Competence area of each conservative assessment method

authoritative even for larger spans (up to 12 meters, as shown in the bottom diagram).

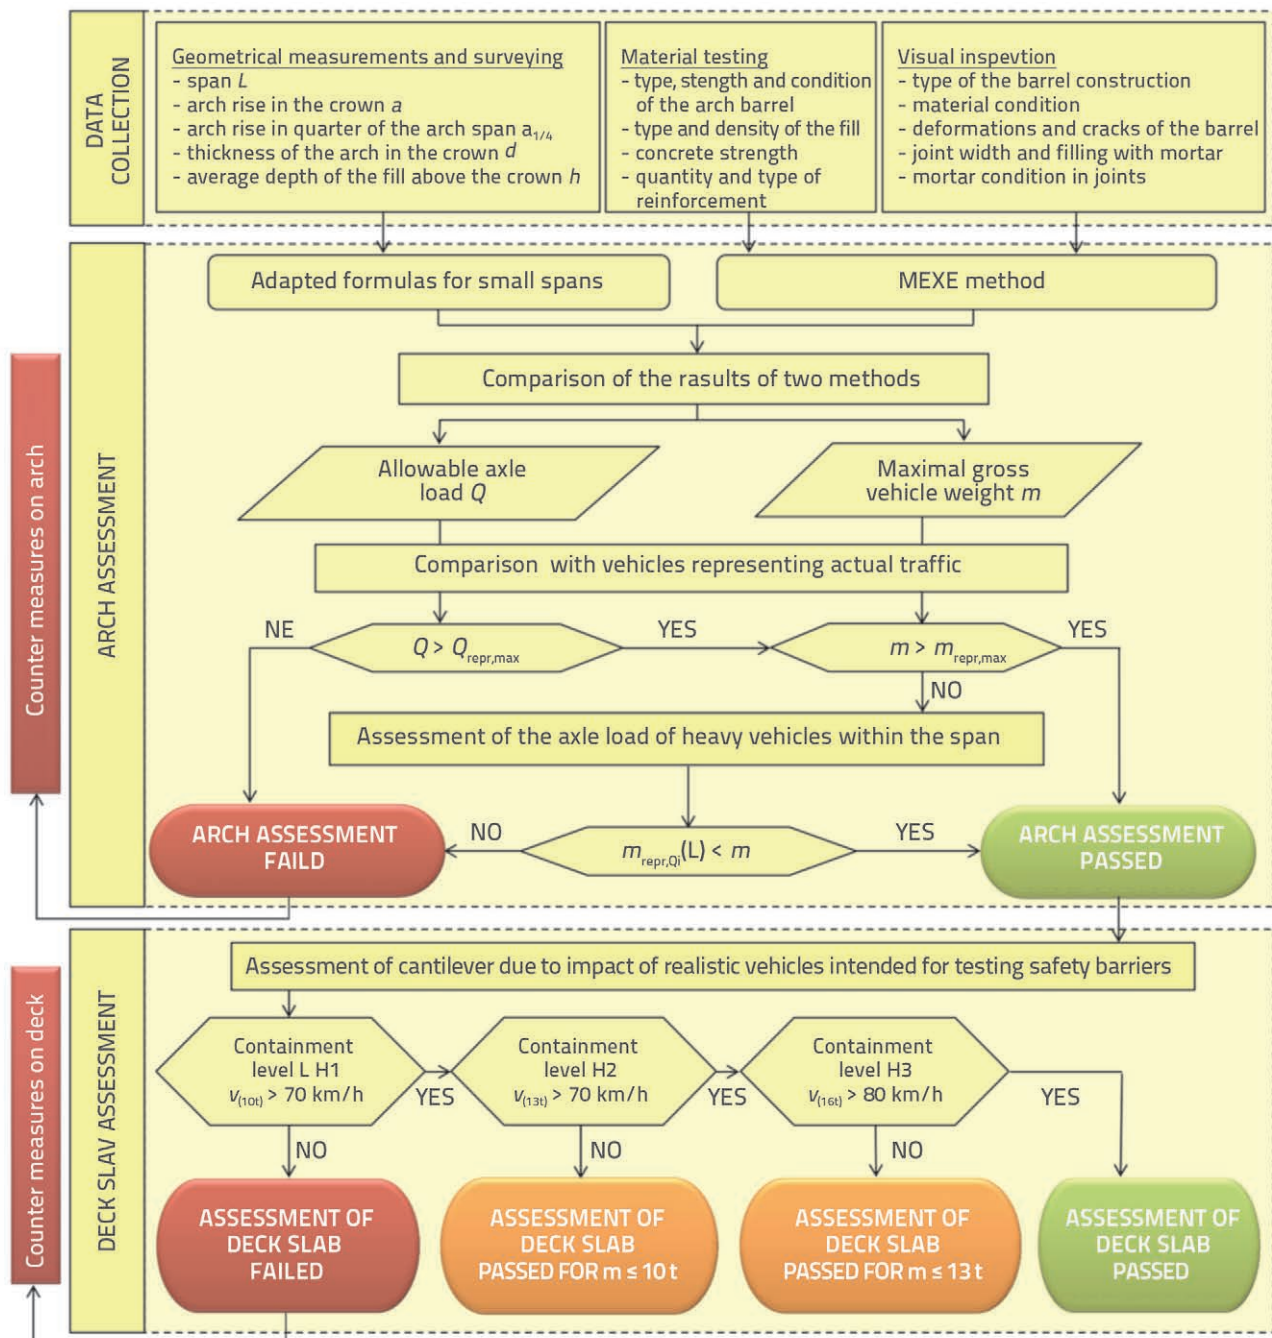
The original procedure of preliminary assessment has been developed on the basis of the state-of-the-art information on the assessment of small-span masonry arch bridges, and according to an additional analysis of the strengthening and adjustment of these bridges to modern traffic demands during their lifetime. The procedure can be used to determine the need for strengthening the barrel itself and/or for subsequent strengthening of the deck slab. First of all, it is necessary to collect appropriate data about the bridge, which implies surveying that will provide basic geometrical data, then testing material in the barrel and fill, deck slab concrete testing, and the unavoidable visual inspection to determine general condition of the bridge. This is followed by barrel

Figure 2. Flow chart for preliminary assessment of small-span masonry arch bridges with concrete deck slab

assessment using two conservative methods, MEXE method and Pippard's method adjusted to small-span bridges. One of these methods, depending on relations between geometrical parameters of the bridge, will be competent, and the result will be expressed as the allowable axle load and the maximum allowed gross vehicle weight.

If the allowable axle load obtained is lower than the axle load of a vehicle representing actual traffic, then the barrel assessment failed and counter measures are necessary. The barrel needs to be strengthened or traffic restrictions should be imposed. If additional inspections of the arch bridge are financially feasible, it is recommended to further assess the bridge using more sophisticated methods that may reveal bridge redundancy.

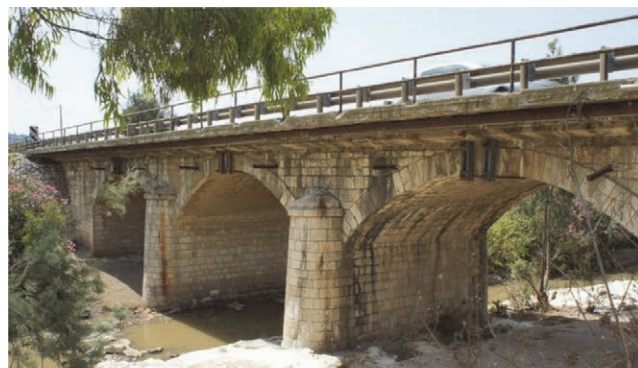
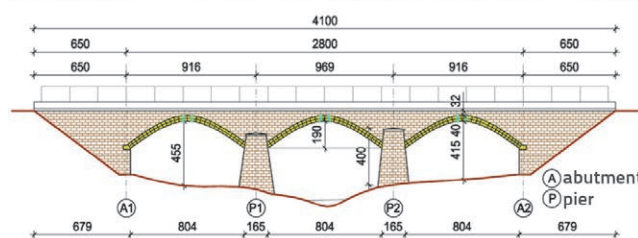
The inspection of arch barrels leads to the conclusion that some kind of repointing works and small reparations were conducted, probably simultaneously with the last bridge

widening works. It is estimated that some loose or friable mortar was removed and filled with new material. Small cracks are present on some old mortar joints, but also on new joints, which is however not a serious problem. All cracks spread in longitudinal direction, but not even close to the ones shown in Figure a) in Table 1. On the other hand, cracks in transverse direction, which may have caused cause the condition presented on Figure c), are almost not present at all.

Figure 3. Example of a masonry bridge

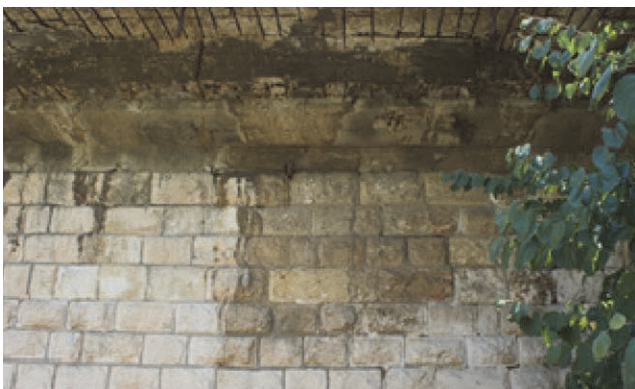
The inspection of spandrel walls shows that they are in good condition, with one local exception on the upstream side near abutment where local signs of spandrel wall bulging were registered. This bulging also changed the colour compared to the rest of the stones. Such damage is comparable to the one shown in Figure p), Table 1. It is possible that this bulging occurred during one of the road widening operations, as an adjustment of the structure to new additional load. The other possibility is retention of water in fill material. There are no signs that this movement occurred recently or that it is currently in progress.

Figure 4. Bulging and colour change at the spandrel wall

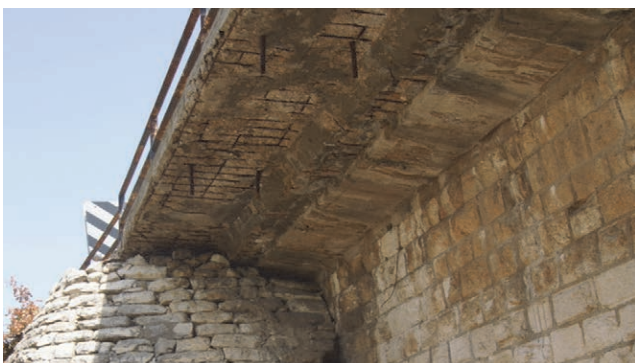
Unlike the lower deck, the upper cantilever deck is in a very poor condition. Along the entire length of the bridge, the areas with separation of the protective concrete layer may be seen, which has resulted in visible corrosion of reinforcement along the entire cantilever part of the upper deck. This is probably due to an insufficient concrete cover defined in the design, and to an inadequate realization of works. Also, numerous cracks have been observed in the transverse direction of the deck. The poor condition of the cantilever part of the upper deck is a threat to the security and stability of safety barriers and pedestrian footway at the bridge, and further accelerated deterioration of the deck is to be expected.

Figure 5. Poor condition of bridge cantilevers

Due to poor condition of the second widening of the deck, the assessment of the deck cantilever was performed. The impact of a real 10-tonne vehicle on the guardrail type H1, and of a 13-tonne vehicle on the guardrail type H2, was investigated for an accidental load situation.

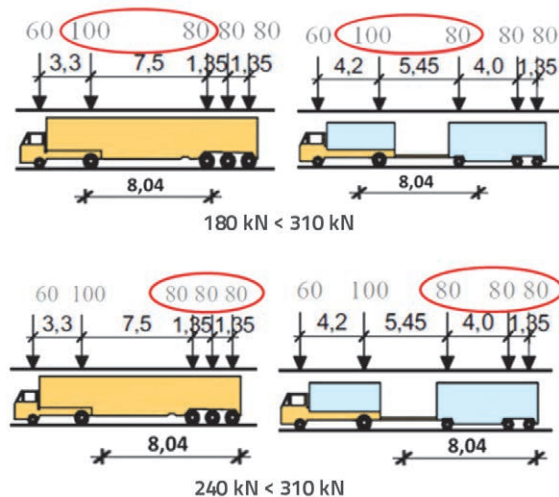
According to the Pippard's method, the maximum allowable axle load is 18.7 tonnes. Based on the modified MEXE method, the maximum allowable axle load is 31.2 tonnes for one-axle, $15.6 \times 2 = 31.2$ tonnes for two-axle, and $18.7 \times 3 = 56.1$ tonnes for the three-axle bogie. According to new formulas developed for short span bridges, maximum allowable axle load is 17.7 tonnes. The gross vehicle weight and the maximum axle load are rounded off to 31 tonnes and 15 tonnes, respectively [22].

Figure 6. Influence of axle distances of the heaviest axle loads of the representative vehicles type 5 (tug trucks) and 6 (trucks with trailers) acting on the bridge with the span smaller than the total vehicle length

If these results are compared with representative vehicle models [19, 20] on Croatian roads, it can be established that all vehicles satisfy the maximum allowable axle load requirement, but tug trucks (as vehicles models 5) and trucks with trailers (as vehicles models 6) do not satisfy the gross vehicle weight limit. However, taking into account the axle distance and the bridge span of 8.04 m these vehicles satisfy the total vehicle weight requirement, which can be a direct span load as well.

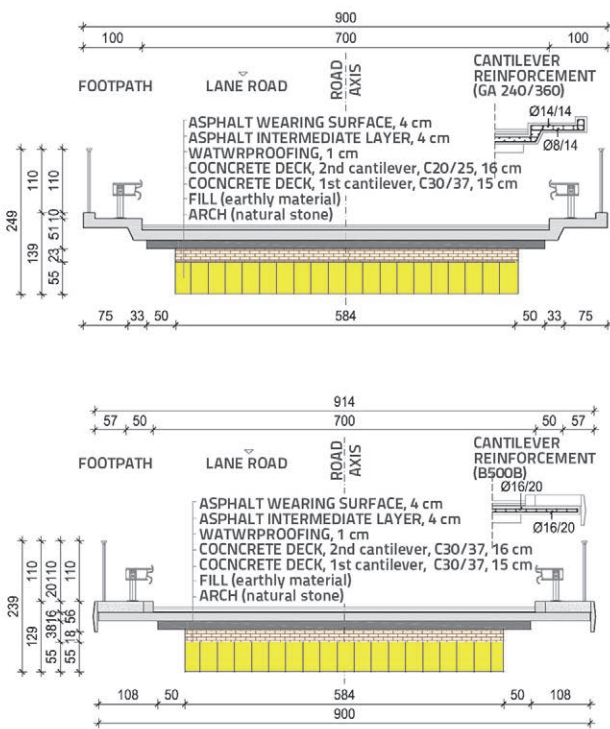
According to conservative arch assessment methods, the gross vehicle weight limit would amount to 31 tonnes. However, due to poor condition of concrete and an inadequate as-built reinforcement, the deck cantilever would not be able to resist the vehicle impact on the guardrail. Based on these assessment results, an appropriate repair of concrete deck is proposed. In addition, the existing deck cantilever was analysed for the persistent load situation with the new European traffic load model (one wheel load of 120 kN and a uniformly distributed pedestrian load of 5 kN/m²). It was concluded that the as-built reinforcement is not sufficient according to contemporary reliability demands. Cantilever replacement with an adequate new reinforcement is proposed (Figure 7) based on the analyses according to normative Eurocode traffic load models and realistic vehicle impacts on guardrails type H1 and H3.

Figure 7. Cross-section of the existing bridge deck (top figure) and a new bridge deck proposal (bottom figure)

Additionally, the bridge cantilever is assessed for the possibility of vehicle impact against the safety barrier. Due to poor condition of the second deck widening, the maximum limiting speed of only 20 km/h was established for the 13-tonne vehicle, which clearly shows that the effect of a greater-mass vehicle would jeopardize safety of the bridge deck cantilever. Therefore, cantilever replacement is proposed as a repair measure. The new solution was verified using analyses according to normative Eurocode traffic load models, and through realistic vehicle impacts against guardrail types H1 and H3.
