Seismic resistance of stone masonry building and effect of grouting

Scientific paper - Preliminary note

Mojmir Uranjek, Roko Žarnič, Violeta Bokan-Bosiljkov, Vlatko Bosiljkov

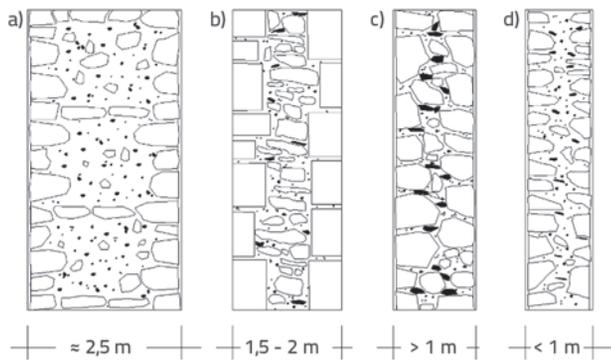
Figure 1. Characteristic cross-sections of stone masonry walls from different historical periods, according to [11]: a) Roman period; b,c) Romanesque period; d) Gothic period

Structural characteristics of stone masonry vary depending on the historical period, importance and location of the building. Some characteristic cross-sections of stone masonry walls in different historical periods are shown in Figure 1. The so-called Roman concrete composed of lime, pozzolana, sand, and crushed brick was used in the Roman period. Roman walls were additionally strengthened with transverse connections between outer leaves. Although hewn stone was also used in the Romanesque period, most of the buildings were built using uncut or irregular stone and lime mortar, occasionally

with the addition of crushed brick. In the Gothic period walls were thinner, built out of partly shaped stones. Hewn stones were used only at corners, intersections, and edges of openings [11].

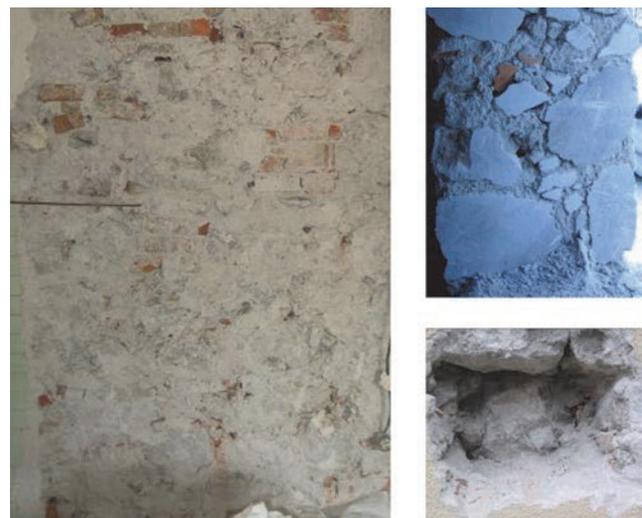
Figure 2. Texture (left) and morphology (right) of stone masonry walls

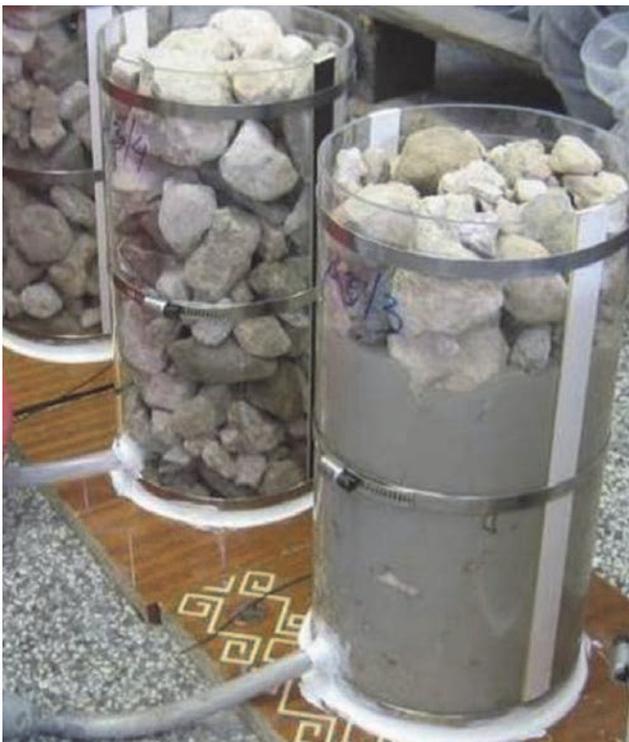
Figure 3. Cylindrical specimens during grout injection

In order to simulate the inner core of the strengthened multiple leaf stone masonry wall, cylinders measuring 15 cm in diameter and 30 cm in height were prepared and injected with the grouts LP1, LC1, LC2, C1 and C2. The cylinders were gradually filled with limestone and sandstone, i.e. 37 % (by mass) of the fractions 45/63 mm and 32/45 mm, 25 % of the fraction 16/32 mm, and 1 % of the fraction 8/16 mm. The cylindrical specimens were injected with the grouts LP1, LC1, LC2, C1, and C2. Cylindrical specimens during grout injection are presented in Figure 3.

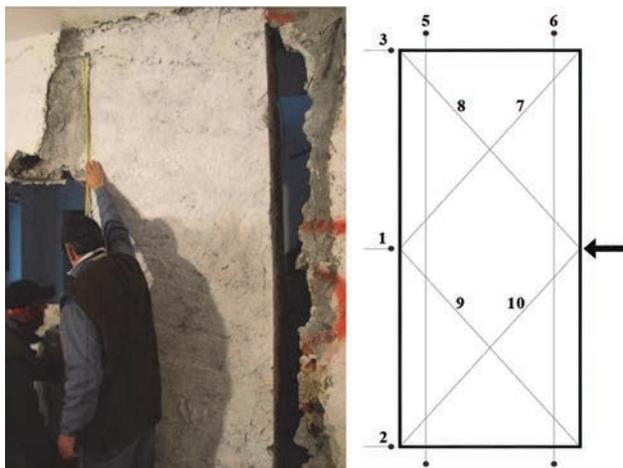
Figure 4. Cutting, measurements and shear test setup of wall specimen

Mechanical properties of wall specimens injected with injection grouts LC1, LC2, C1, and C2 were assessed 180 days after grout injection, while one wall specimen was tested in an un-grouted state. The shear tests, along with flat jack test, enabled us to evaluate mechanical properties of the walls and also the effectiveness of the grout injection technique. The earthquake response of wall specimens was simulated with an in situ shear test by which the in-plane lateral resistance, effective stiffness, and tensile (shear) strength of tested wall specimens was determined. Fixed-ended wall specimens measuring 250 cm in height, 100 cm in width, and 40 cm (2-LC1, 3-LC2) and 50 cm (1-C1, 4-C2, 6) in thickness were obtained using the diamond circular saw, and the preparation included realization of vertical grooves (Figure 4).

The lateral load was applied by hydraulic actuator, and displacements were increased in 0.25 mm increments up to the limit state. Although the goal was to achieve the NC (near collapse) limit state, the tests were ended, due to safety issues, once the SD (significant damage) limit state was exceeded.

During the testing, the displacements at the lower, middle and upper spans of the wall specimen were measured. Diagonal deformations and possible vertical displacements were also measured. The relationship between the lateral load and drift (the ratio between the relative lateral displacement d and the height of specimen h in %), along with the stiffness degradation of the wall specimens, is presented in Figure 5.

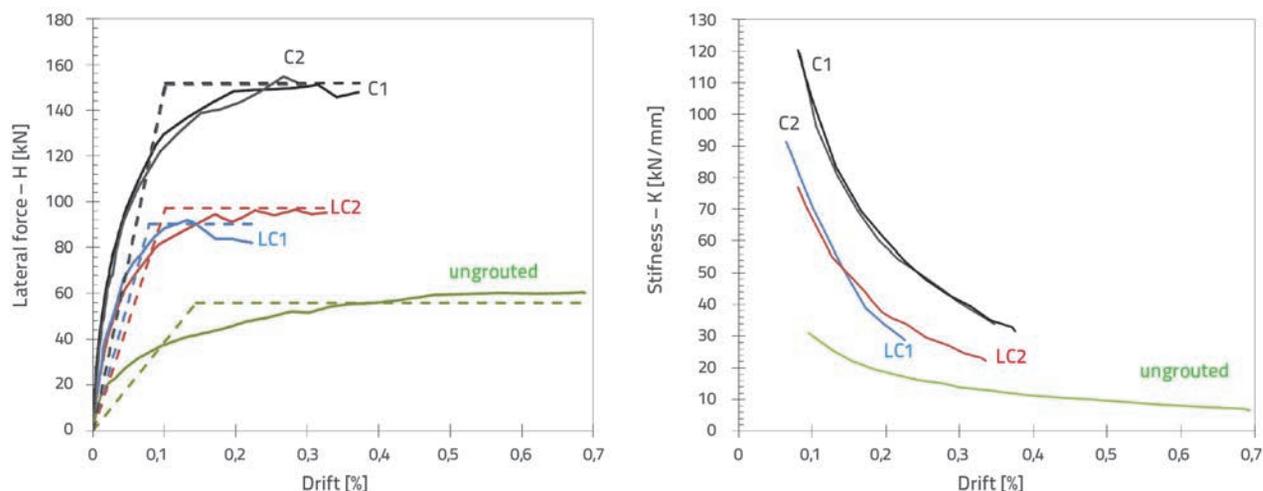
Figure 5. Horizontal resistance and stiffness degradation of wall specimens obtained by in situ shear testing

The experimentally obtained hysteresis envelopes were idealized with bilinear envelopes which were defined by the effective stiffness and displacement at the completion of the test. The effective stiffness of the injected wall specimens was calculated at the lateral load level at which first significant cracks were formed. The average crack-formation level for the injected specimens was at $H_{cr} = 0.80H_{max}$ at the drift of 0.10 %. In case of un-grouted specimen, the formation of significant cracks began at a lower lateral force level $H_{cr} = 0.61H_{max}$ and a higher drift of 0.14 %. The effective stiffness K_e was defined as the ratio between the lateral resistance H_{cr} and the wall displacement d_{cr} at the crack limit:

As can be seen from Figure 5, the stiffness degradation of injected wall specimens by the increasing displacement was very similar. After the formation of first significant cracks, a significant reduction of stiffness, with a sharp decline of curve slopes, was registered. For the un-grouted wall specimen, the decline of the curve showing stiffness degradation was much smaller. Although the stiffness of the wall specimens increased substantially after grouting, the imposed displacements beyond the achieved effective stiffness resulted in faster propagation of damage, and faster reduction in stiffness, compared to the un-grouted wall specimen. The ultimate resistance of wall specimens was calculated using Eq. 2:

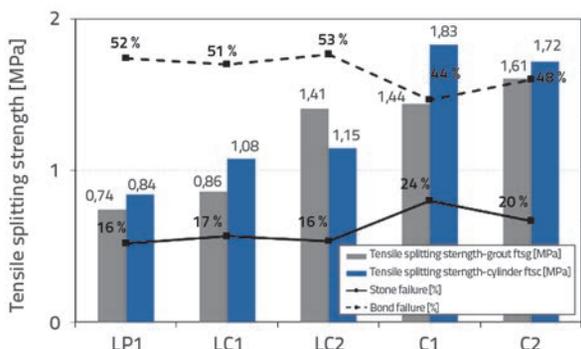
Figure 7. Average splitting tensile strengths of cylinders and grouts, and percentage of stone and bond failure at tensile splitting strength test of cylinders

An obvious distinction between related types of grouts (cement/cement-lime grouts) was revealed both in the case of compressive and splitting tensile strength tests of injected cylinders, and in the case of shear tests performed on walls. The analysis of split surfaces, which was performed on cylinders after the splitting tensile tests (Figure 7), showed

that the prevailing mode of failure was that of the bond between the stones and the grout, and that better bonding was achieved in the case of cement grouts, compared to the cement-lime and lime-pozzolan grouts.

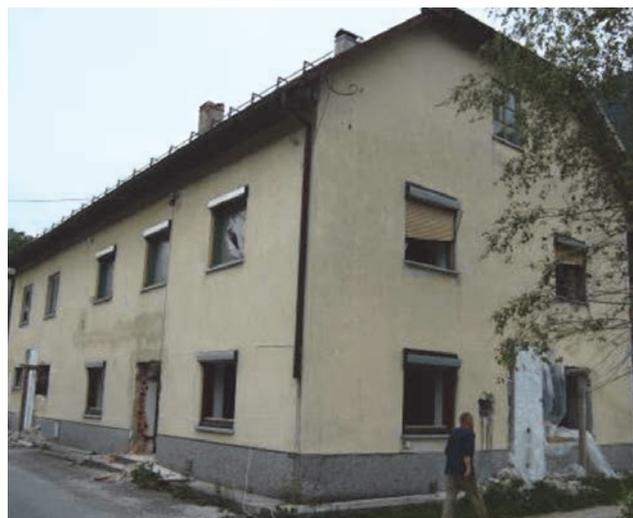
Figure 8. Northern and western facade of the building

Seismic response of the building in its existing-unstrengthened state was analyzed by two numerical tools, both based on the non-linear static analysis using pushover method. Firstly, the structure was analysed by considering the so-called storey mechanism approach with the SREMB software [29]. Secondly, the analysis was carried out using the software package 3MURI [27] that considers global response by modelling the structure with the Frame by Macro Elements (FME) method. Results obtained for the existing-unstrengthened state of the building were compared with actual registered damage following the cracking pattern investigation of the building after it suffered earthquake damage in 2004. The facades of the building are presented in Figure 8, and the models used for seismic analysis are shown in Figure 9.

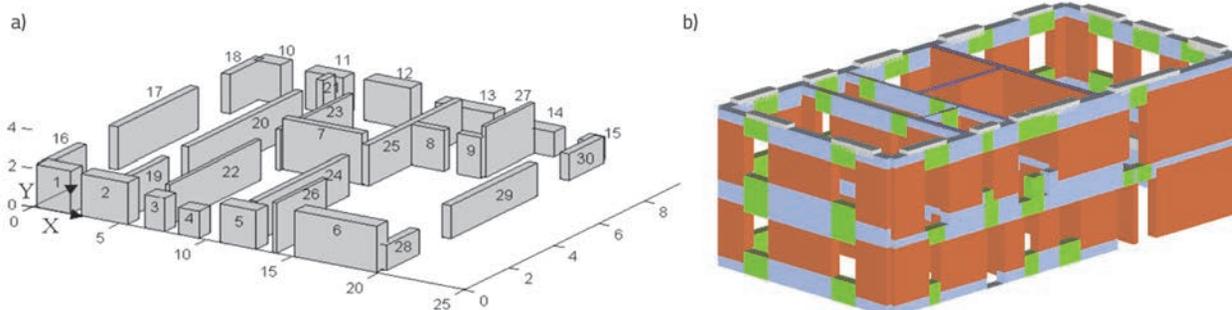
Figure 9. Models used for non-linear seismic analysis: a) SREMB; b) 3MURI

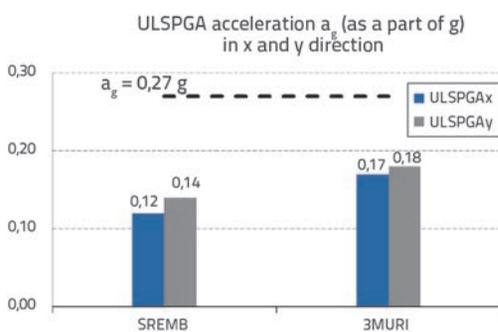
Figure 10. Seismic resistance of the building in the existing state, calculated using SREMB and 3MURI

Our analysis took into account mechanical properties obtained through in situ shear and double flat-jack tests (with the exception of actual ductilities). The full knowledge level (KL3) of the building, and the confidence factor of $CF = 1.0$ according to EC8-3 [30], were assumed. Consequently, the actually obtained values were considered in the numerical analysis. In order to compare the results of both programs, the results obtained by SREMB were converted into the form of ULSPGA (ultimate limit state peak ground acceleration) taking into account the relations defined in the N2 method [31]. The results obtained are presented in Figure 10. The expected peak ground acceleration on the micro location of the building considering the soil factor of $S = 1.2$ amounts to $0.27g$, and is marked with a dashed line. As can be seen, the seismic demand in the existing un-grouted state is not achieved by either of the programs used.

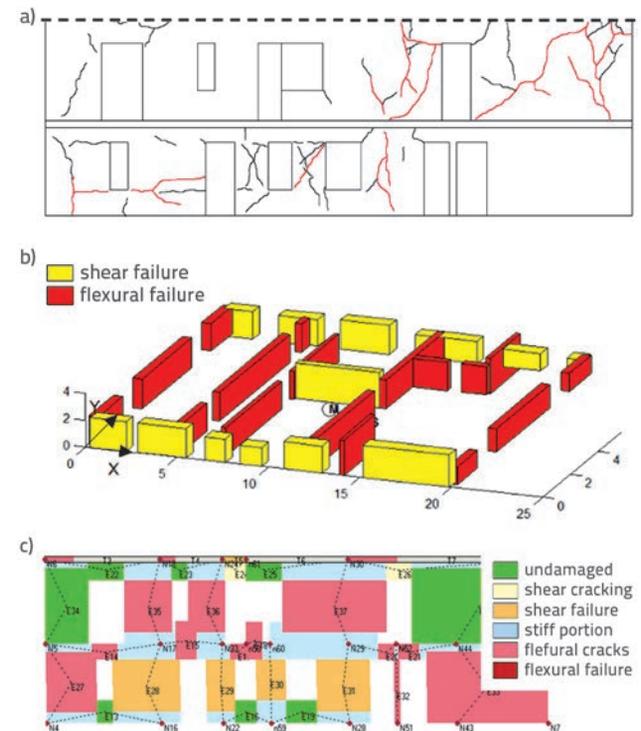
Figure 11. Cracking pattern registered at the south façade: a) compared to the failure mode at ultimate state obtained by SREMB; b) and 3MURI; c) for un-grouted state

The crack pattern registered at the south façade wall is compared to the failure mode at the ultimate state obtained by SREMB and 3MURI for the existing un-grouted state (cf. Figure 11). As can be seen, the shear failure prevails in both models at the ground storey, which is in accordance with registered crack pattern. A somewhat better interpretation of the actual damage state of the ground storey is obtained by the 3MURI model. In the upper storey, the 3MURI model foresees primarily flexural cracks in the middle portion and an undamaged state at the left and right parts of the storey walls. In the actual state, the flexural cracks are also present,

but a substantial shear cracking is also present mainly in rightmost and leftmost parts of the storey walls.

The results of the crack pattern investigation revealed that the damage was not concentrated only in the ground storey wall piers as predicted by the SREMB model, but that the cracks also formed in the upper storey, and in lintel area of the lower storey. Although the 3MURI model was not able to provide the exact interpretation of the actual state of damage, it seems that in the case of the analysed building it enabled better approximation of the actual state compared to the SREMB model.

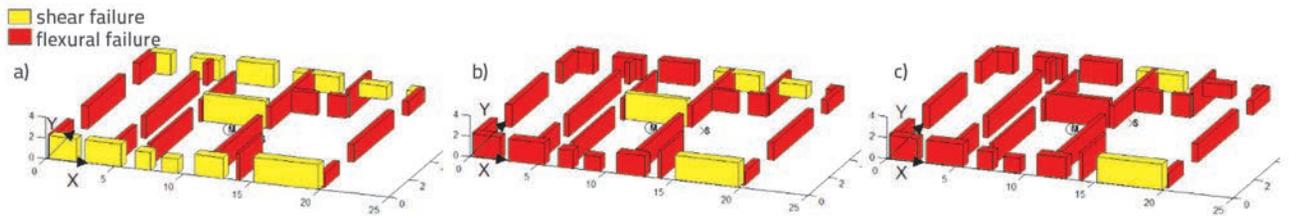
Figure 12. Failure modes at ultimate state in x direction obtained by SREMB: a) before grouting; b) after grouting with LC1; c) after grouting with C1

after grouting, as obtained by SREMB, is presented in Figure 12. As can be seen in this figure, the shear failure prevails in the existing un-grouted state. As the tensile strength of the walls increases substantially after grouting, the failure mechanism changes from shear to flexural for most of the walls in the x direction. Since the increase in tensile strength is higher if cement grouts are used, the share of walls that exhibit flexural failure is somewhat higher after injection with cement grouts C1 and C2, compared to injection with lime-cement grouts LC1 and LC2. In the y direction, the walls are mostly longer (lower height/length ratio), and so shear is the predominant mode of failure even after grouting. The comparison of failure modes at ultimate state in the y direction before and after grouting, as obtained by 3MURI, is presented in Figure 13. In the existing un-grouted state, the shear failure prevails in the wall piers with flexural cracks in the lintels of the lower storey. The upper storey walls remain mostly undamaged, with the exception of the shear cracking at

the left lintel, and flexural cracking at the right-side pier. After grouting, flexural cracks form in most of the wall elements, regardless of the type of injection grout used (LC1, C1). In terms of ductile behaviour and energy dissipation during seismic loading, the flexural mechanism that prevails after grouting is more favourable than the shear mechanism. The seismic resistance of the structure in terms of the ULSPGA, calculated with SREMB and 3MURI before and after grout injection, is presented in Figure 14. After grout injection, the seismic resistance calculated with both programs increases significantly, with a slightly higher increase in the case of cement injection grouts C1 and C2, compared to lime-cement grouts LC1 and LC2. As can be seen, the values obtained by 3MURI are considerably higher compared to those obtained by SREMB. 3MURI takes into account the entire structure allowing the failure mechanisms to be formed in piers and lintels with an even distribution throughout the height of the structure. Consequently, the deformation capacity of such structure

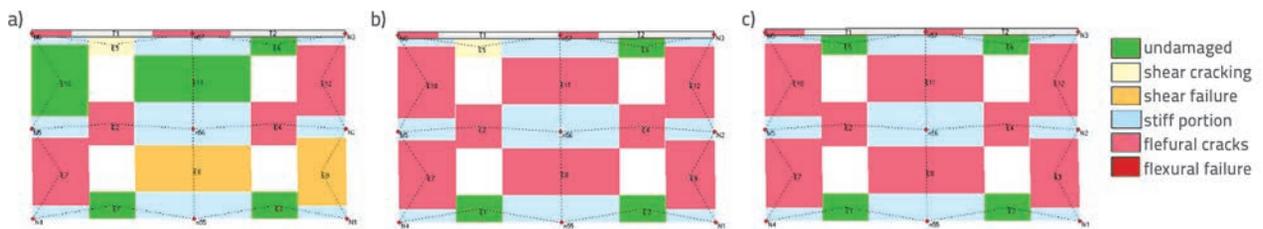
Figure 13. Failure modes at ultimate state in y direction (west façade wall) obtained by 3MURI: a) before grouting; b) after grouting with LC1; c) after grouting with C1

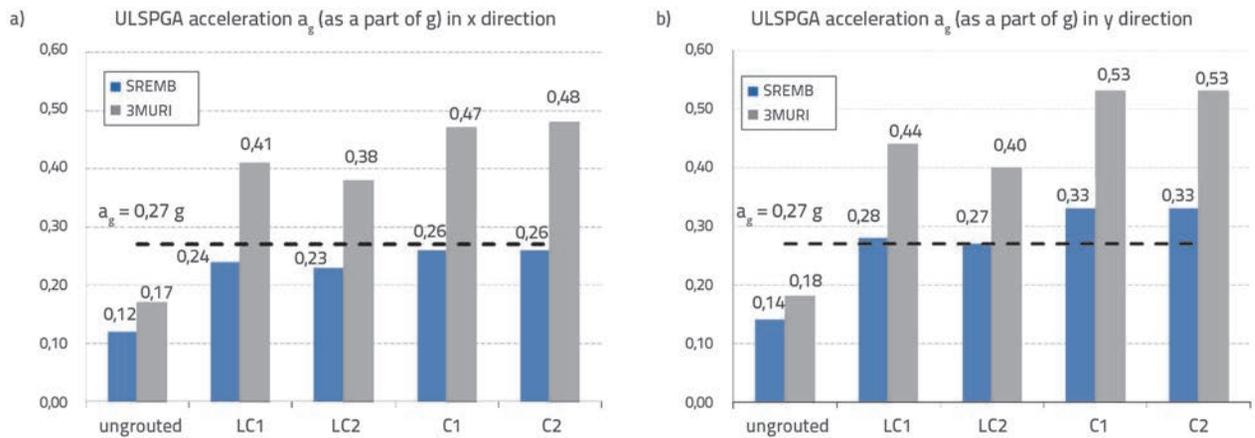
Figure 14. ULSPGA acceleration a_g (as a part of g) calculated with SREMB and 3MURI in: a) x direction; b) y direction - for all analysed cases

is much higher compared to the single storey mechanism approach considered by SREMB, resulting in higher ULSPGA values. In the un-grouted state, the ULSPGA is higher by 41.7 % in the x direction, and by 28.6 % in the y direction, according to the global mechanism response model, compared to the storey mechanism response. After grouting, the comparison between different models reveals the increase by 70.8 % in the x direction and by 57.1 % in the y direction using the injection grout LC1, and by 80.8 % and 60.6 % in the x and y directions, respectively, by using the injection grout C1, all in favour of the global mechanism response.
