Structural repair of Careva Ćuprija Bridge in Sarajevo

Professional paper

Structural condition and repair of the Careva Ćuprija Bridge in Sarajevo is presented in the paper. This historic structure has been exposed to various atmospheric influences during its use, and also to significant traffic load for which it was not initially designed, which has ultimately resulted in degradation of its structure. To enable continued functioning of this bridge its structure must be repaired taking into account the fact that the bridge was proclaimed a national monument of Bosnia and Herzegovina on 11 March 2009.

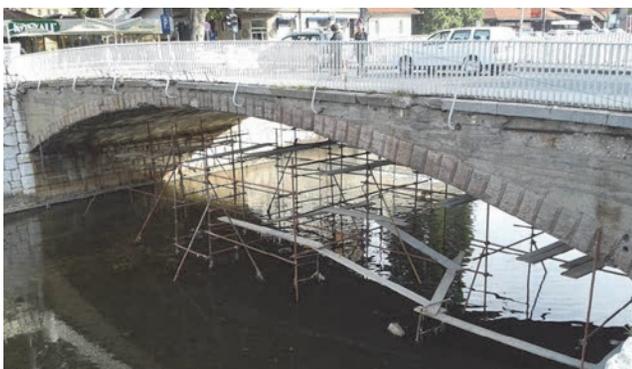
Figure 5. Careva Ćuprija Bridge with scaffolding during investigation works in 2015 [5]

During this period the bridge was used for both pedestrian and cart traffic. After the First World War, the motor vehicle traffic started to be operated across the bridge. Figure 5 shows the Careva Ćuprija Bridge with scaffolding under the bridge during investigation works conducted in 2015. It can be seen that some changes were made on the bridge regarding the pedestrian railing, and that bridge lighting was removed.

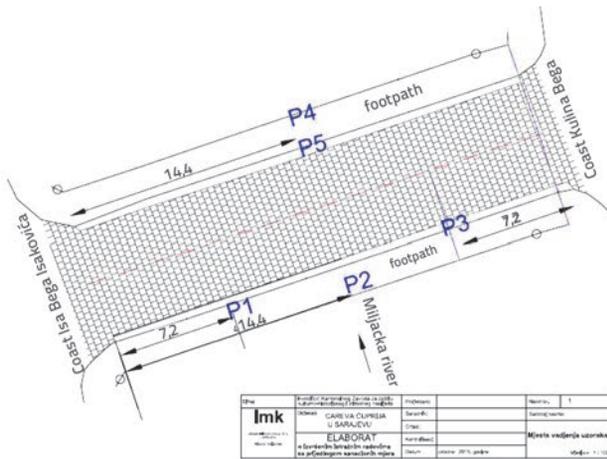
Figure 23. Location of samples [8]

After sampling, it was established that the thickness of the arch varies not only along the arch, but that the thickness in the crown is also not constant (Table 1).

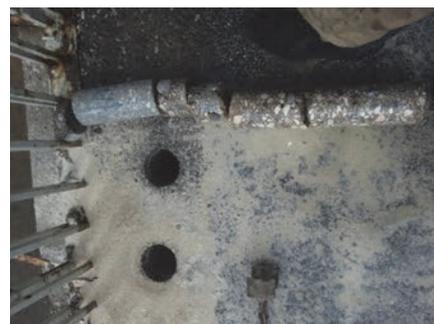
Figure 26. Concrete samples

Figure 26 shows one of the samples extracted at the crown of the bridge and a sample taken in 2007, so that the quality of concrete can be compared.

Although the tests were conducted on a small number of samples taken from bridge structure, it can nevertheless be stated that the concrete strength did not reduce as compared to the testing conducted by the Institute in 2007 [7]. However, the bridge structure further deteriorated due to soft water corrosion (corrosion by leaching) as combined with general acid corrosion (soluble gases CO₂, H₂S).

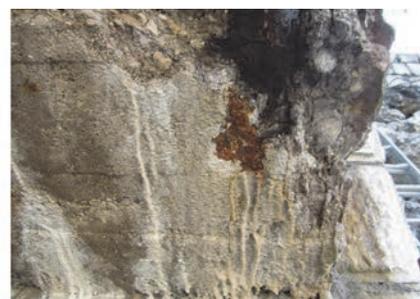
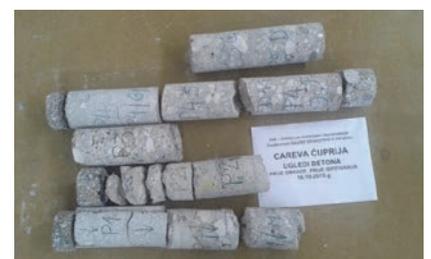
Figure 27. Sample before treatment and testing

The analysis of P4 samples has revealed that a different type of concrete was used (Figure 28), and that it is a well structured factory-mixed concrete with dolomite aggregate, most probably originating from the post-war decades of the past century, or from this century. These data

cannot be taken into account when calculating the current class of concrete from the bridge arch because it represents a "new" concrete that was obviously used in bridge repair some ten to fifteen years ago. This concrete sample is completely different from the other samples regarding its structure, where in all other samples river aggregate and another type of cement has been used.

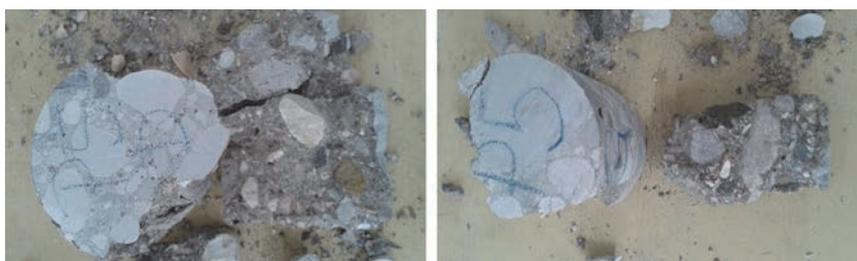
Figure 30. Samples P5 D and P5 G

occurs at the location where these samples were extracted. Due to the soft water seepage, capillaries are being filled, which is manifested by concrete coagulation and increase of density in hardened state. The values of density (2142 kg/m³ and 2134 kg/m³) and compressive strength on the cube (37.0 MPa and 39.5 MPa) greatly deviate from all other similar results [8]. Water seepage through concrete is characterised by uneven filtration: the number of filtration channels is the greatest at the beginning of the filtration path, next to concrete surface exposed to pressure. Blockage of filtration occurs due to hydrolytic decomposition of cement stone and swelling of colloidal compounds (mostly calcium hydrosilicate). The process of leaching is significantly slowed down only if the layer depleted and weakened by leaching of lime, which is formed on the surface of concrete, does not fall apart due to mechanical or hydraulic effects (Figure 30). Significant corrosion of concrete can be observed on all samples (Figure 31).

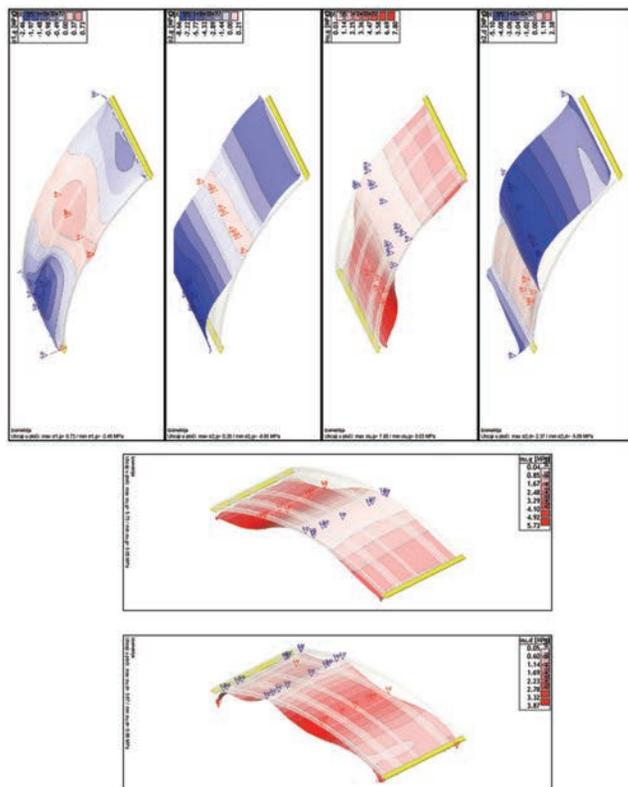
Figure 33 shows the stress state for the load combination +II+III+IV – V300+V300 which was adopted as the structure can not be strengthened using greater load while respecting at the same time the requirement to make as little interventions on the structure as possible.

The ratio of actual to necessary reinforcement for the existing situation as per regulations for required safety factors and the traffic load for V300+V300 is provided in Table 7.

Figure 33. Stresses for load combination with load vehicles V300 + V300 - existing structure: I - dead weight of the structure, II - weight of the fill and bulk material, III - load from top layers and railing weight, IV - type of live load

It was established according to calculations that the intrados of the bridge structure will be strengthened with reinforcement meshes (MA 500/560) Q524 and with sprayed concrete class

MB 20 10 cm in thickness. The extrados will be reinforced with meshes (MA 500/560) Q524 and with sprayed concrete class MB 20 approximately 5 cm in thickness. Shotcrete is traditionally used to increase the arch thickness in order to increase the carrying capacity, and to stabilize and protect structures exposed to atmospheric conditions. A large number of Victorian masonry bridges and arch structures in England were strengthened in this way [14].

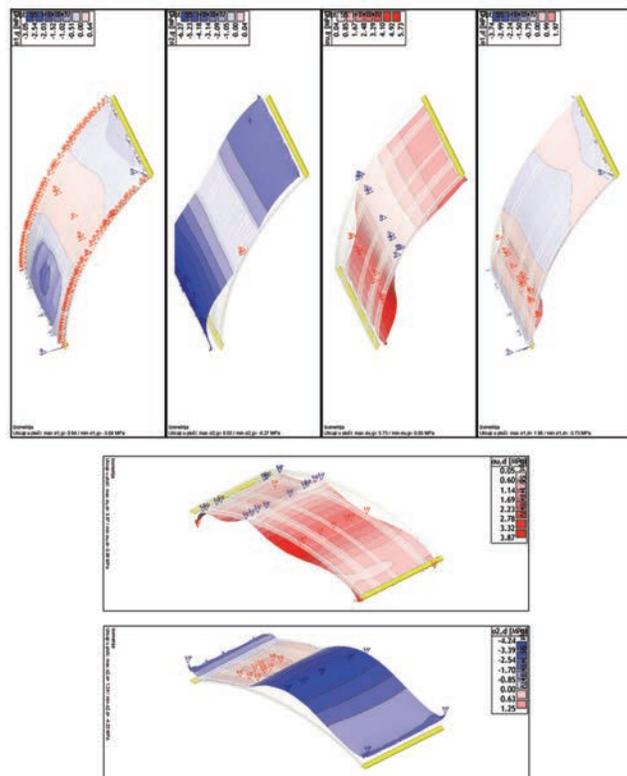
Figure 34. Stresses for load combination with load vehicles V300 + V300 - rehabilitated structure

Finally, an analysis of the rehabilitated structures was done in accordance with the investor's approval. The stress state of the arch is shown in Table 8 and Figure 34. Table 9 shows the amount of reinforcement needed to take over the tensile stresses.

rehabilitation of the arch. In this sense, an appropriate loadbearing structure rehabilitation - involving the use of reinforcement mesh on the side of the intrados and extrados - has been proposed, with the goal of making minimum intervention on the bridge. In addition, the entire structure above the intrados has to be replaced which will require participation of experts from the field of cultural and historical heritage, so that the bridge can be restored to its original state from 1897, as shown in Figure 4.
