Why did residential block in Croatian national revival street in Sisak damaged in earthquake had to be demolished

Professional paper

Residential block located in Croatian national revival street in Sisak is the largest building demolished after being damaged by Petrinja earthquakes in 2020. After the earthquake building was declared unsuitable for housing because of damage. All residents had to move out and since then the building is not in use. Classification of damage to building was determined according to The European Macroseismic Scale (EMS-98) and Technical Regulations for Structures (NN 7/22, article 24). In this paper is explained why is it necessary to determine the level of actual earthquake resistance for buildings of this type, period of construction and initial seismic flaws. Earthquake resistance level of existing building can be determined only by seismic design calculations. Except for standard methods of calculations, such as linear-elastic calculation using response spectrum, it is necessary to calculate structures using nonlinear methods, such as pushover analysis. Reconstruction level and concept are defined by buildings damage level and determined earthquake

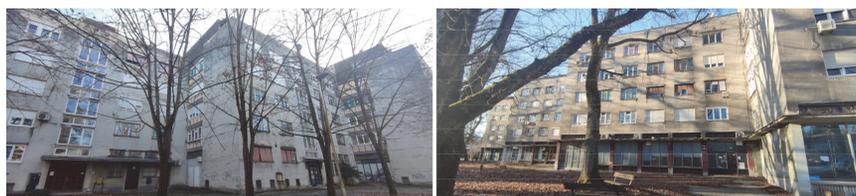
Figure 2. Building block front facade

made of solid clay brick. Some load-bearing walls are discontinued in ground level and they are supported by reinforced concrete girders and columns instead. Building block was heavily damaged during earthquake which occurred on 29. December 2020. After the initial assessment, which was made by professional engineers to determine usability of the building, it was declared that the building is unsuitable for housing because of damage it sustained. Residents were required to move out and building was not in use since then. Building block front is shown on Figure 2.

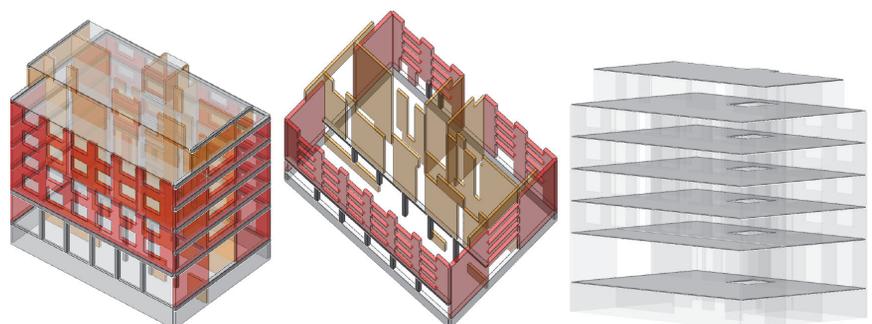
Figure 12. Calculation model of the structure

Due to cracking, the bending stiffness of all elements is reduced by 50 %. The importance factor was taken in the amount of 1.0 because it is a building of ordinary importance. The behavior factor is 1.50 in accordance with HRN EN 1998-1 [7] for an unreinforced masonry system. Since unreinforced masonry is not ductile and there is no possibility of seismic energy dissipation, a higher behavior factor should not be used in the calculation. The soil category taken into account is C. The value of the soil reaction modulus according to the geotechnical study is 6300 kN/m³, and the modal analysis was performed on a model where the supports are assumed to be infinitely rigid. Figure 12 shows the construction elements of the calculation model.

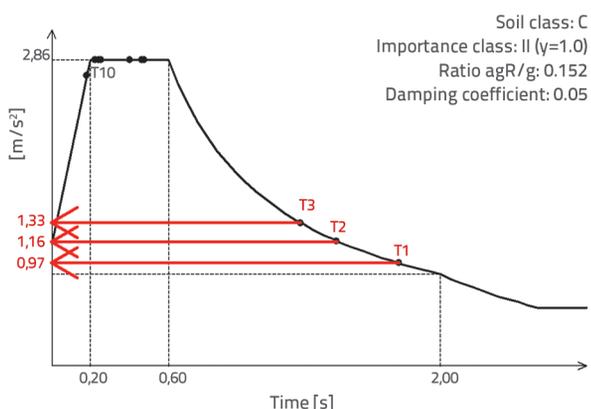
Figure 13. Design spectrum

The modal analysis conducted determined that the first three periods of vibration of the structure are $T1 = 1.79$ s, $T2 = 1.47$ s and $T3 = 1.28$ s, respectively. The first form of vibration is translational in the transverse direction, the second is torsional, and the third is translational in the longitudinal direction. The identified damage to the structure is in correlation with the results obtained from the calculations. The severe damage to the facade load-bearing walls determined corresponds to the first, translational form of vibration in the transverse direction of the building, i.e. in the direction of these walls, while the separations of the building edges determined by survey correspond to the second, torsional form of vibration. Due to the large vibration periods, which are on the descending branch of the response spectrum, the seismic forces acting on the structural elements are significantly reduced, as shown in Figure 13.

Through linear-elastic calculation for ground acceleration with a 475-year return period, i.e., for 0.15g, the internal forces in the walls were obtained, and masonry design was performed. The total weight of one expansion joint is 34,000 kN. Using linear-elastic calculation with the response spectrum method, the transverse force in the ground floor was obtained as 4,400 kN in the longitudinal direction and 3,100 kN in the transverse direction. Therefore, the transverse force in the longitudinal direction of the building is 13 % of the mass, and in the transverse direction 9 %, which is significantly higher than the forces for which buildings built in that period were calculated and designed. Since the elements are brittle, or do not have sufficient ductility, and also insufficient load-bearing capacity, they fail at relatively small values of internal forces in the elements. In other words, the limit state of significant damage is reached for a significantly lower ground acceleration. For this reason, it is not possible to verify the limit state of significant damage, or determine the IZO factor, using a linear elastic calculation for the full value of ground acceleration. As a rule, for such structures, the determination of the existing resistance should be demonstrated by performing several iterative linear calculations, reducing the ground acceleration until each structural element satisfies it. In accordance with point 9.4 (6) of the HRN EN 1998-1 standard, it is also possible to take into

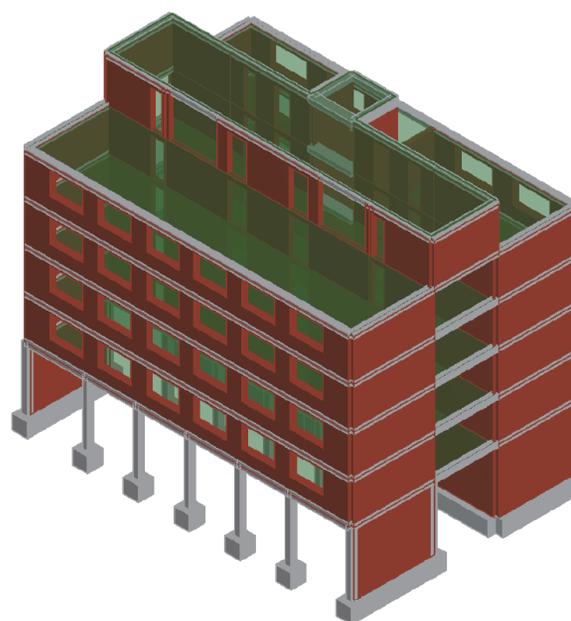
Figure 14. Calculation model of the structure

For the analysis of this building, a nonlinear analysis will be performed using the Pushover method. Material nonlinearity is taken into account at the element level via the corresponding load-bearing capacity curves. A bilinear material behavior curve (strain-strain) is adopted. The mechanical characteristics of the materials used in the model for nonlinear calculation are not the same, as nonlinear calculations use mean values, while linear calculations use characteristic values. A representation of the structural model is given in Figure 14. and the values used are as follows:

- Masonry: Modulus of elasticity 1500 MPa
- Shear modulus 500 MPa
- Characteristic compressive strength 3.40 MPa
- Characteristic shear strength 0.16 MPa
- Concrete strength class MB 30 (corresponds to modern strength class C25/30)
- Reinforcement: smooth GA 240/360
