# Time-dependant stability of slopes excavated in marl

Prof. **Predrag Mišćević**, PhD. CE  
University of Split  
Faculty of Civil Engineering, Arch. and Geodesy  
Department of Geotechnical Engineering  
[predrag.miscevic@gradst.hr](mailto:predrag.miscevic@gradst.hr)

**Goran Vlastelica**, B.Sc. CE  
University of Split  
Faculty of Civil Engineering, Arch. and Geodesy  
Department of Geotechnical Engineering  
[goran.vlastelica@gradst.hr](mailto:goran.vlastelica@gradst.hr)

Preliminary note

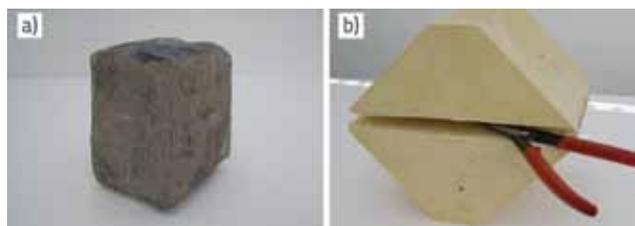
Figure 7. Preparation of test samples: a) sample wrapped in mesh before it is placed into the testing plaster; b) example of mesh cutting once the sample is placed into the testing plaster

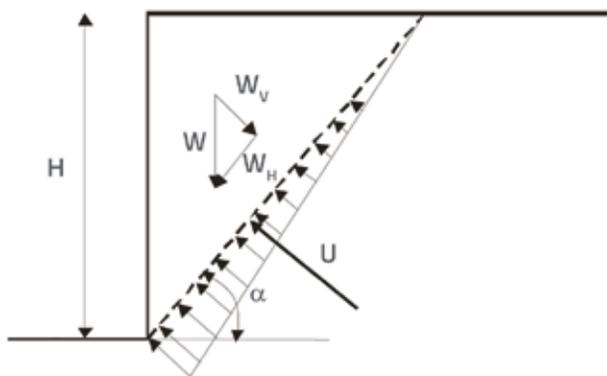
The parametric analysis of wedge sliding along the joint at an angle  $\alpha$  (cross section in Figure 14) was conducted in the scope of analysis of shear strength at which the sliding occurs. This analysis was conducted for the side cut 10m in height. The rock mass was modelled with the unit weight of  $\gamma = 23 \text{ kN/m}^3$ , and the cohesion and joint inclination toward the side cut ( $\alpha$ ) were varied for the constant angle of friction along joints  $\varphi_j = 30^\circ$ . The value of the angle of internal friction was selected based on shear strength measurements in marl, as shown in Tables 2, 3 and 4, and for the weathered and non-weathered samples. The goal was to define the value  $c_j$  for which the limit state ( $F_s = 1$ ) is obtained at different joint dip values ( $\alpha$ ). The influence of water pressure on joints is

analyzed under assumption that the bottom end of the joint was still non-weathered immediately prior to fracturing i.e., that water could not have escaped toward the bottom end of the joint. Thus the hydrostatic pressure was modelled along the joints (example from Figure 10). The following expression was derived from these conditions:

Figure 14. Model of wedge sliding along the joint, as used in parametric analysis

Parametric analysis results are presented in Table 5. If cohesion values obtained from the above analysis are considered, it can be concluded that they roughly correspond to the cohesion value measured at degraded samples treated by laboratory weathering (Tables 3 and 4). The end product of weathering is the residual material in form of marly clay, and the shear strength of fully degraded material should correspond to the strength of marly clay. However, the weathering level is not necessarily the same along the entire length of the joint, or along the material depth. For that reason, the shear strength at which the failure and sliding occur can only be taken as an average value along the failure surface.
