Static and dynamic analysis of the old stone bridge in Mostar

Professional paper

Jure Radnić, Alen Harapin, Marija Smilović, Nikola Grgić, Mladen Glibić

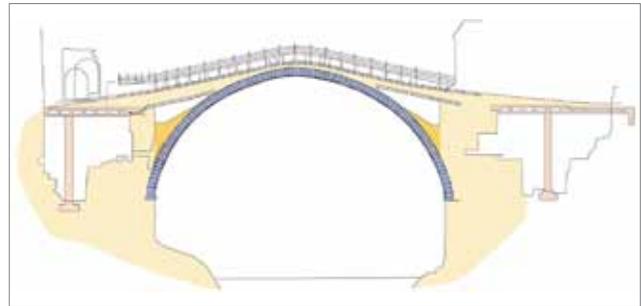
Figure 3. Longitudinal cross-section of the bridge

- Big hollow areas, with reinforced-concrete bearing structure, in which archaeological museums are positioned, were left in the zones immediately behind both abutments [6] (Figure 3). The bottom of the hollow areas is at the arch spring level. Compared to the original situation, this has reduced favourable action of the permanent vertical load behind the arch heel, and has at the same time increased horizontal deformability of the arch.

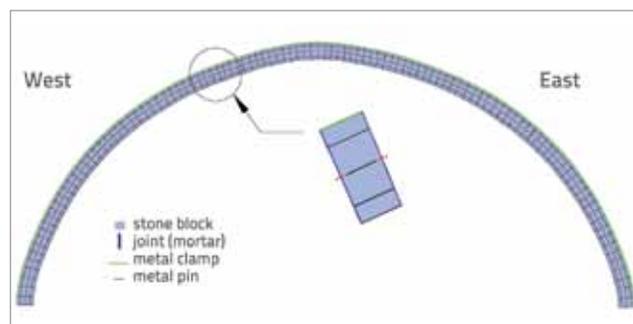
Figure 10. Bridge structure geometry model NM1

The arch discretisation by finite elements is shown in Figure 10. The deformed arch geometry, as selected during bridge renovation [3], with the wall micromodel [1, 2], was adopted. In this geometry model, each stone block along the arch axis is modelled by finite elements of equal width. Along the arch height, each stone block was modelled with four finite elements. The mortar between the stone blocks was simulated by contact elements 6 mm in thickness, corresponding to the width of joints. The connection of stone blocks along the arch extrados was simulated with metal cramps (tension bar elements), while the link between stone blocks in the arch axis was simulated with metal dowels (shear bar elements). Appropriate boundary conditions were applied at the connection between the arch and massive abutments

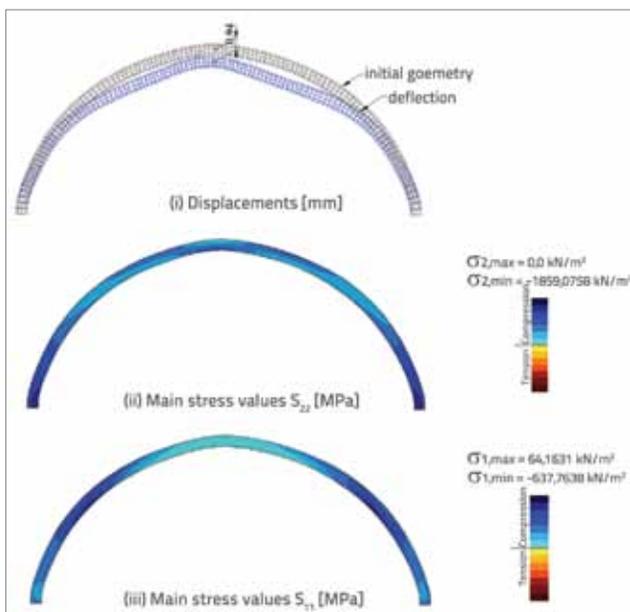
Some analysis results for vertical load only (self-weight of the arch, spandrel structure weight, and pedestrian load) are presented in Figure 11. The pedestrian load of 5 kN/m² was assumed along the entire walking surface of the bridge. It amounts to as little as 7 percent of the total permanent load. The design deflection of arch in the crown amounts to 0.94 mm, which almost corresponds to the displacement of 0.9

Figure 11. Some numerical results for vertical load only (permanent load and pedestrians) – NM1 model

mm as measured after the scaffold was released (south side) [10]. In the direction of axis, the arch dominantly assumes compressive load and this along the entire thickness. The biggest main compressive stress in the arch amounts to -1.86 MPa. Tensile stresses in stone blocks do not exceed the tensile strength of the stone, i.e. there are no cracks in stone blocks.

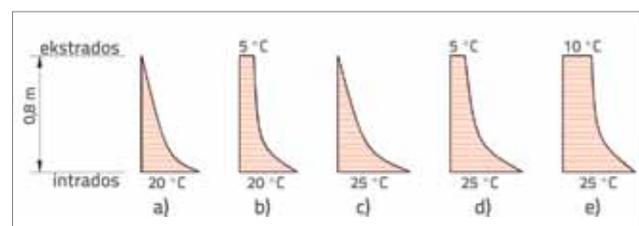
The stress in arch due to temperature changes was activated after the final arch closing at the crown level (21 August 2003). In fact the arch was closed in crown in the summer period, at the ambient temperature of about 25 °C. Annual temperature variations in the town of Mostar are quite big, and mostly range from -5 °C to 50 °C [8]. Different annual and diurnal temperature variations are also possible along the arch length and thickness. For simplicity of analysis, we assumed that the temperature is constant along the arch length, and variable along the arch thickness. Some temperature changes, believed to be possible and ranking among the most unfavourable ones, are presented in Figure 12. Relevant temperature variations are those that cause pressure next to the arch intrados, as compared to the pressure situation at the arch closing time. The temperature coefficient of $\alpha_{tb} = 6,5 \times 10^{-6}$ was assumed for stone blocks, and this coefficient in joints was assumed to be $\alpha_{tm} = 6,0 \times 10^{-6}$. Some results obtained for simultaneous action of vertical load and temperature changes according to Figure 12a are shown in Figure 13. The highest main compressive stress in stone blocks amounts to -3.48 MPa. The design position of cracks in stone blocks at the arch face is shown in Figure 14, which corresponds well to the actual present time cracks shown in Figure 9.

Figure 12. Some temperature changes along the arch thickness

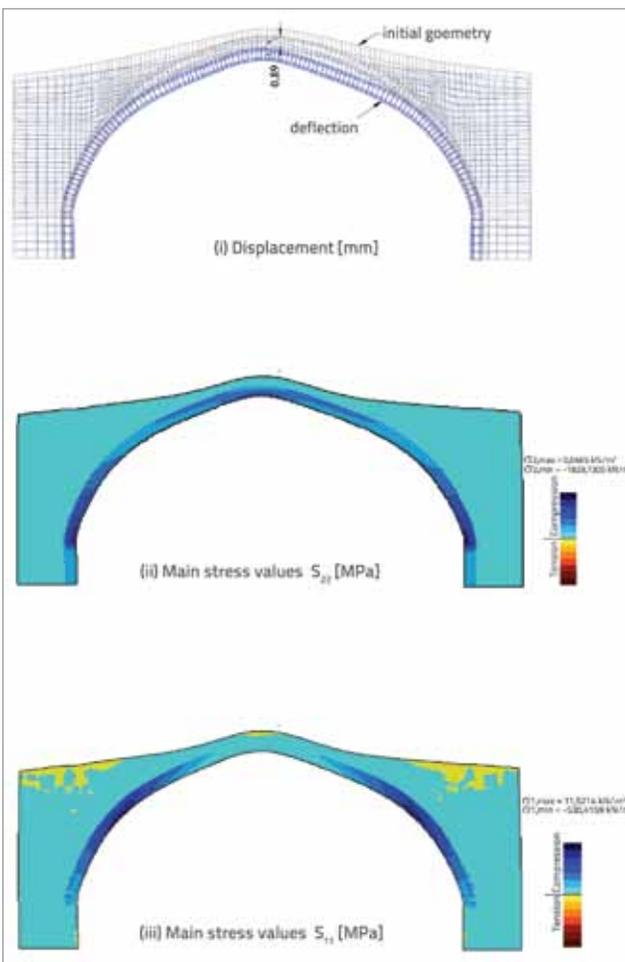
Some calculation results defining the influence of vertical load only are presented in Figure 16. It can be seen that the results correspond well to those given in figure 11 for the geometry model NM1. Some numerical results for the influence of vertical load and temperature changes according to figure 12a are presented in Figure 17. Here also we can see a good correspondence of results with those from Figure 13 for the NM1 model.

Figure 16. Some calculation results for the total vertical load - NM2 model)

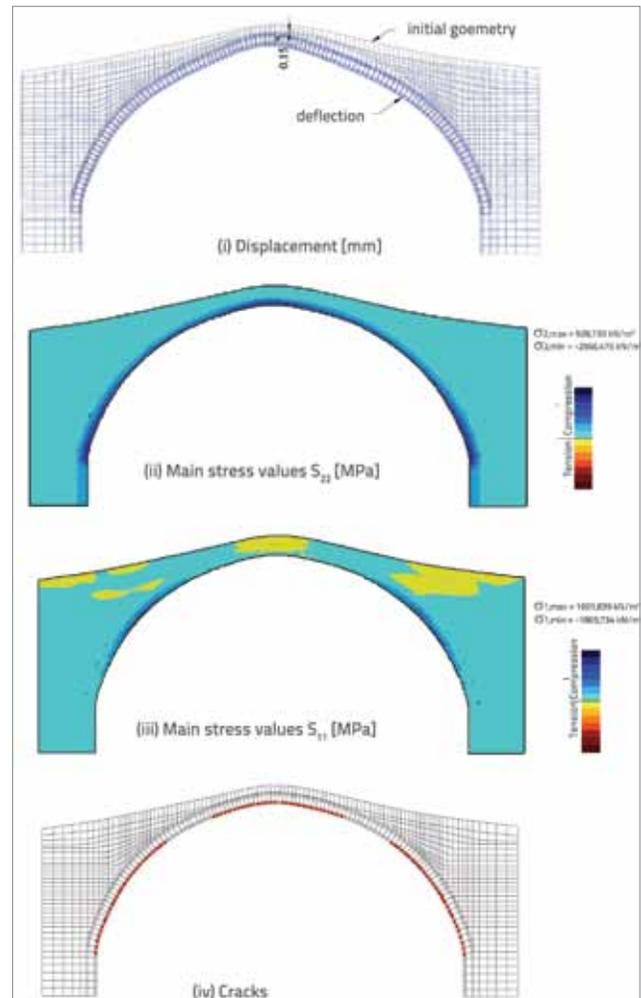
Figure 17. Some calculation results for vertical load and temperature changes according to Figure 12a - NM2 model

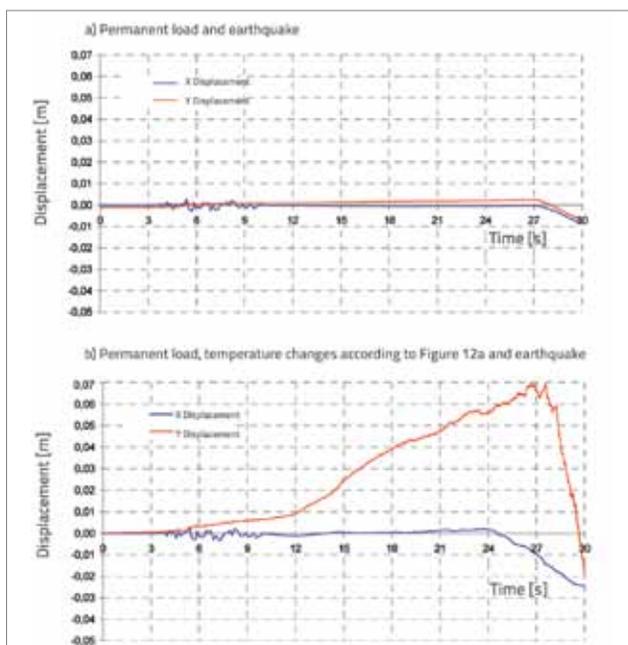
The arch displacement in crown for the Ston earthquake according to Figure 18 is presented in Figure 20. At that the following cases were analyzed: (i) only permanent load and earthquake and (ii) permanent load, temperature changes according to Figure 12a, and earthquake. In both cases, a sudden increase in displacement and crushing of materials, i.e. the divergence of numerical procedure or structural failure, occurs near the end of the earthquake action.

Figure 20. Arch displacement in crown for the Ston earthquake according to Figure 18

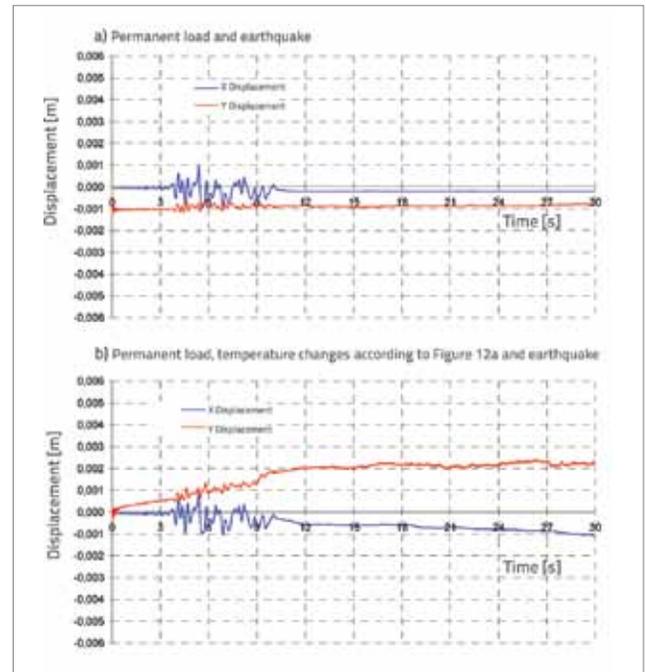
Figure 21. Displacement in arch crown for the scaled Ston earthquake (greatest horizontal acceleration: 0.3g)

Some calculation results for the scaled Ston earthquake, with the biggest horizontal acceleration of 0.3g, are presented in Figures 21-23. Despite severe damage (cracking), the bridge structure "survived" in the following cases of load: (i) permanent load and earthquake, and (ii) permanent load, temperature changes according to figure 12a, and earthquake.

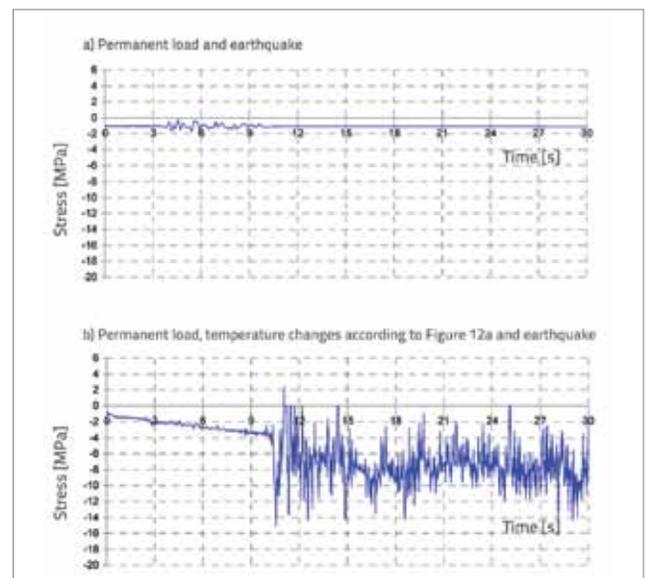
Figure 22. Stress in stone block at arch spring next to intrados for the scaled Ston earthquake (greatest horizontal acceleration 0.3g)

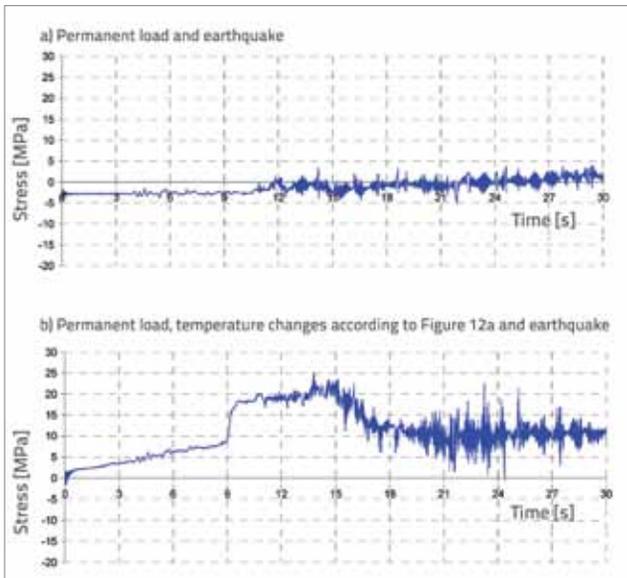
Figure 23. Stress in metal cramp in arch crown for the scaled Ston earthquake (greatest horizontal acceleration 0.3g)
