Wooden structures in the historic port of Rijeka

Subject review

A review of the use of wood in construction of the historic port of Rijeka is given in the paper. Traditional use of wooden structures for floors and roofs can be seen in ancillary structures and early warehouses, while the first temporary storage units were also wooden skeletal structures. The Grain Silo, a veritable masterpiece of carpentry skill, can be singled out by its demanding and unusual structure, together with half-timber structures of Quarnero Bathhouse, and those of rowing clubs on the breakwater.

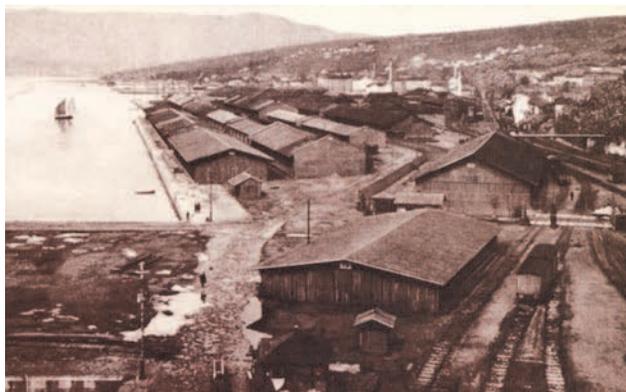
Figure 9. Photo of warehouses at the foot of the Marie Valerie pier (Visinpier), and at the Wharf to the wartime harbour (Prague wharf)

Skeleton structures (or beam-post structures) with bigger spacing of the posts and beams were most commonly used for the construction of temporary warehouses, which were characteristic for the first phase of development of the railway-port zone (Figure 9). They were usually one-storey buildings of simple rectangular shape, while in rare cases their shape was more complex, adjusted to the locality. The dimensions and spans were standard, with posts spaced at up to 5m intervals in several longitudinal rows, the end ones being peripheral elements. The façade lining was solved in several ways. The cheaper versions consisted of one-layer planks which were butt-jointed and directly nailed only from outside onto horizontal beams of

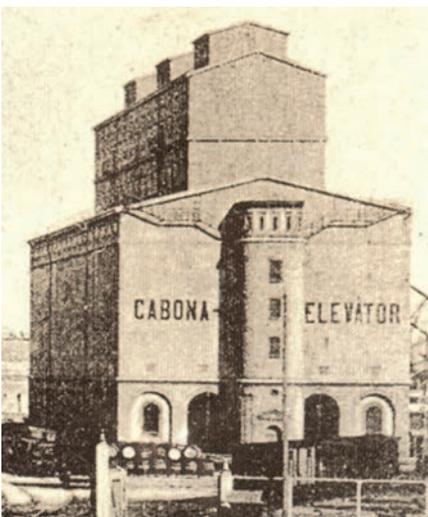
Figure 13. Grain silo, view on western front [26]

Except for the 12 m tall storey with chambers, all other storeys were of standard height, which varied between 3.30 and 5 m (Figure 13 and Figure 14) [1]. The grains were raised up to all storeys of the silo using elevators, while further transport was operated with conveyors, Redler systems, or flutes. All upper storeys were built as traditional storages in which the cargo is

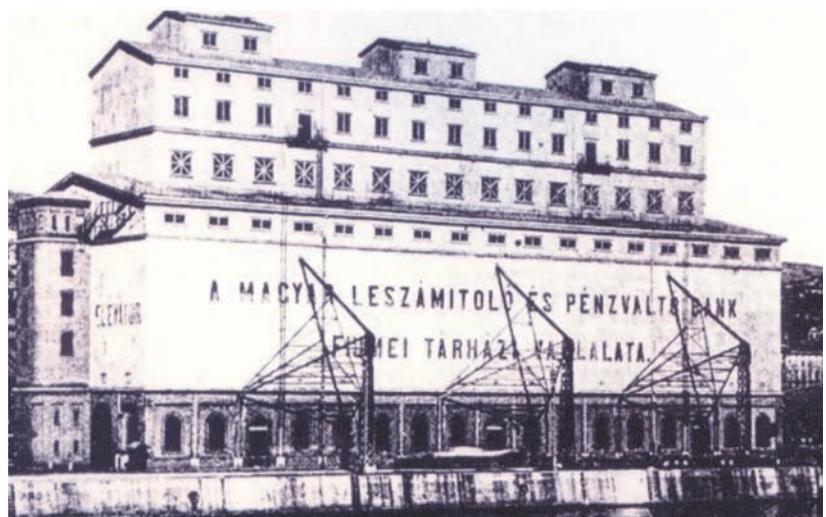
Figure 14. Grain silo, view on southern front [27]

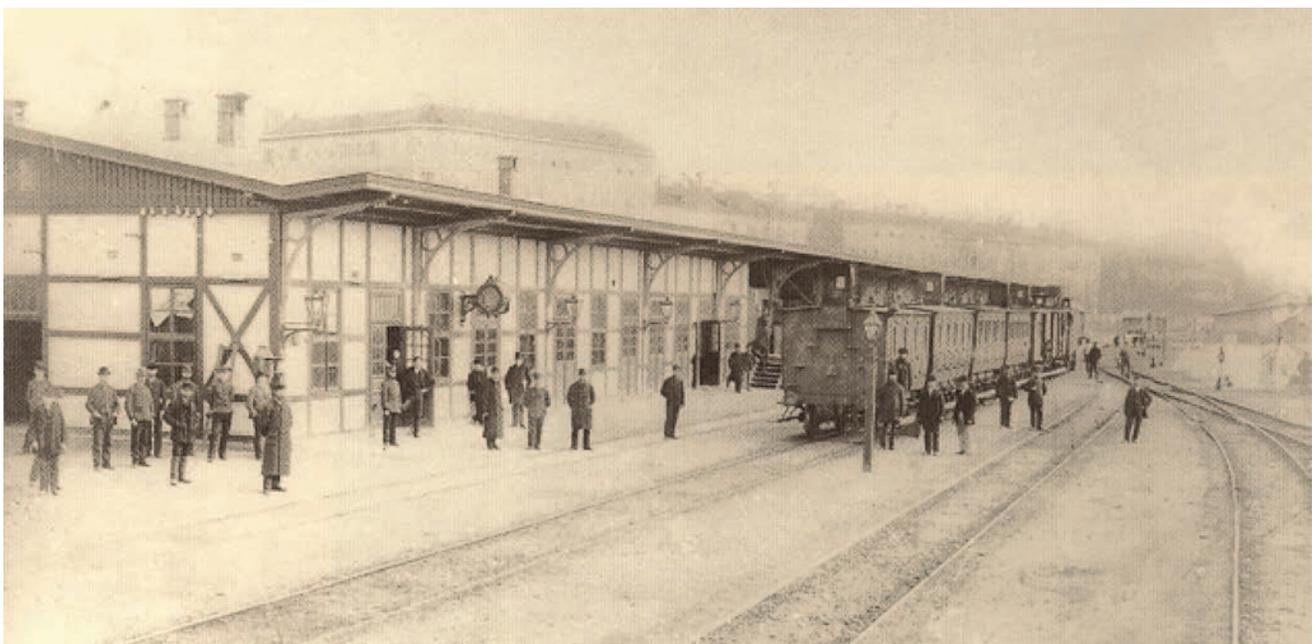
Figure 20. Old railway station (1873-1888), southern façade and part of western façade [1]

the design was not preserved, and so we now have only two photographs showing its smaller parts, i.e. one shows parts of its southern and western façades (Figure 20), and the other the eastern façade. It can be discerned from the photos that this was a rectangular building, typologically similar to warehouse 31, but with wooden structure. The building had two parallel slightly sloping double-pitched roofs, which extended from the eastern (probably also the northern) side into canopies supported by cantilevers. The central part of the station was somewhat elevated with regard to its sides, and was accessed via laterally placed (probably both sided) wooden stairs. The station was not a traditional half-timbered building, but rather a skeletal and half-timbered combination. The posts of the structure were spaced at smaller intervals in longitudinal direction, while the spacing in transverse direction was greater compared to the one typically used for half-timbered structures. The wall structure between internal posts was divided by beams into four sections, while cross-diagonal braces for side-post stiffening were set in two central sections of the corners. The wall infill of the half-timber structure probably consisted of bricks finished with plaster [1].

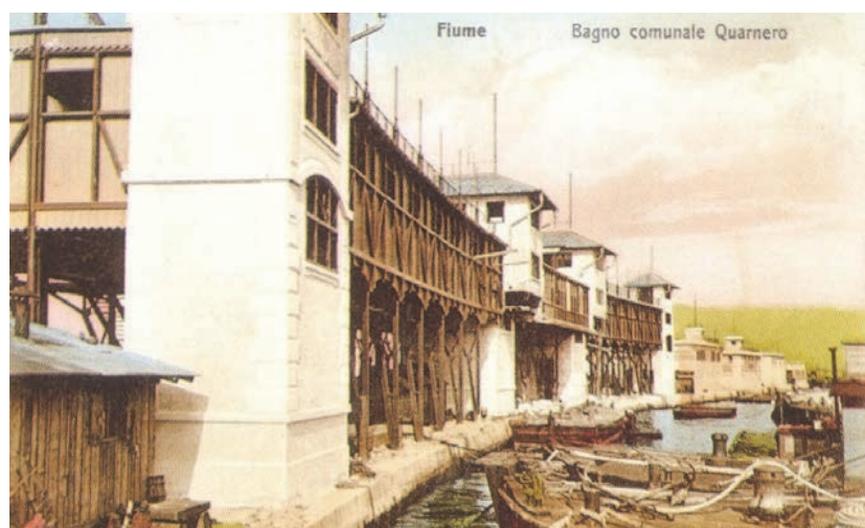
Figure 24. Quarnero Bath, northern front facing the town, next to rowing clubs Quarnero, Canottieri Fiumani, Liburnia and Eneo [24]

meters of clearance for the passage of trains. The high ground floor area was constructed as a skeletal steel structure, while the upper storeys were realized as a half-timbered and skeletal structure (Figures 24, 25).

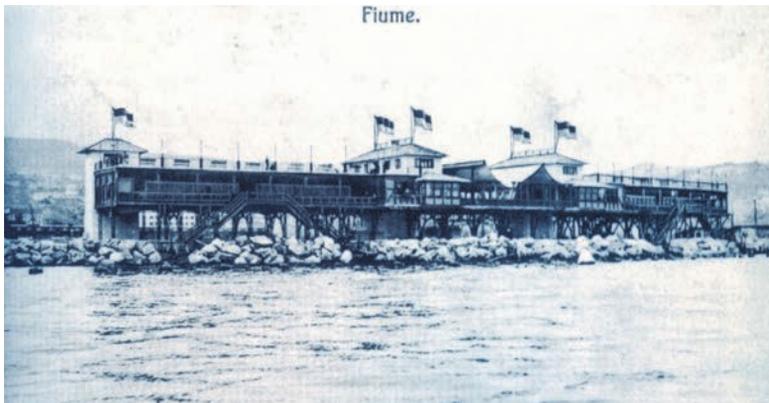
Figure 25. Quarnero Bath, southern front towards the bay [24]
